Client: New Homes Inc.
Project: Smithfield - French Country - FE / LH
Address: 394 Duncans Creek
Lillington, NC
Harnett County

Date: 5/22/2025
Input by: Hampton Horrocks
Job Name: 158 Duncans Creek
Project #: J1124-6344

FJ13 BLI 40 11.875" - No Repair Required
See User Note 1

FJ9 BLI 40 11.875" - - No Repair Required
See User Note 1

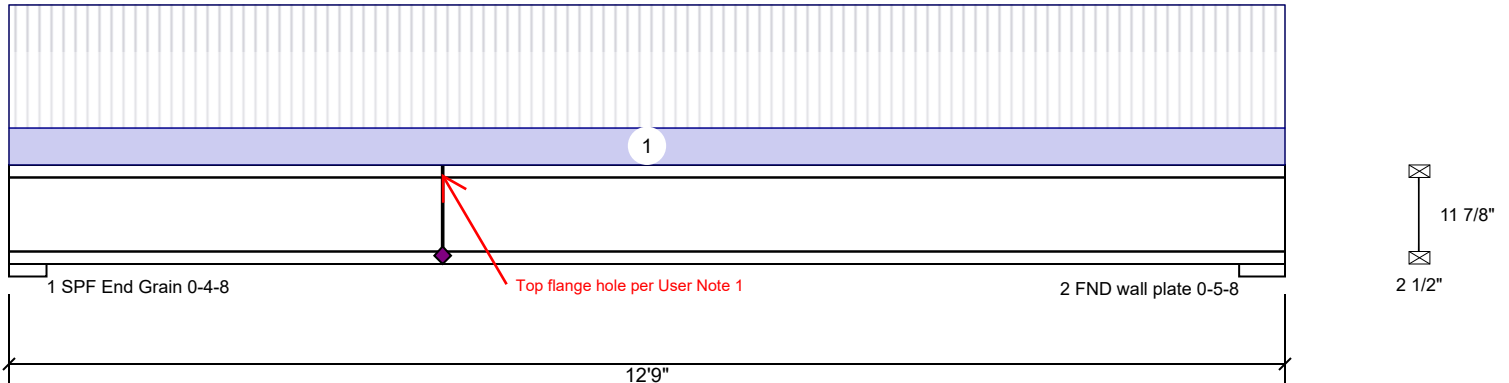
Analysis	Actual	Location	Allowed	Capacity	Comb.	Case
Moment	1257 ft-lb	6'4"	3545 ft-lb	35%	D+L	L
Shear	413 lb	4 1/2"	1480 lb	28%	D+L	L
LL Defl inch	0.077 (L/1865)	6'4"	0.301 (L/480)	26%	L	L
TL Defl inch	0.101 (L/1435)	6'4"	0.602 (L/240)	17%	D+L	L

Analysis Type	Location	Max Value	Ld. Comb.	Ld. Case
Pos Moment	4'4"	1118 ft-lb	D+L	L
Shear	4'4"	139 lb	D+L	L
Down Defl	4'4"	0.088	D+L	L

- Location Analysis represents a vertical hole through one leg of top flange. The web was not disturbed. This design based on scaling of provided photograph. No definitive cross-section dimensions of joist flange hole were provided. No repair required.

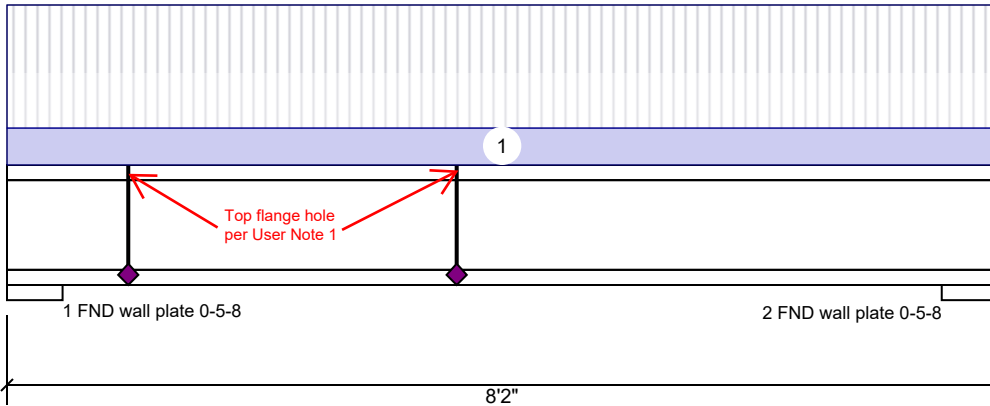
Analysis	Actual	Location	Allowed	Capacity	Comb.	Case
Moment	471 ft-lb	4'1"	3545 ft-lb	13%	D+L	L
Shear	251 lb	7'8 1/2"	1480 lb	17%	D+L	L
LL Defl inch	0.014 (L/6137)	4'1 1/16"	0.184 (L/480)	8%	L	L
TL Defl inch	0.019 (L/4720)	4'1 1/16"	0.369 (L/240)	5%	D+L	L

Analysis Type	Location	Max Value	Ld. Comb.	Ld. Case
Pos Moment	1'	142 ft-lb	D+L	L
Shear	1'	214 lb	D+L	L
Down Defl	1'	0.005	D+L	L
Pos Moment	3'8 1/2"	467 ft-lb	D+L	L
Shear	3'8 1/2"	26 lb	D+L	L
Down Defl	3'8 1/2"	0.019	D+L	L

- Location Analysis points represent two vertical holes through one leg of top flange. The web was not disturbed. This design based on scaling of provided photograph. No definitive cross-section dimensions of joist flange holes were provided. No repair required.
