**RE:** Daily Field Report for 02/08/2025  
228 Dove Road (CMT) Cameron, NC  
Building & Earth Project No : RD250059

## Field Observations Report

| Monitoring: | <b>Shallow Foundation Inspection</b> | | |

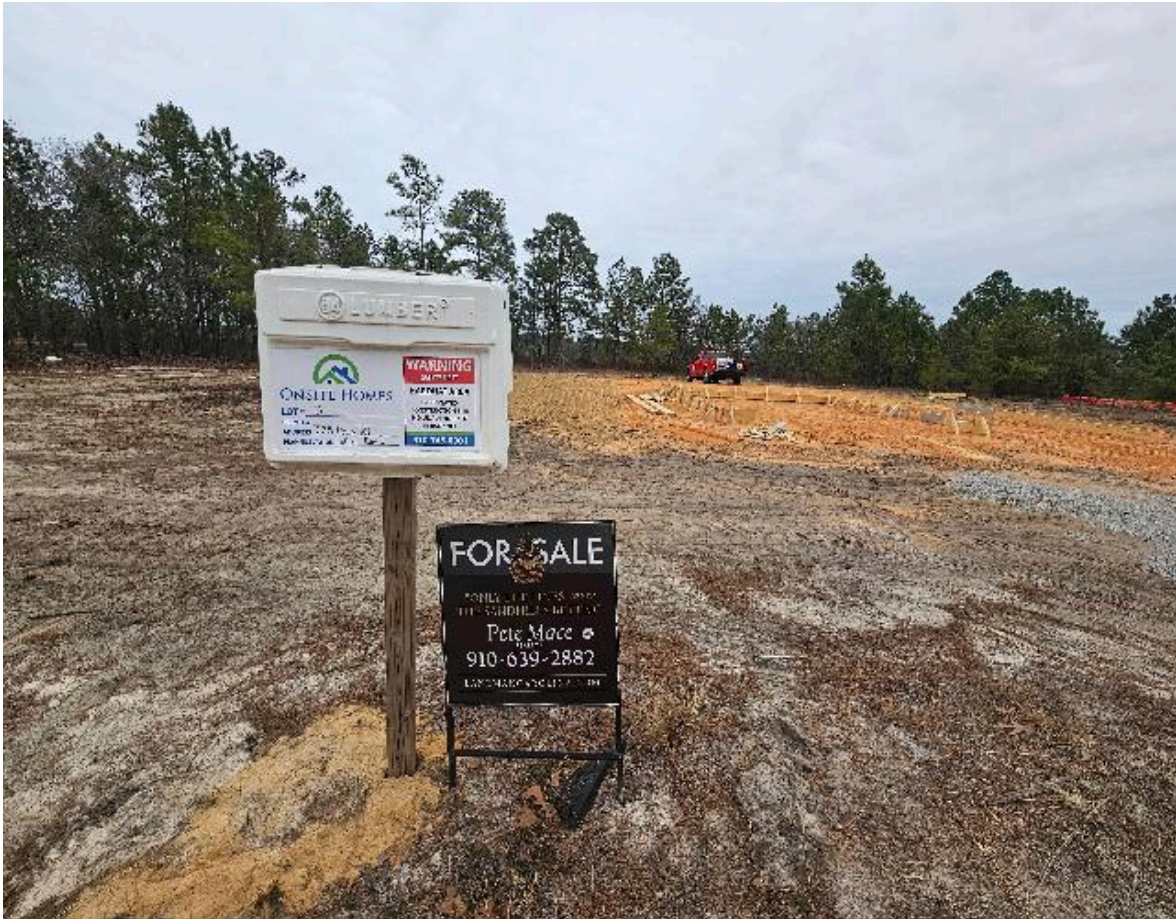
| Picture ID | Lot Sign |
|---|---|
| 101074 | |

| Picture ID | Lot Sign |
