Client: New Homes, Inc.
Project: Smithfield - French Country GR
Address: 4524 Duncan Creek Road
Lillington, NC - 27546

Date: 4/22/2025
Input by: Hampton Horrocks
Job Name: 156 Duncan's Creek - 1st Floor EWP
Project #: J1024-5460

**FJ28-rear BLI 40 11.875" - No Repair Required
See User Note 1**

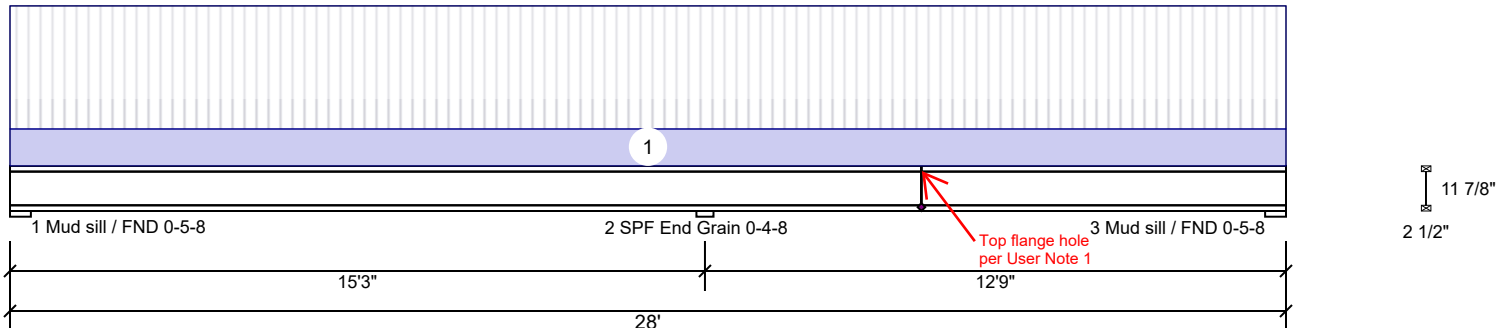
- Location Analysis represents ~1/2" diameter vertical hole going through one side of top flange. Hole is located against web, but does not appear to intrude into the web. This design based on scaling of provided photograph. No definitive cross-section dimensions of vertical top flange hole were provided. Stated cross-section dimensions of damage depicted in this calculation should be field-verified. No repair required.

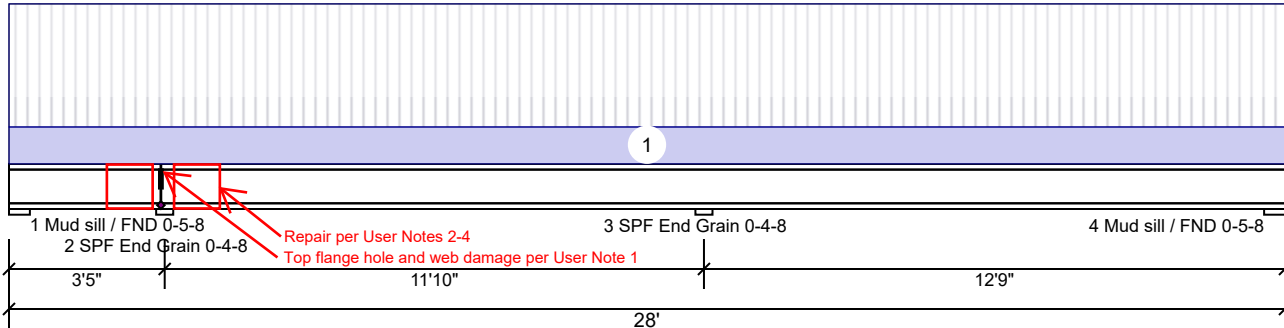
FJ28-front BLI 40 11.875" - Repair Required
See User Notes 1-4

Hole Type	Location	Size	Capacity	Act Shr.	All. Shr.
Rec.	H3'4"	1" X 5"	48%	308 lb	649 lb

- 1 Location Analysis represents ~1/2" diameter vertical hole going through one side of top flange. Hole is located against web. Web appears to be damaged below vertical hole as indicated in Hole Analysis table. This design based on scaling of provided photograph. No definitive cross-section dimensions of vertical top flange hole were provided. Stated cross-section dimensions of damage depicted in this calculation should be field-verified. Repair as follows.

- 2 Attach 23/32" x 11 7/8" high x 12" long APA 48/24 span-rated plywood (face grain horizontal) to top & bottom flanges on one face with 8d Sinker Nails (0.113 x 2 3/8") @ 3" o.c.
- 3 Use 1/4" bead of carpenter's wood glue on all contact surfaces.
- 4 Locate at both vertical edges of perpendicular blocking.

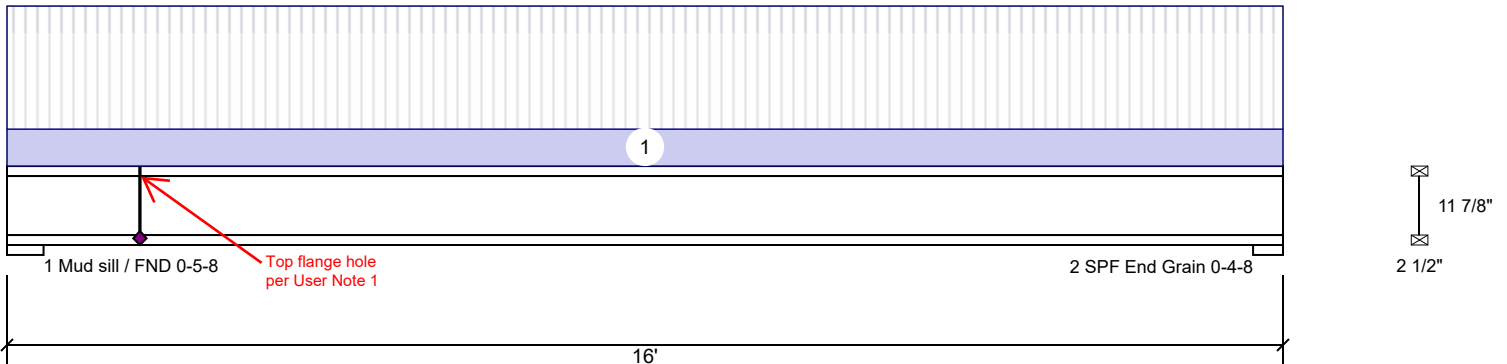
FJ16 BLI 40 11.875" - No Repair Required
See User Note 1

- Location Analysis represents ~1/2" diameter vertical hole going through one side of top flange. Hole is located against web, but does not appear to intrude into the web. This design based on scaling of provided photograph. No definitive cross-section dimensions of vertical top flange hole were provided. Stated cross-section dimensions of damage depicted in this calculation should be field-verified. No repair required.

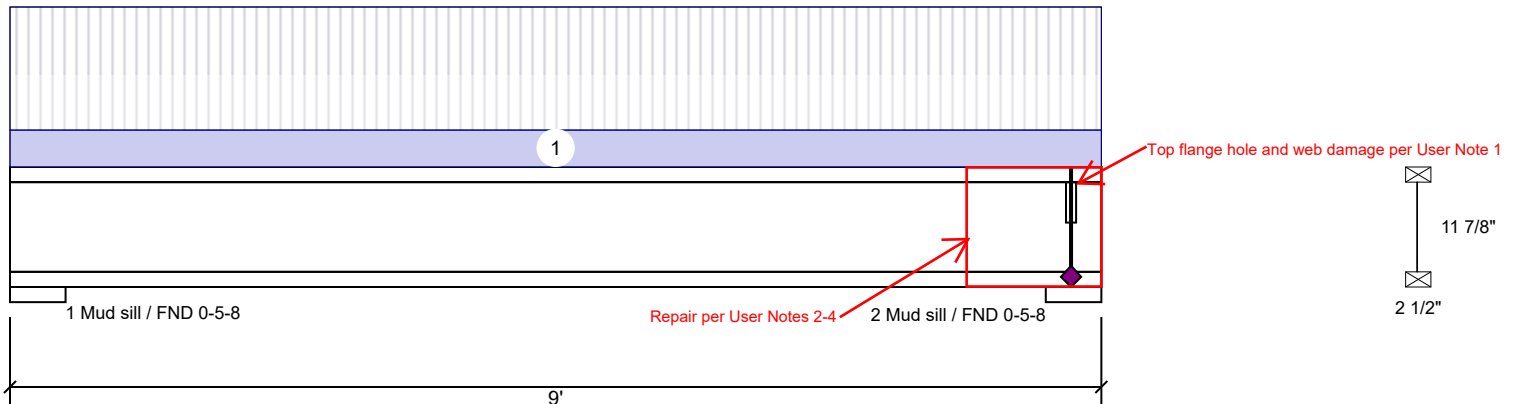
FJ9 BLI 40 11.875" - Repair Required See User Notes 1-4

- 1 Location Analysis represents ~1/2" diameter vertical hole going through one side of top flange. Hole is located against web. Web appears to be damaged below vertical hole as indicated in Hole Analysis table. This design based on scaling of provided photograph. No definitive cross-section dimensions of vertical top flange hole were provided. Stated cross-section dimensions of damage depicted in this calculation should be field-verified. Repair as follows.
- 2 Attach 23/32" x 14" high x 12" long APA 48/24 span-rated plywood (face grain horizontal) to top & bottom flanges on opposite face from web damage with 8d Sinker Nails (0.113 x 2 3/8") @ 3" o.c.
- 3 Use 1/4" bead of carpenter's wood glue on all contact surfaces.
- 4 Locate end of gusset at right end of joist.
