MEMBER REPORT

1st Floor, FC1: J1 (i1464)

Job Notes TC 156058 544 DUNCAN CREEK ROAD LILLINGTON, NC, 27546 DUNCAN'S CREEK 155

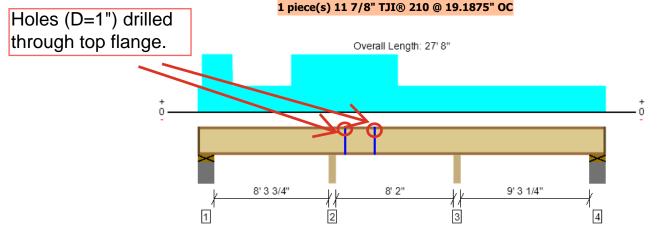
Design Results	Actual @ Location	Allowed	Result	LDF	Load: Combination (Pattern)
Member Reaction (lbs)	1118 @ 9' 1 1/2"	2145 (3.50")	Passed (52%)	1.00	1.0 D + 1.0 L (Adj Spans)
Shear (lbs)	506 @ 8' 11 3/4"	1821	Passed (28%)	1.00	1.0 D + 1.0 L (Adj Spans)
Moment (Ft-lbs)	-853 @ 9' 1 1/2"	3795	Passed (22%)	1.00	1.0 D + 1.0 L (Adj Spans)
Live Load Defl. (in)	0.034 @ 22' 6 13/16"	0.237	Passed (L/999+)		1.0 D + 1.0 L (Alt Spans)
Total Load Defl. (in)	0.041 @ 22' 7 3/4"	0.475	Passed (L/999+)		1.0 D + 1.0 L (Alt Spans)
TJ-Pro [™] Rating	60	40	Passed

Shear (lbs)		Moment (Ft-Ibs)		Deflection (in)				
Location Analysis	Actual	Allowed	LDF	Actual	Allowed	LDF	Live Load Total		Comments
1 - 10'									1" hole drilled through top flange
2 - 12'									1" hole drilled through top flange

Member with damage as shown (and repaired if required) has adequate structural capacity for the design condition indicated. I have not reviewed the project plans or field conditions. The proper authority is to review the damage evaluation inputs and confirm they are consistent with the intent of the overall building design and field conditions. This damage evaluation is based on the information provided to Weyerhaeuser; if not consistent with the building design and field conditions, it should be rejected or returned to us to be corrected.
