lis	Design		Client: Project: Address:	New Home	Inc Is Creek Road	I, Lillingtor	n NC	Date: Input by: Job Name Project #:	3/19/202 Johnnie e: The Selr J1023-56	Baggett na				Page 1 of 5
FJ1 N	II-40x	11 875	" - No	Renair	Require	d		,	Level: Level

isDesign Address: 1723 Neills Creek Road, Lillington NC Job Name: Th	ohnnie Baggett	
	he Selma	
Project #: J1	1023-5899/5900	
FJ4 NI-40x 11.875" - No Repair Required	el: Level	
See User Note 1		
1		
	1	
		11 7/8" ⊠
	flange hole 3 SPF End Grain 0-3-8 User Note 1	2 1/2"
9' 5/8" 1 8'5 1		
17'5 3/4"		
	'	
Member Information Reactions PATTER	RNFD lb (Unlift)	
Type: Joist Application: Floor Brg Direction	Live Dead Snow	Wind Const
	66 (-10) 90 0	0 0
Moisture Condition: Dry         Building Code:         IBC/IRC 2015         2         Vertical	662 248 0	0 0
	50 (-19) 81 0	0 0
Deflection TL: 360 Deck: 23/32 APA Rated Sturd- I-FloorOSB Nailed and		
Glued Glued		
Temperature: Temp <= 100°F Ceiling: Gypsum 1/2" Bearings		
Vibration: OK	Dir Can Baaat D/Lilb Tatal Ld	Casa Id Camb
Vibration CCMC - CSA086-19	Dir. Cap. React D/L lb Total Ld	
	Vert 25% 90 / 265 355 L_	D+L
Vibration Span: 18-7-0 (47%) End Vibration Span: 18-7-0 (44%) Grain

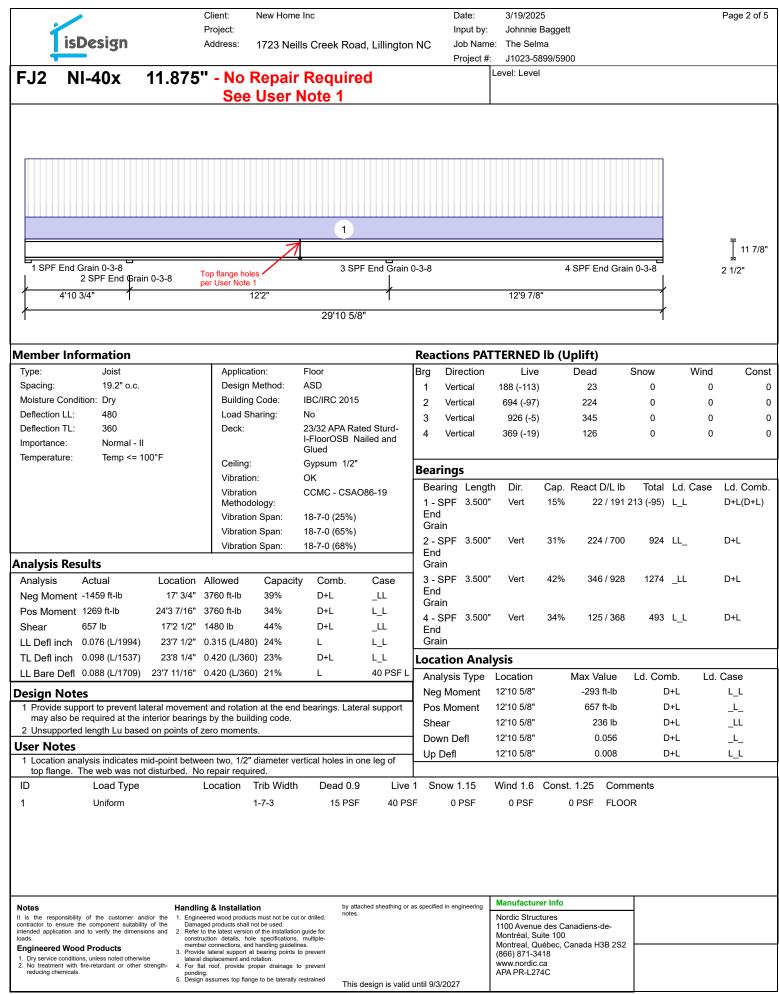
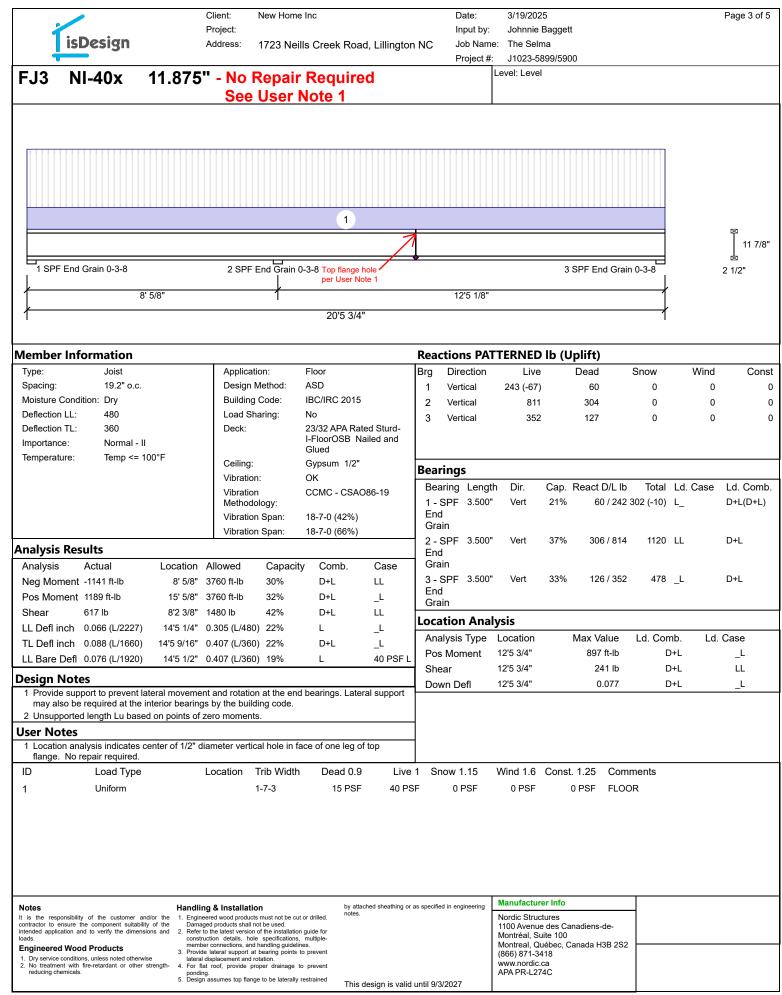
-	ed on points of	zero momen	ts.			Pos	Moment	8'		1009 ft-lb	D+	L	L_LL
User Notes							She		8'		247 lb	D+	L	LL
		center of 1/2" d repair required.		cal hole in or	ne leg of top flan	ge. The	Dov	wn Defl	8'		0.088	D+	L	L_LL
ID	Load Type	- · · ·		Trib Width	Dead 0.9	Live	1 Sr	now 1.15	Wind 1.6	Const	. 1.25 Com	ments		
1	Uniform			1-7-3	15 PSF	40 PS		0 PSF	0 PSF		0 PSF FLOC			
I	omonn			1-1-0	10 - 01	-+v r c		UT OF	010		FLUC			
Notes Handling & Installation by attached sheathing or a								ed in engineering	Manufactur	er Info				
It is the responsibili	ity of the customer	and/or the 1. Engine	ered wood produc	ts must not be cut	notee				Nordic Struc					
contractor to ensure the component suitability of the intended application and to verify the dimensions and 2. Refer to the latest version of the installation guide for									1100 Avenue Montréal, Su		nadiens-de-			
loads. Engineered Wood Products S. Provide lateral support at bearing points to prevent									Montreal, Q	lébec, C	anada H3B 2S2
