Project #25-123

5075 Old US 421,

At your request, a limited structural inspection was performed on the properties located at the above address to inspect the following items. This report has been prepared based on that inspection. Directions are used herein as they would appear to an observer facing the properties from the front main entrance.

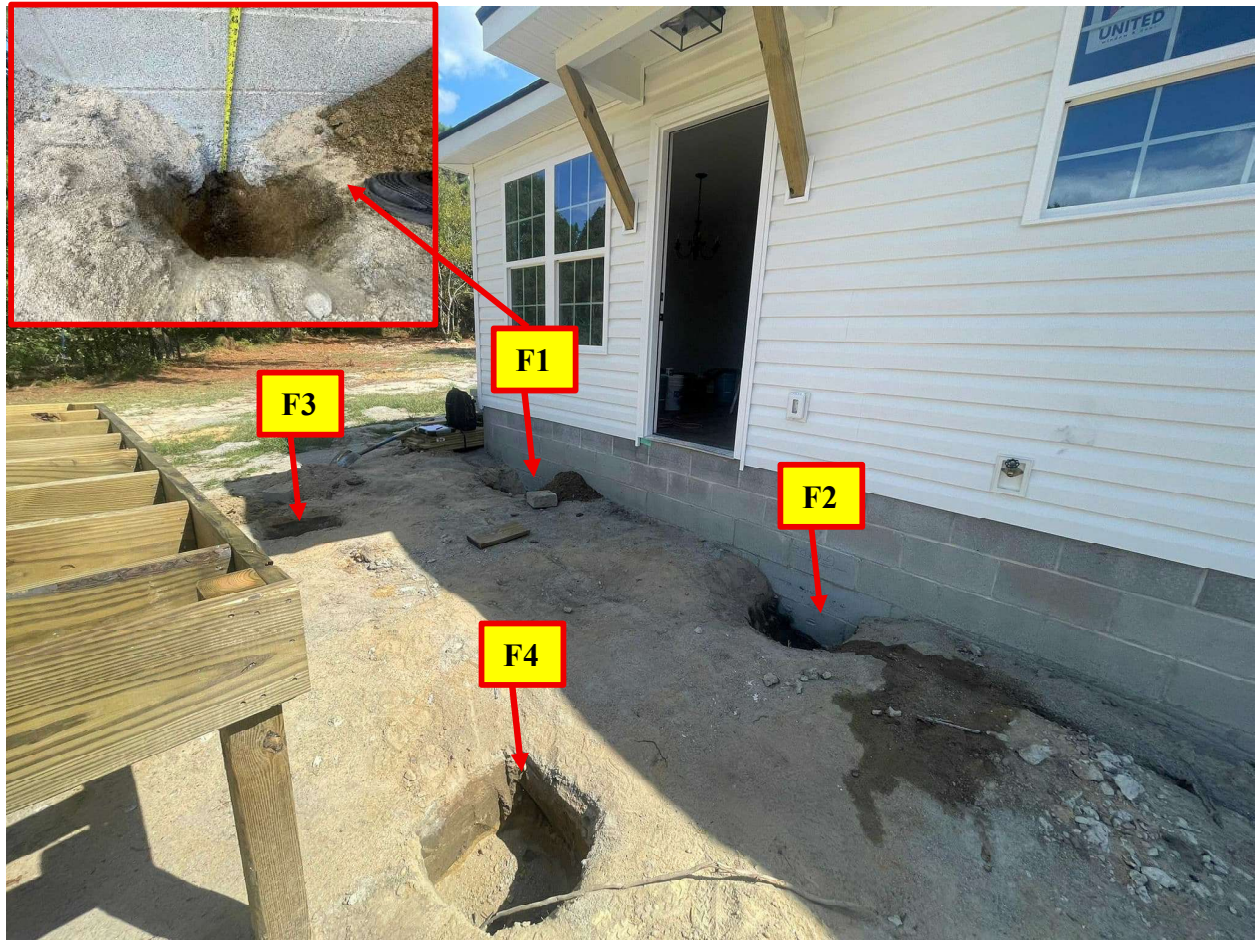
Picture 1

A site visit was made to inspect the soil and footing excavations for a proposed deck at the rear right side of the house. EEI noted that at the location of the footing marked as "F1", the existing continuous concrete footing along the rear side of the house was cut (see Picture 1).

A Dynamic Cone Penetrometer (DCP) test was performed at three different locations to determine the bearing capacity of the soil. Based on the DCP test and interpretation of the test data, a minimum of 2000 psf soil bearing capacity can be achieved at approximately 12" below the finished grade.

Based on the evaluation of the loads applied from the proposed floor framing system, each footing marked as "F1 to F4" shall be minimum of 24"x24"x12" deep (see Picture 1). Underneath each footing, a minimum of 6" layer of compacted gravel shall be placed so that the bottom of compacted gravel is 18" below the ground level, and the bottom of the footings is at 12" below the ground level. Footings shall be reinforced with a minimum of 4 pieces of #4 rebars spaced at 6" o.c., both ways with a minimum of 3" rebar clear cover. Additionally, EEI recommends attaching the new concrete footing "F1" to the existing cut continuous concrete footing along the rear side of the house using (4) pieces of #4 rebars spaced at maximum 6" on center at the mid-depth of the height of the footing. EEI recommends that the rebars should be drilled a minimum 6" into existing concrete and shall extend a minimum of 12" into the newly footing using the "HILTY HIT-RE 100" epoxy adhesive system or approved equivalent. The concrete shall have a minimum 28-day compressive strength of 2500 psi. All reinforcing steel shall conform to ASTM A615, Grade 60.

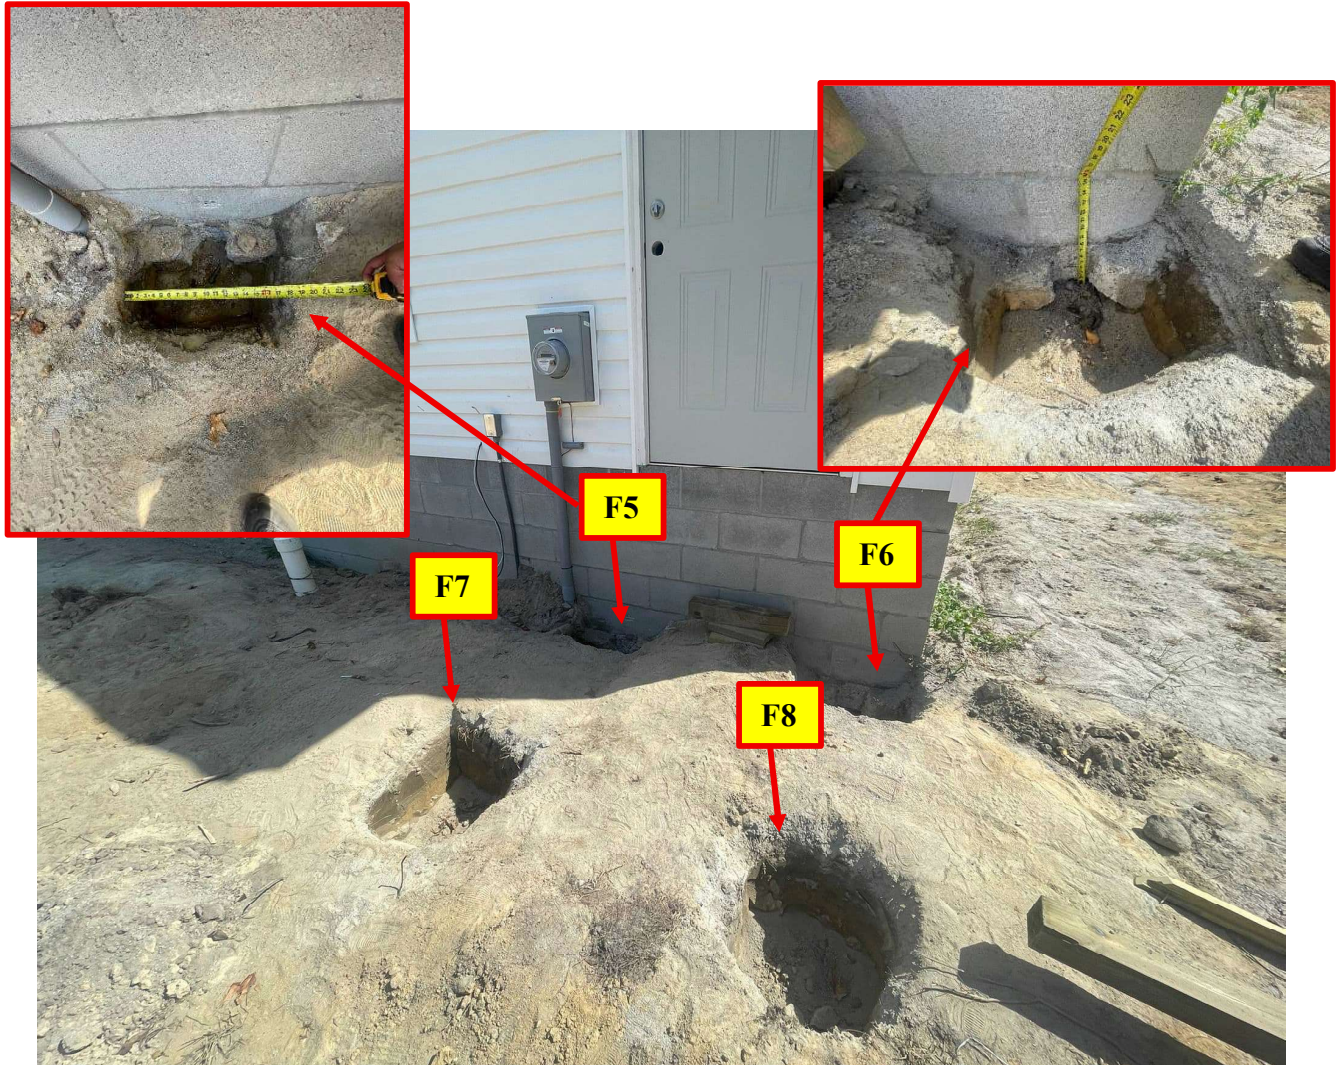
**Picture 2**

A site visit was made to inspect the soil and footing excavations for a proposed deck at the rear left side of the house. EEI noted that at the location of the footing marked as “F5 and F6”, the existing continuous concrete footing along the rear side of the house was cut (see Picture 2).

A Dynamic Cone Penetrometer (DCP) test was performed at three different locations to determine the bearing capacity of the soil. Based on the DCP test and interpretation of the test data, a minimum of 2000 psf soil bearing capacity can be achieved at approximately 12” below the finished grade.

Based on the evaluation of the loads applied from the proposed framing system, each footing marked as “F5 to F8” shall be a minimum of 24”x24”x12” deep (see Picture 2). Underneath each footing, a minimum 6” layer of compacted gravel shall be placed so that the bottom of compacted gravel is 18” below the ground level, and the bottom of the footings is 12” below the ground level. Footings shall be reinforced with a minimum of 4 pieces of #4 rebars spaced at 6” o.c., both ways, with a minimum of 3” rebar clear cover. Additionally, EEI recommends attaching the new concrete footing “F5 and F6” to the existing cut continuous concrete footing along the rear side of the house using (4) pieces of #4 rebars spaced at maximum of 6” on center at the mid-depth of the height of the footing. EEI recommends that the rebars should be drilled a minimum 6” into existing concrete and shall extend a minimum 12” into the newly footing using the “HILTY HIT-RE 100” epoxy adhesive system or approved equivalent. The concrete shall have a minimum 28-day compressive strength of 2500 psi. All reinforcing steel shall conform to ASTM A615, Grade 60.
