| Job 72505429REP1 | Truss C1 | Truss Type Truss | Qty 5 | Ply 1 | PBS/GUILFORD GEORGIAN LH ROOF Job Reference (optional) |

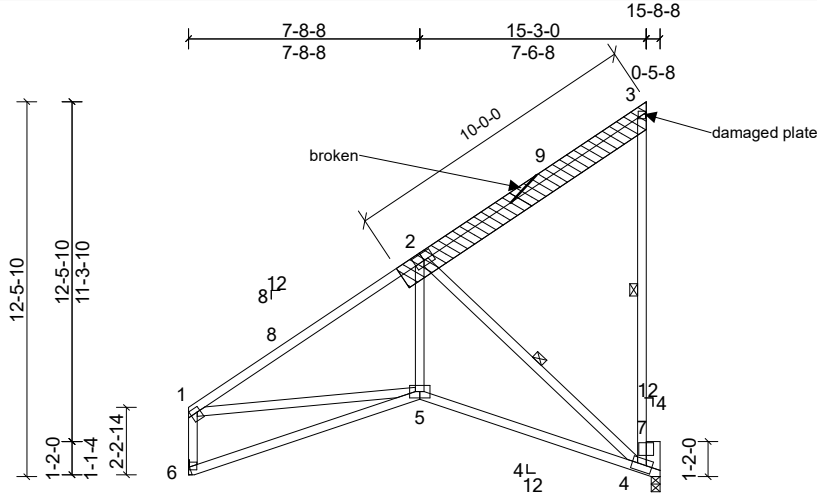
Repair for a broken top chord and damaged plate as shown.

Attach 2x10 x 10' SPF No.2 scab to one face of truss as shown with 2 rows of 10d (.131" x 3") nails 4" oc in the top chord and with 3 evenly spaced 10d nails in each web and end vertical.
