RE: Daily Field Report for 07/21/2025
Lot 46 Magnolia Ridge (CMT) Lillington, NC
Building & Earth Project No : RD250707

Field Observations Report

Report of Field Density Testing

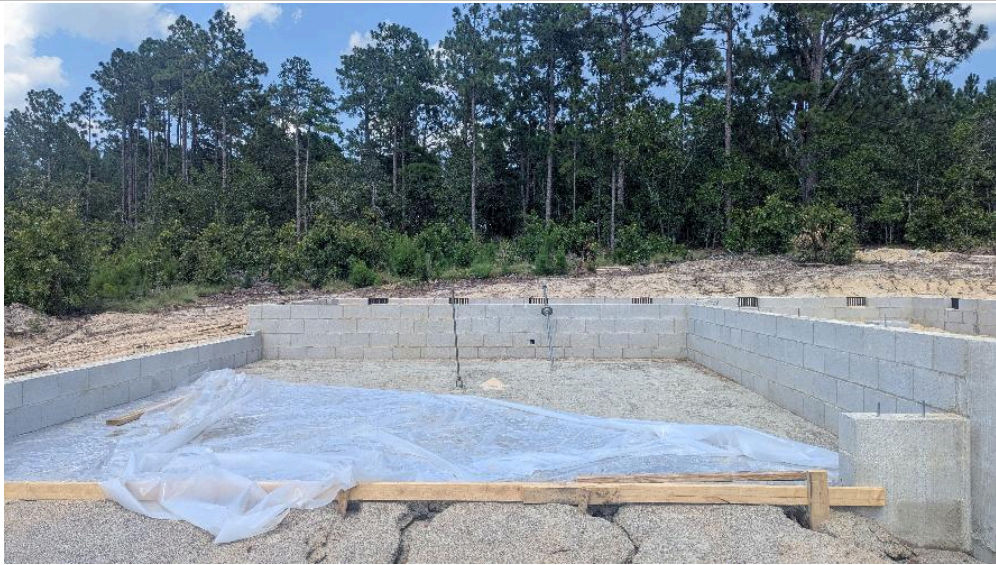
Test 1: Center of garage

Depth	Soil Color	USCS	Notes
8'	Gray	Silty sand	Soils appeared to be dry of optimum moisture
12'	Gray	Silty sand	Soils appeared to be dry of optimum moisture
9'	Red	Silty clay	Soils appeared to be dry optimum moisture
15'	Red	Silty clay	Soils appeared to be dry of optimum moisture

Picture ID	
	1st DCP center of garage
111303

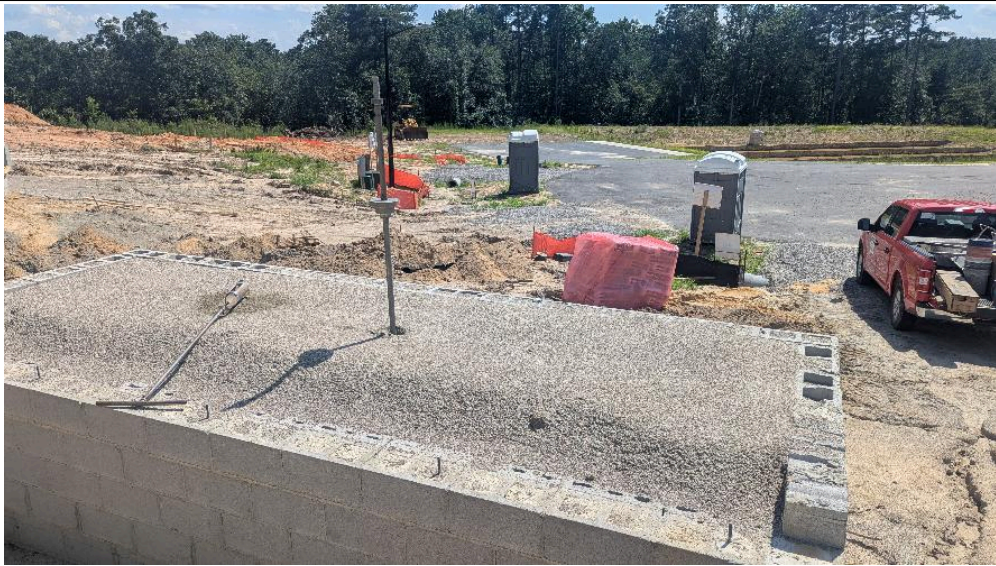
Test 2: Center of patio

Depth	Soil Color	USCS	Notes
10'	Gray	Silty sand	Soils appeared to be dry of optimum moisture
12'	Gray	Silty sand	Soils appeared to be dry of optimum moisture
14'	Red	Silty clay	Soils appeared to be dry optimum moisture
4'	Red	Silty clay	Soils appeared to be dry of optimum moisture

Second DCP on patio
111304
