Per information you provided, I understand there is concern regarding bottom flange nailing in Boise Cascade BCI® joists at the subject project.

Lot 4 Ila's Way  
82 Boston River Drive  
Dunn, NC

**Reinforcement for 14" BCI® 4500s**  
**Joists Damaged From Overnailing**

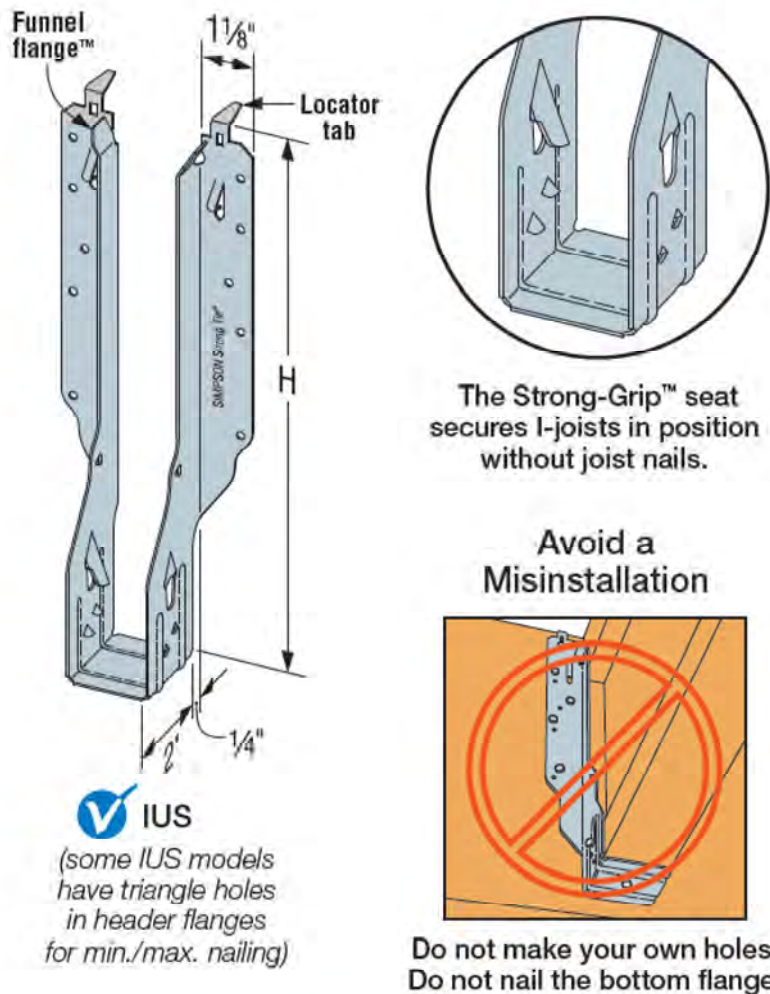
Figure 2: Simpson StrongTie IUS hanger information

Simpson IU1.81/14 hangers have been installed to support one end of the above joists. The IUS hangers do not require nails in the joist as shown in figure 2 and attached page 144 from Simpson Strong-Tie Wood Construction Connectors 2024-2025 C-C-2024 catalog.

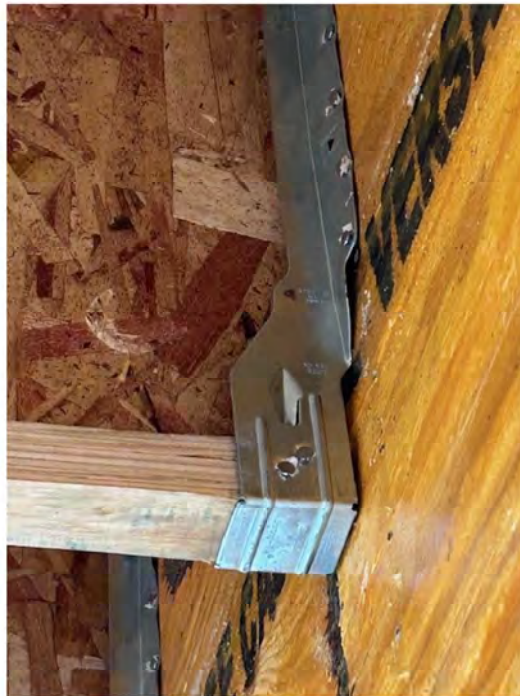
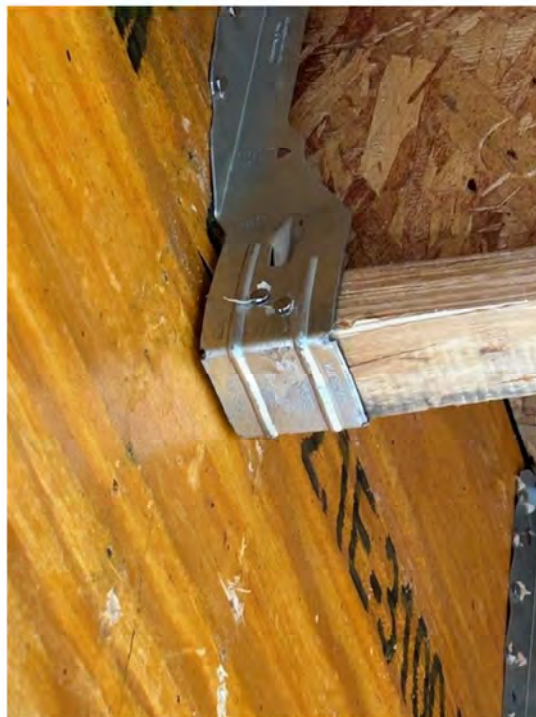
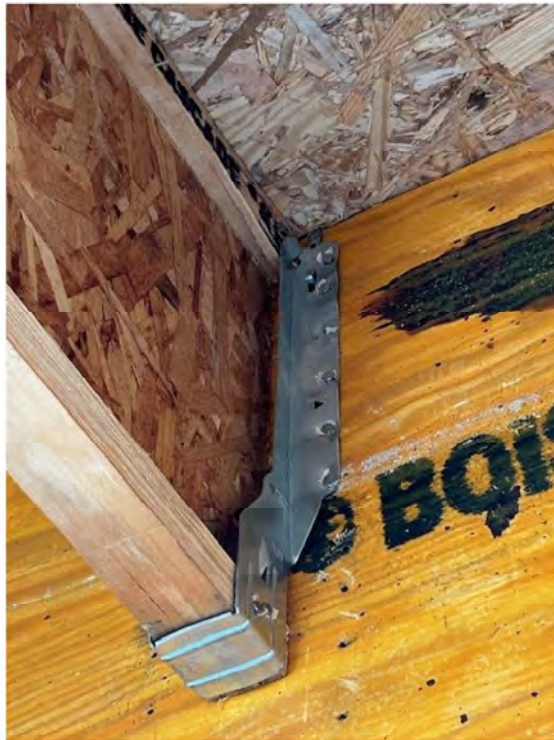
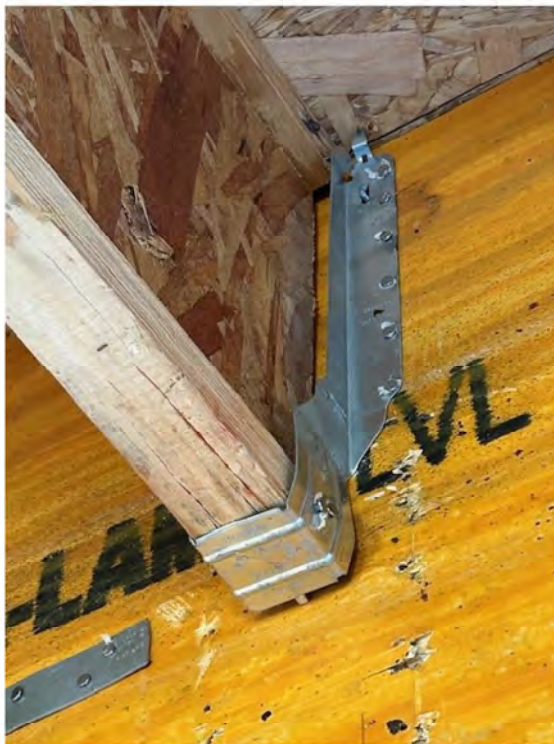
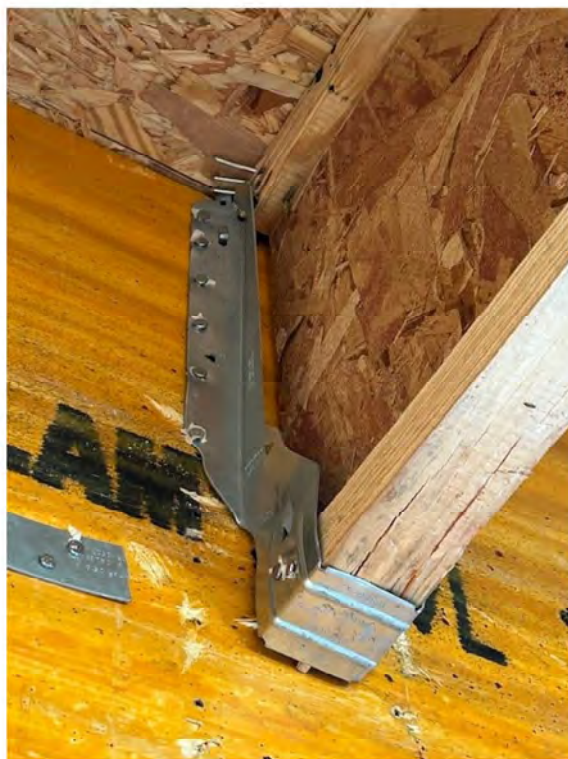
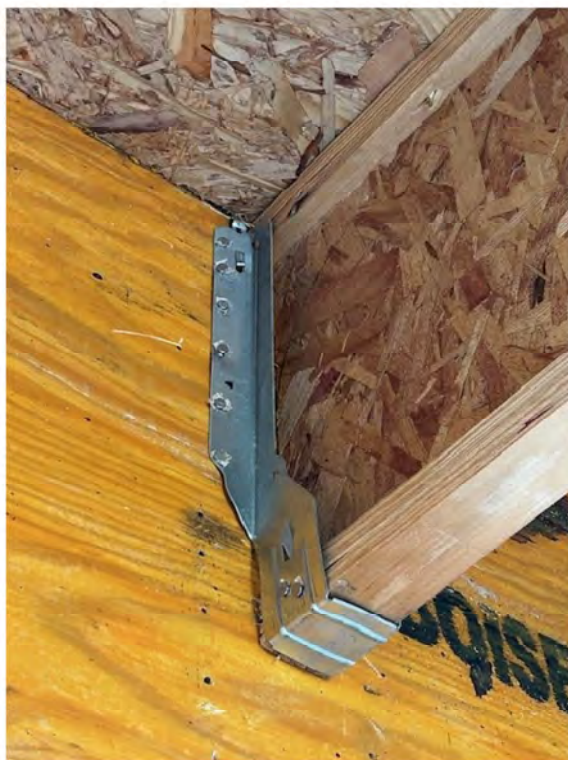
Nails have been driven through the sides of the hangers into the bottom flanges as shown in images 1-6.

Image 1: Bottom flange nailing in 14" BCI® 4500s joists, provided by Builders FirstSource

Image 2: Bottom flange nailing in 14" BCI® 4500s joists, provided by Builders FirstSource

Image 3: Bottom flange nailing in 14" BCI® 4500s joists, provided by Builders FirstSource

Image 4: Bottom flange nailing in 14" BCI® 4500s joists, provided by Builders FirstSource

Image 5: Bottom flange nailing in 14" BCI® 4500s joists, provided by Builders FirstSource

Image 6: Bottom flange nailing in 14" BCI® 4500s joists, provided by Builders FirstSource

No repair is required for the joists listed above with flange splitting that does not exceed a maximum length of 3" measured from the inside face of the hanger.

Joists listed above with flange splitting exceeding 3" up to a maximum length of 12" measured from the inside face of the hanger shall be reinforced per the attached repair detail.
