NESHAP ASBESTOS AND LEAD PAINT SURVEY REPORT

Johnsonville Elementary School – Building 2

November 30, 2021

Terracon Project No. 70217436

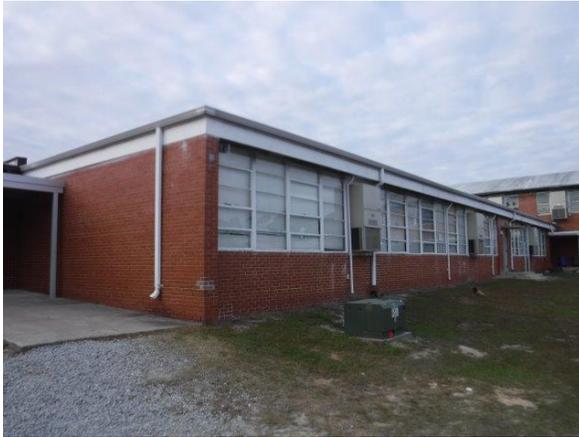
Photo #1 View of rear of building.

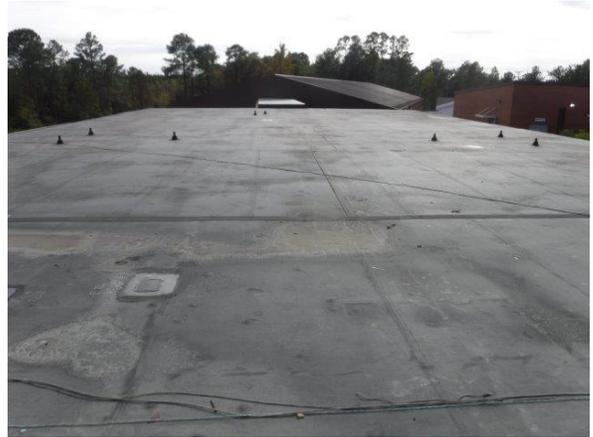
Photo #2 View of EPDM rubber roof.

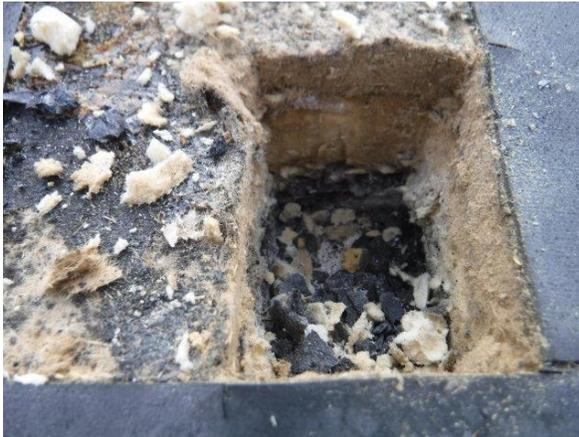
Photo #3 View of HA 1, non-asbestos containing modified bitumen roofing under EPDM rubber.

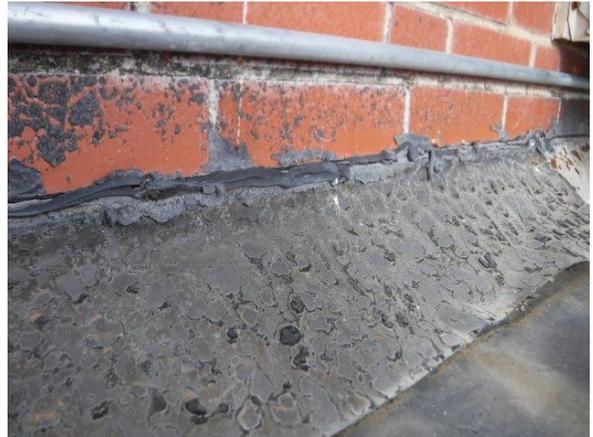
- Light gray flashing mastic
- Mastic associated with 12"x12" cream with cream and gray specks floor tile
- Mastic associated with 12"x12" white with light and dark specks floor tile
- 9"x9" brown with black and white streaks floor tile and associated mastic

Photo #4 View of HA 2, asbestos containing light gray flashing mastic behind HA 3, non-asbestos dark gray flashing mastic.

Terracon recommends that the identified ACM be removed and disposed of by a State of North Carolina licensed asbestos abatement contractor prior to renovation if it will be disturbed. Materials containing less than or equal to 1% asbestos should be removed by OSHA trained personnel in accordance with OSHA regulations if they will be disturbed. We understand as part of the next phase of this project, an abatement specification may be developed to address the handling of identified asbestos-containing materials for the selected renovations.

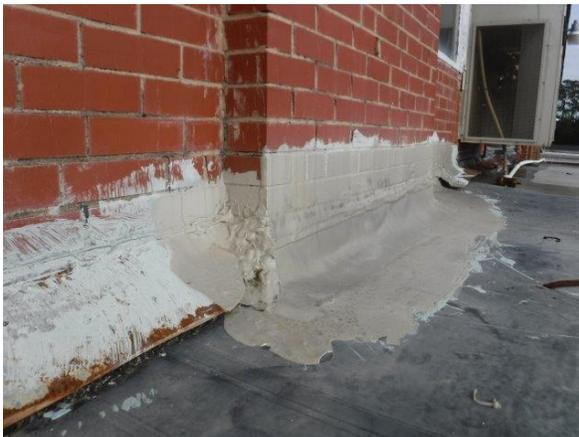
Photo #5 View of HA 4, non-asbestos containing cream colored roof patch.

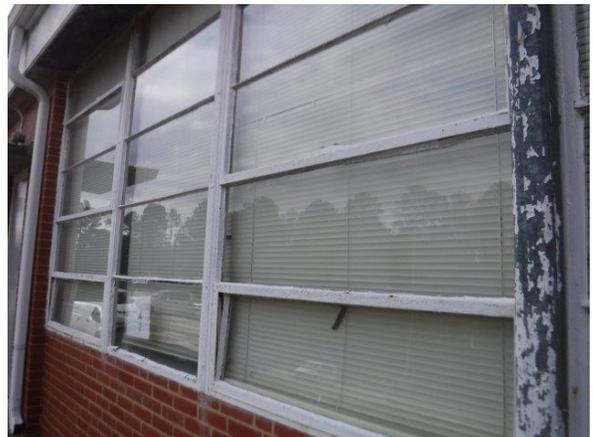
- Window glazing
- 12"x12" cream with cream and gray specks floor tile

Photo #6 View of HA 5, <0.25% asbestos containing window glazing.

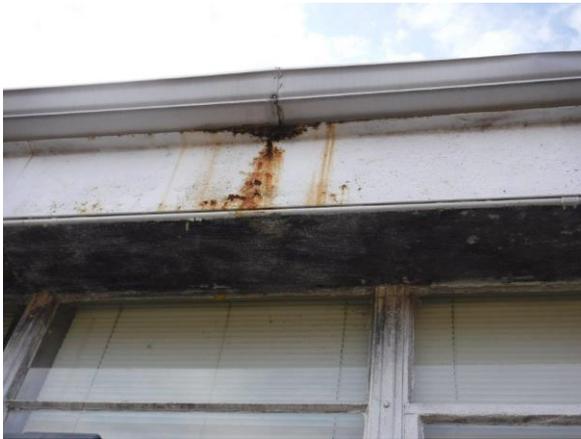
Photo #7 View of HA 6, non-asbestos containing white gutter caulk.

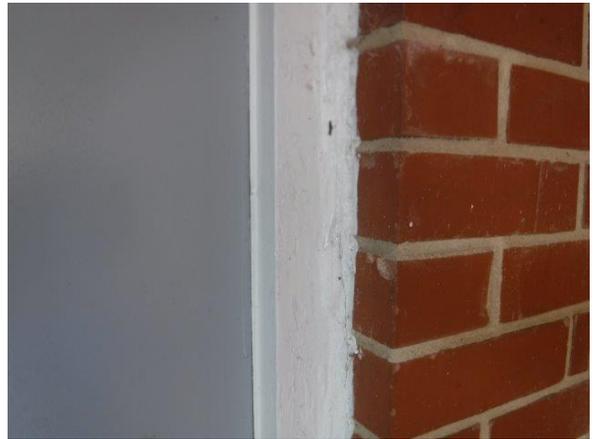
Photo #8 View of HA 7, non-asbestos containing white metal frame door caulk.

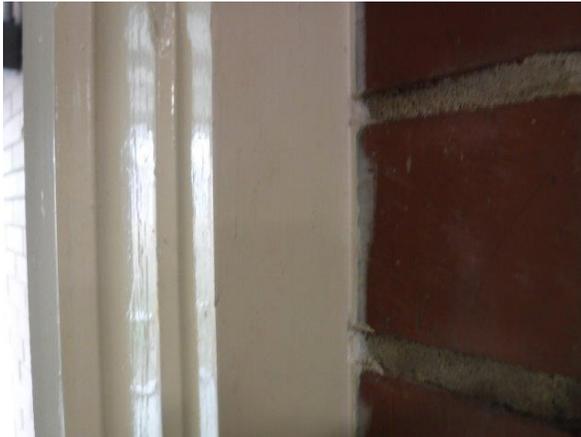
Photo #9 View of HA 8, non-asbestos containing white wood frame door caulk.

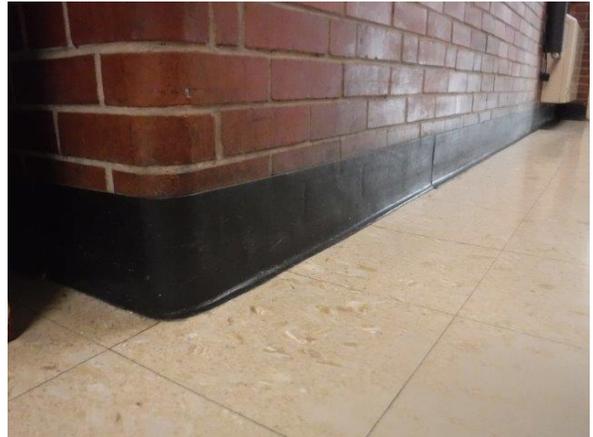
Photo #10 View of HA 9, non-asbestos containing 6" black cove base and mastic.

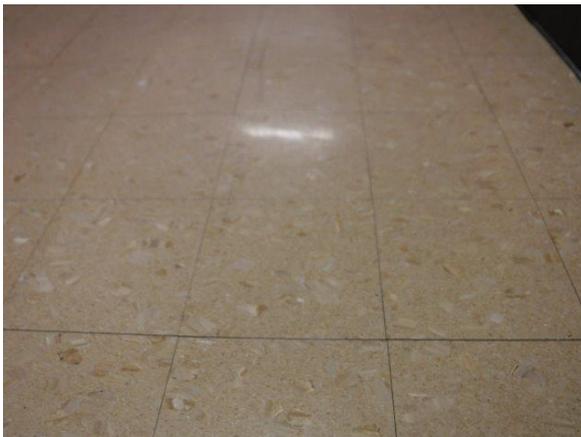
Photo #11 View of HA 10, <1% asbestos containing 12"x12" cream with cream and gray specks floor tile and 5% asbestos containing mastic.

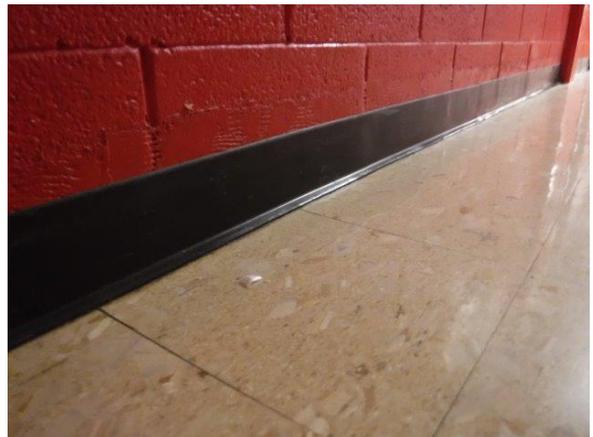
Photo #12 View of HA 11, non-asbestos containing 4" black cove base and mastic.

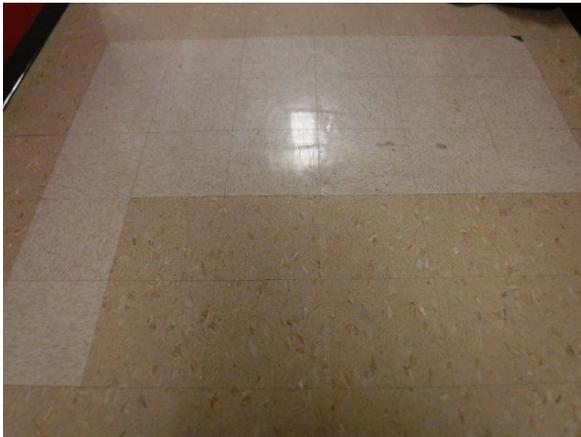
Photo #13 View of HA 12, non-asbestos containing 12"x12" white with light and dark specks floor tile and asbestos containing mastic.

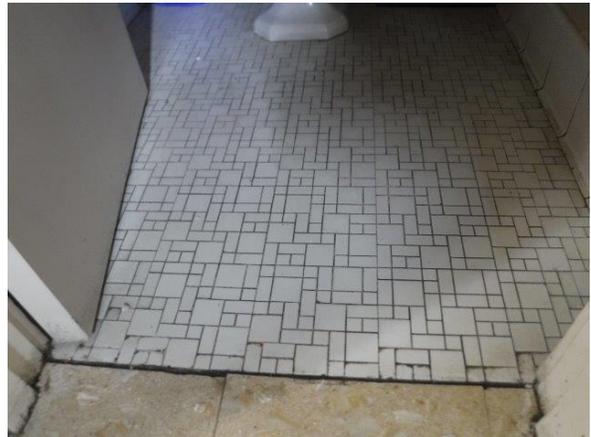
Photo #14 View of HA 13, non-asbestos containing mosaic tile, grout, and mortar.

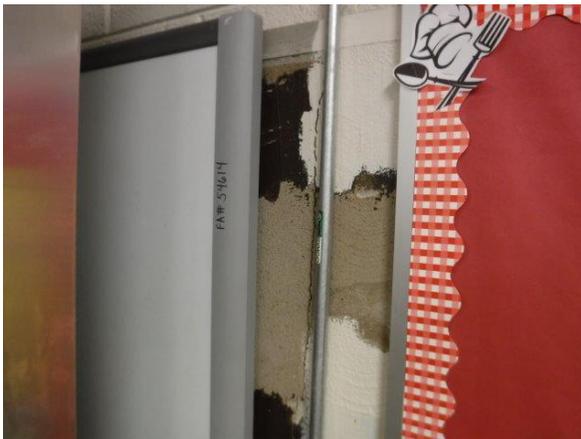
Photo #15 View of HA 14, non-asbestos containing black chalkboard mastic and non-asbestos containing brown skim coat.

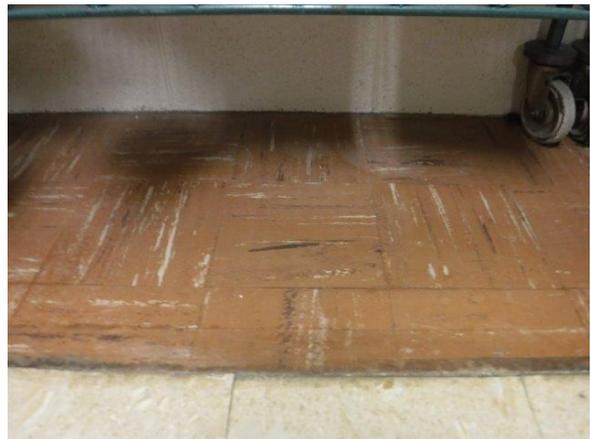
Photo #16 View of HA 15, asbestos containing 9"x9" brown with black and white streaks floor tile and asbestos containing mastic.

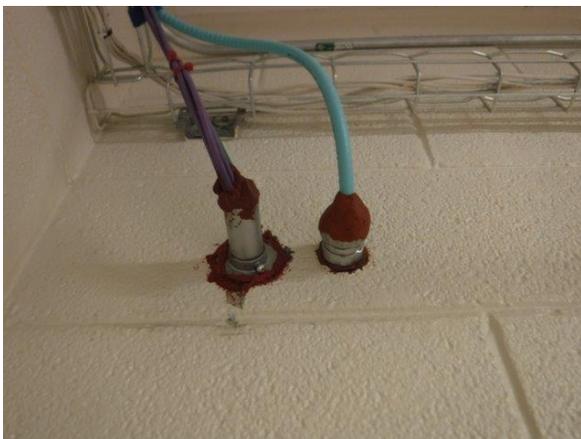
Photo #17 View of HA 16, non-asbestos containing red fire caulk.

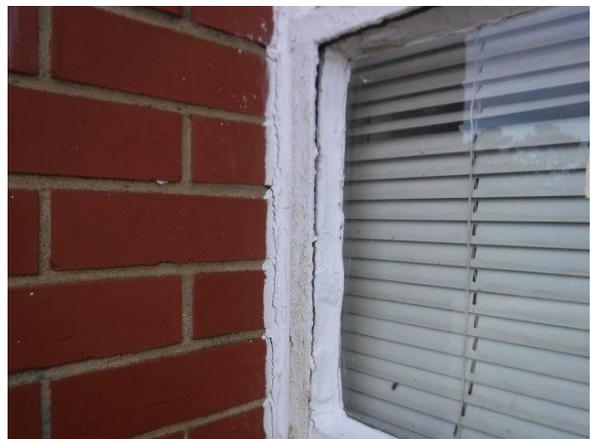
Photo #18 View of HA 17, non-asbestos containing white window caulk.
