Rc:Dexterfield Subdivision, Lots 14, 15, 26, and 27

A final soils evaluation was completed on the above referenced property in January, 2008. The purpose of the evaluation was to determine the ability of the soils to support a subsurface waste disposal system for initial and/or repair for a three bedroom house. All ratings and determinations were made in accordance with "Laws and Rules for Sewage Treatment and Disposal Systems, 15A NCAC 18A .1900".

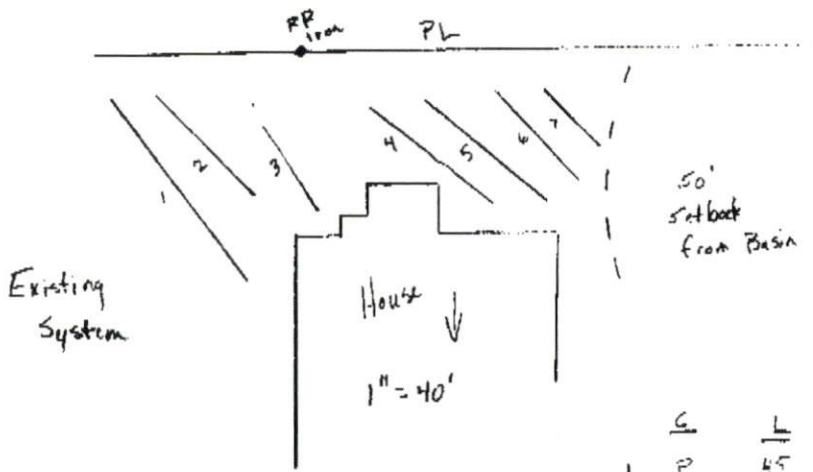
lot 141 Dexterfield

3 BDRM
 .375 as permitted
 160' PPBPS required for repair

Typical Soils
 0-18-5L
 18-46 SCL
 <2-46"

Repair System may
 require Pressure Manifold
 to equally distribute effluent

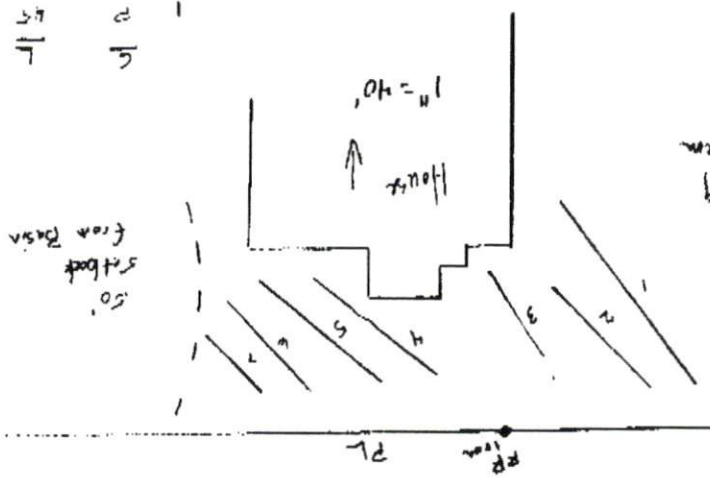
Lot 14 Dexterfield

Typical Soils

0-18-5L
18-46 SL
42-46"

3 BDRM
.375 as permitted
160' PPBPS required for repair

Repair System may require Pressure Manifold to equally distribute effluent
