MiTek Industries, Inc.

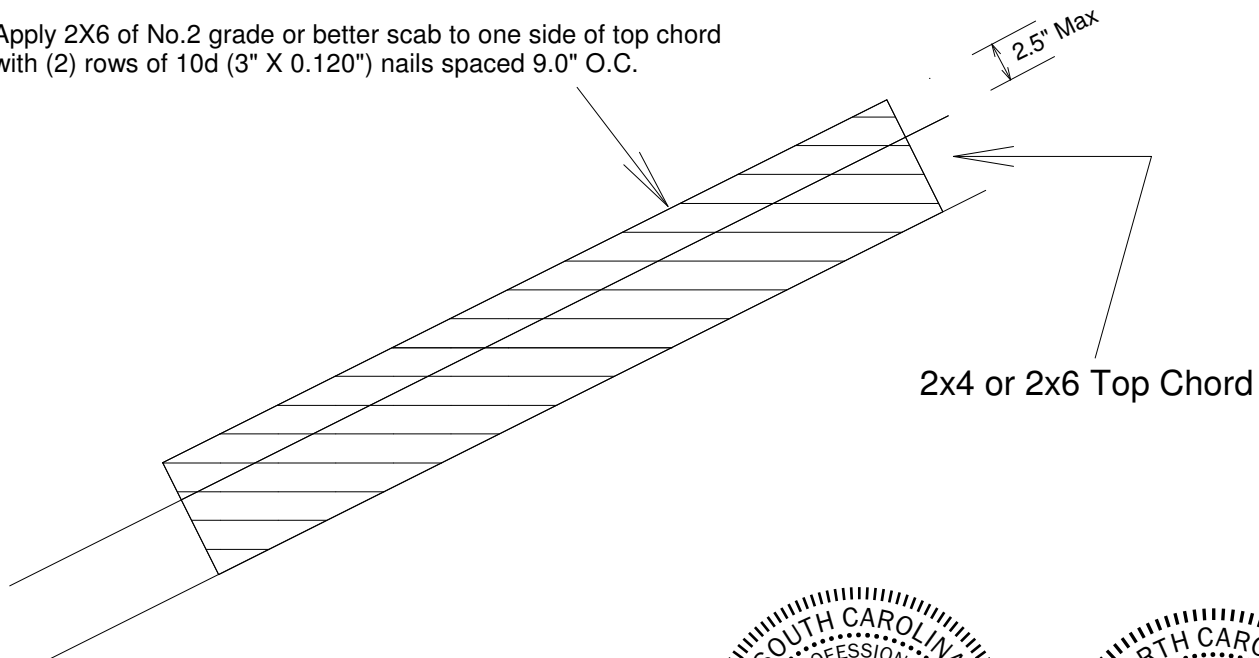
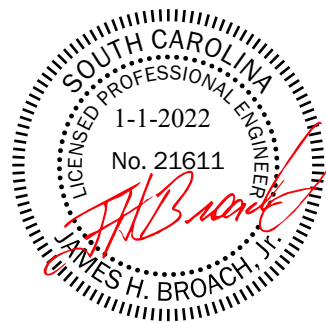
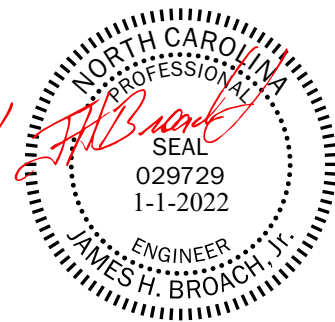
This repair to be used only with trusses (spans less than 40') spaced 24" o.c. maximum and having pitches between 5/12 and 10/12 and total top chord loads less than 50 psf. Trusses not fitting these criteria should be examined individually.

Apply 2X6 of No.2 grade or better scab to one side of top chord with (2) rows of 10d (3" X 0.120") nails spaced 9.0" O.C.
