June 5, 2023

Reference: Engineering Services 7934 NC-210 Bunnlevel, NC 28323 TE&D Project No.: 2301-020499

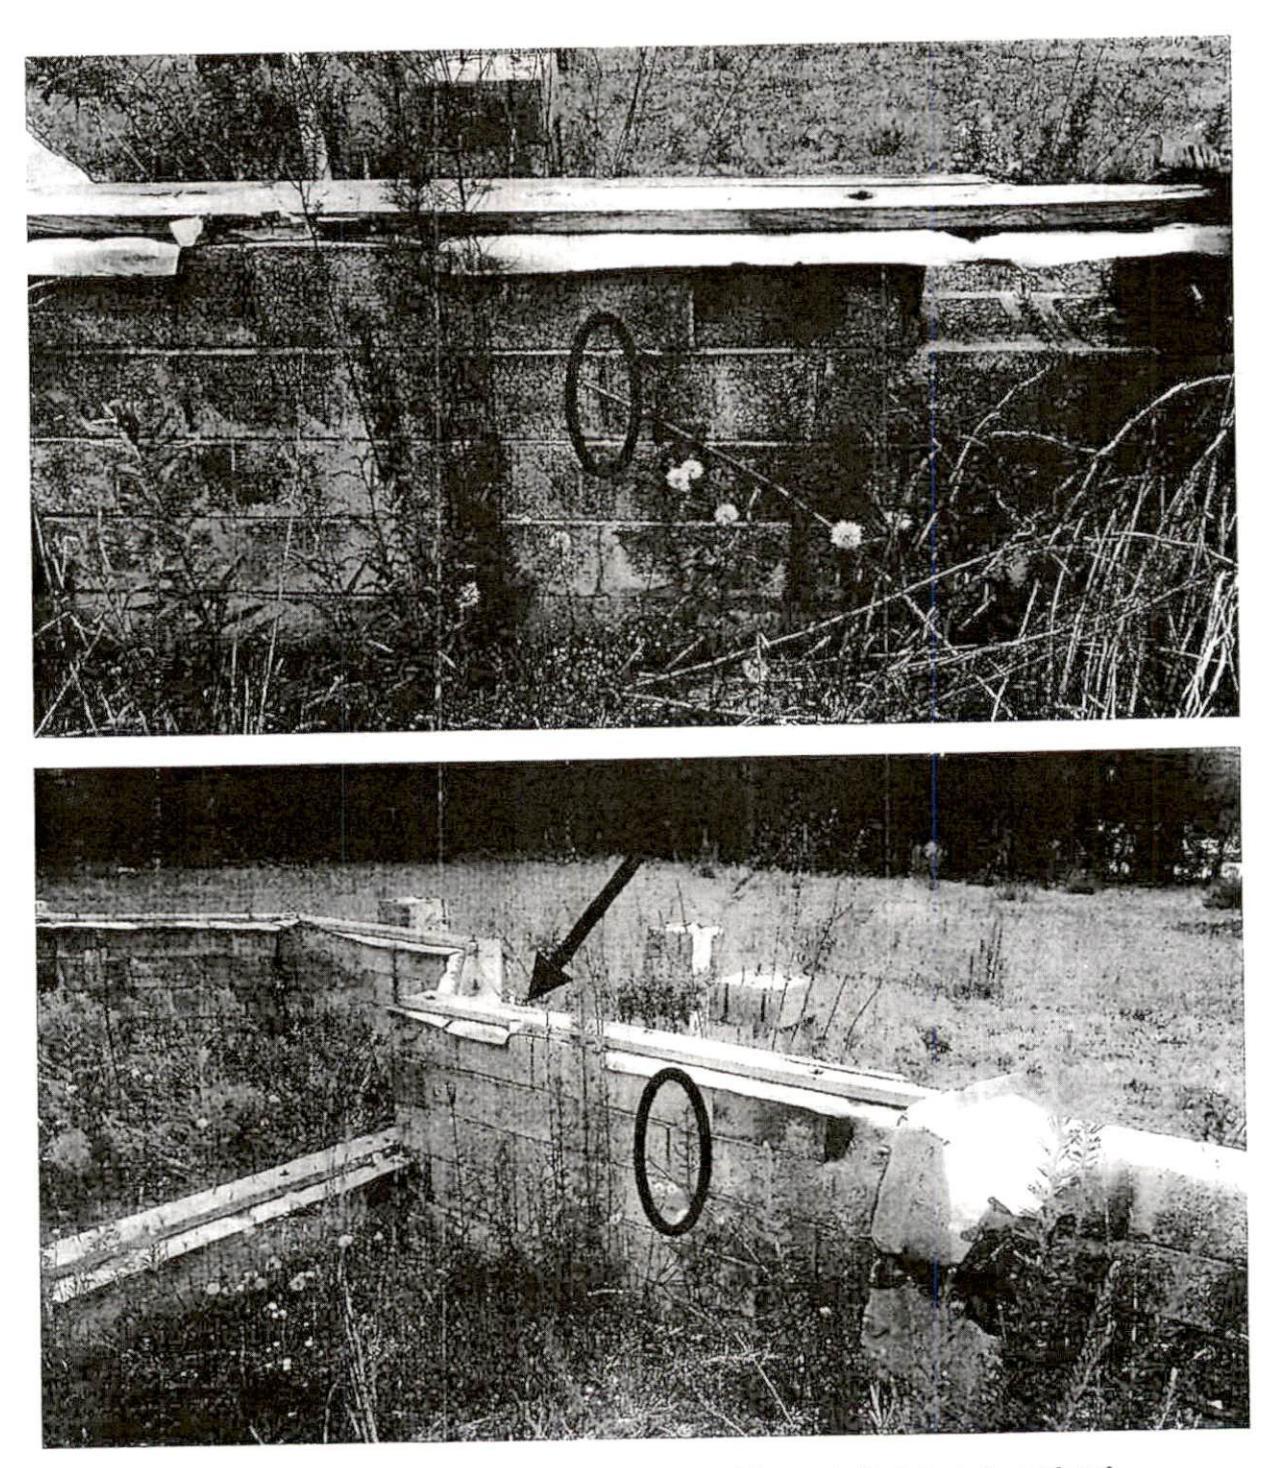
- At multiple locations, we observed severe deterioration of the existing mortar joints. Based on our observations and analysis, we recommend the deteriorated mortar joints be removed and repointed with mortar as needed.

Items 2a and 2c) Examples of deteriorated mortar joints and sill plates to be replaced

- c. We also recommend the remaining sill plates be removed and replaced with new pressure treated 2 x 8 sill plates. New sill plates are to be installed so that the existing anchor bolts are within 1'-0" of plate splices. If this cannot be achieved, or the existing anchor bolts are damaged during removal, the sill plate may be fastened to the existing foundation with 1/2" x 8" Simpson Titen HD screws or 1/2" x 12" threaded rods with nuts and washers. The rods are to be embedded a minimum 10" into the turned down footing with Hilti HIT-HY 200 Epoxy per the manufacturer's specifications. Screws and/or rods are to be installed with spacing no greater than 6'-0" o.c. and within 12" of plate splices.

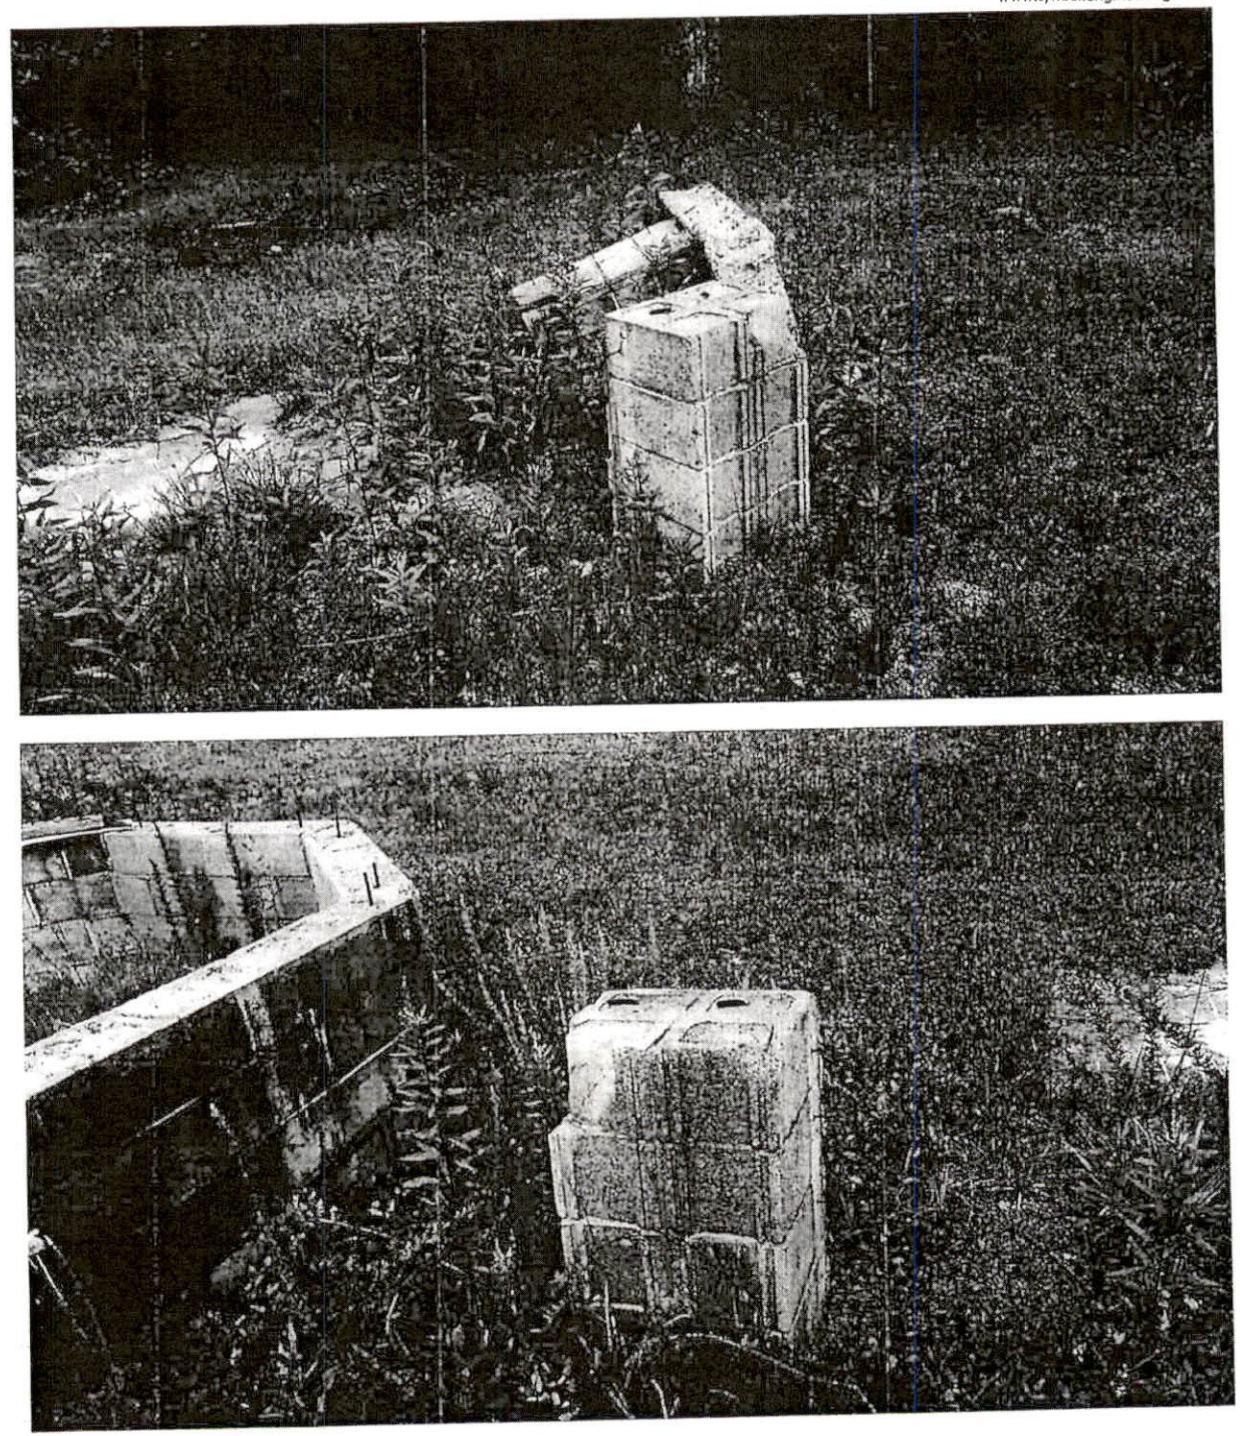
- b. At the front porch piers, we observed several piers as being damaged at the top course. Based on our observations and analysis, we recommend the damaged piers be repaired as needed by removing the topmost course and replacing it with new 16" x 16" CMU blocks.

Item 2b) Examples of damaged piers to be repaired
