# PROOFROLLING OBSERVATION REPORT

**Report Number:** 70241180.0013  
**Service Date:** 01/21/26  
**Report Date:** 01/23/26  
**Task:** Soils-Concrete Testing

3D Community Church  
658 Graham Road  
Sanford, NC 27332

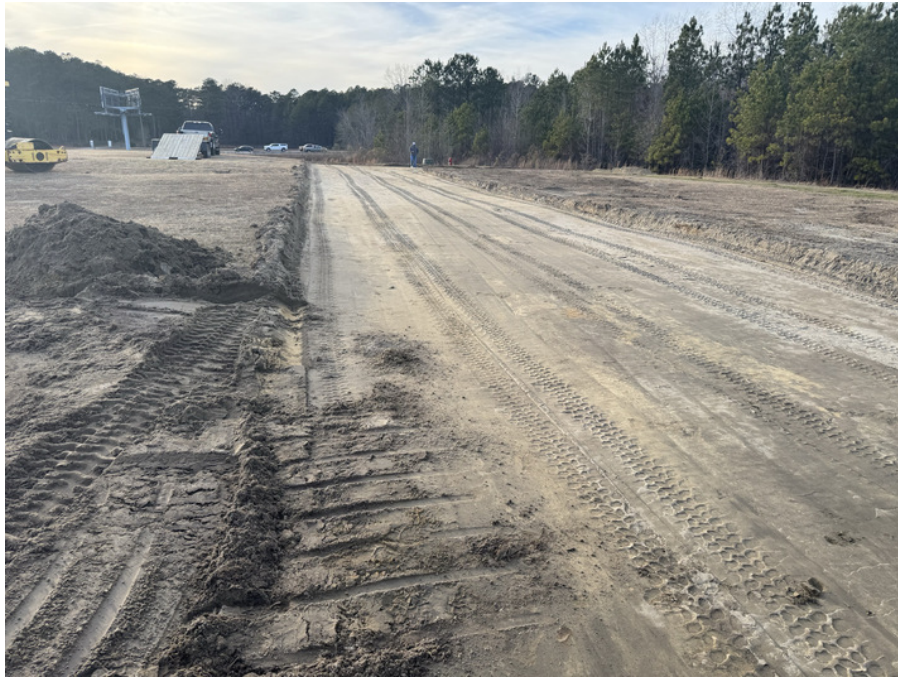
(P1) Overall area

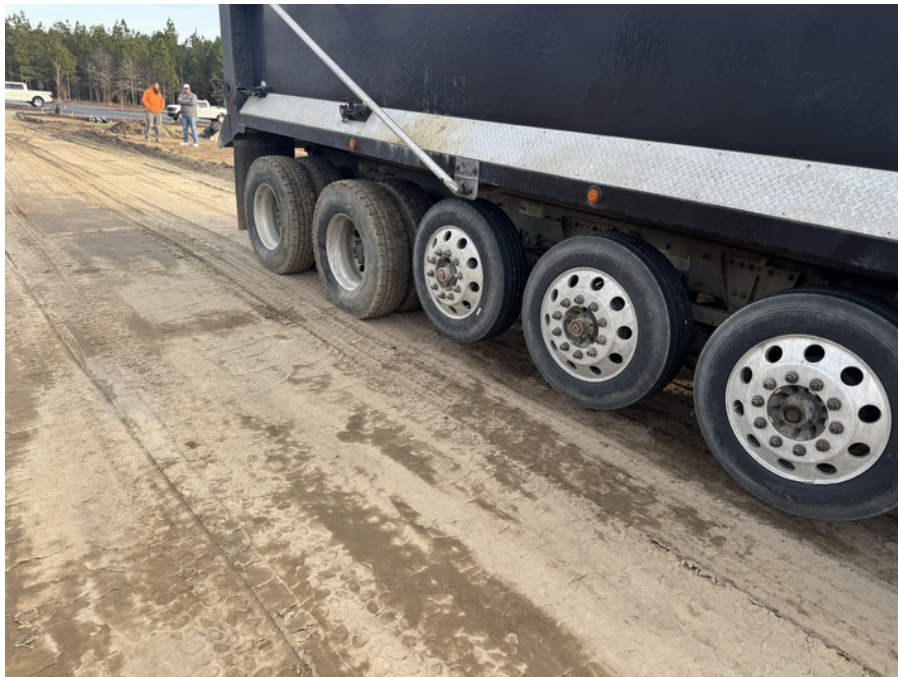
Iwaly Grading Inc used a fully loaded (74,220 pound) dump truck to make multiple passes in a parallel pattern.

(P2) Proofroll in progress

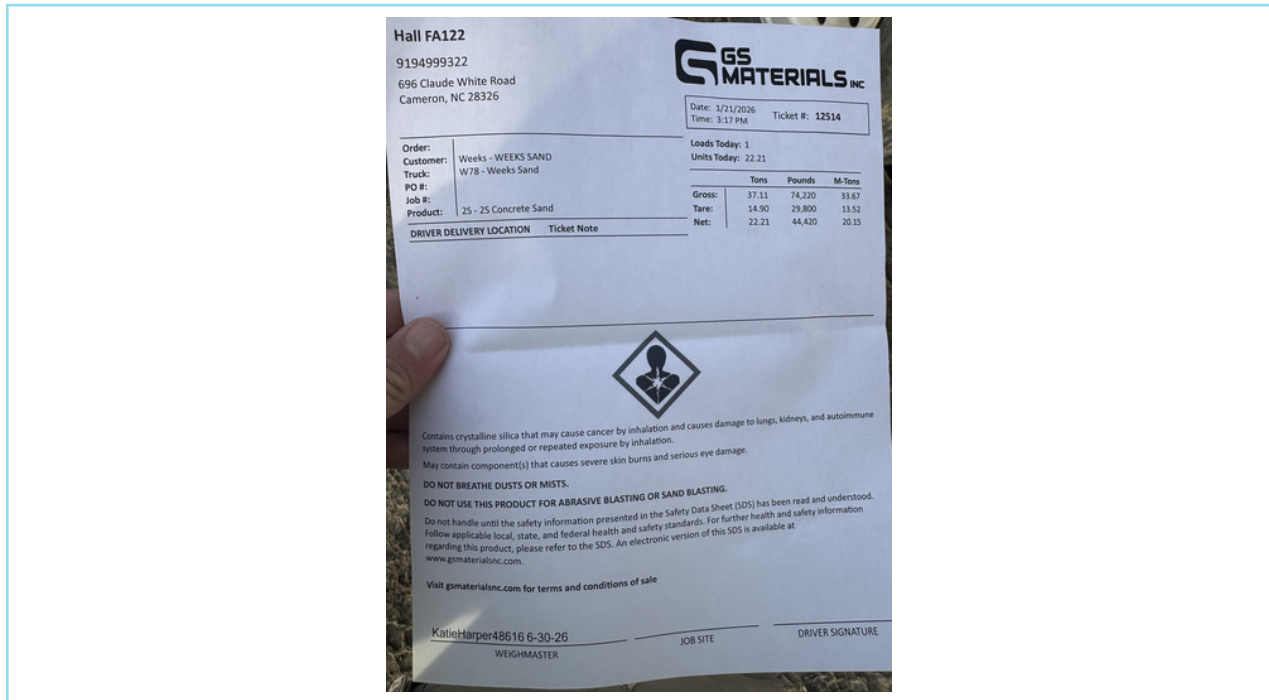
(P3) Truck load ticket

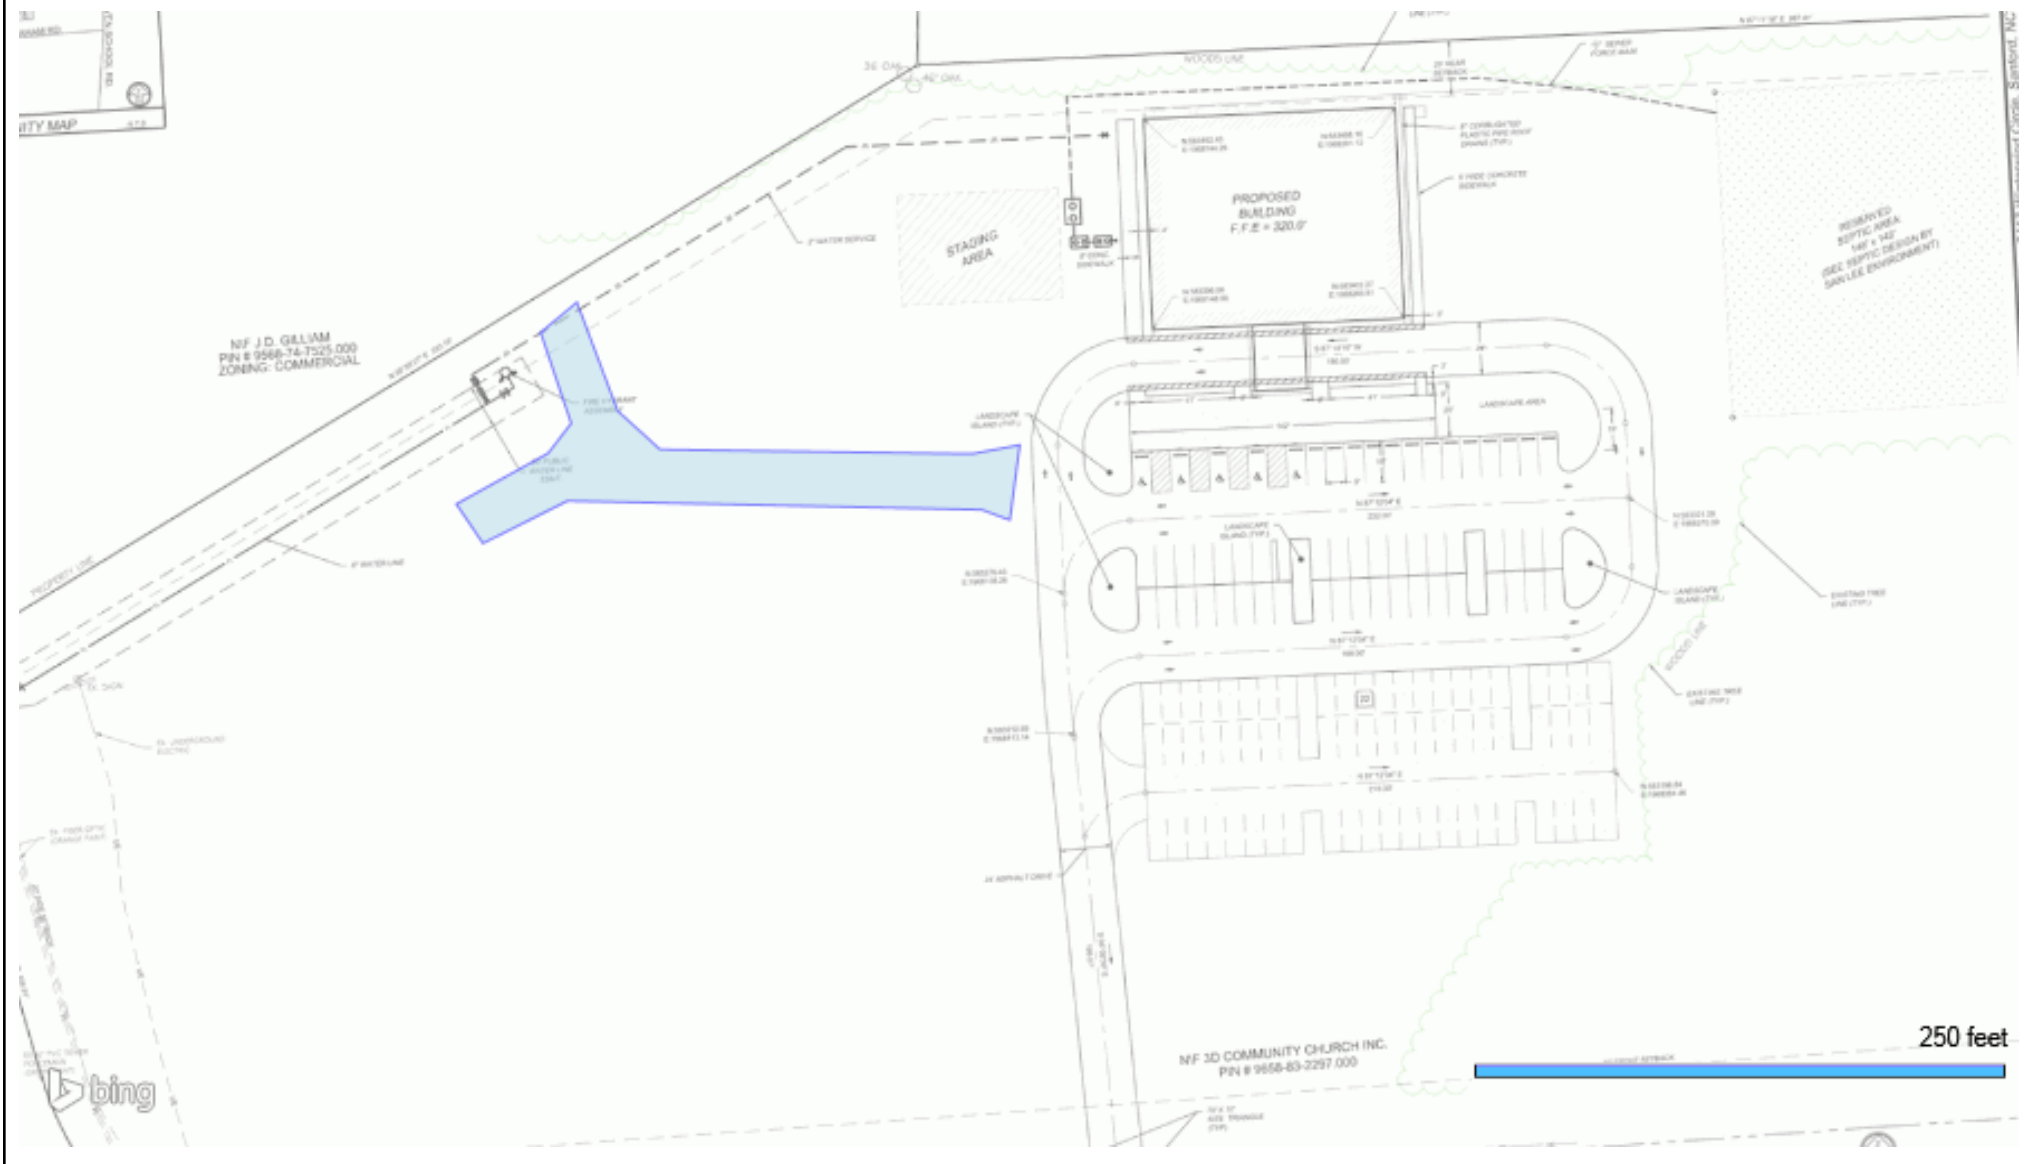
Exhibit
<b>A-1</b>

Observed Location	Visual Subgrade Description & Elevation	Status
(1) Paving - Fire access road	Light brown sand - Final Soil Subgrade	Complies

<b>3D Community Church</b>
Proofrolling Observation
