RE: **Champs Convenience Store**
ECS Job # **33:7060**

FIELD REPORT

Project **Champs Convenience Store**
 Location **Fuguay-Varina, NC**
 Client **Regency Construction**
 Contractor **None Listed**

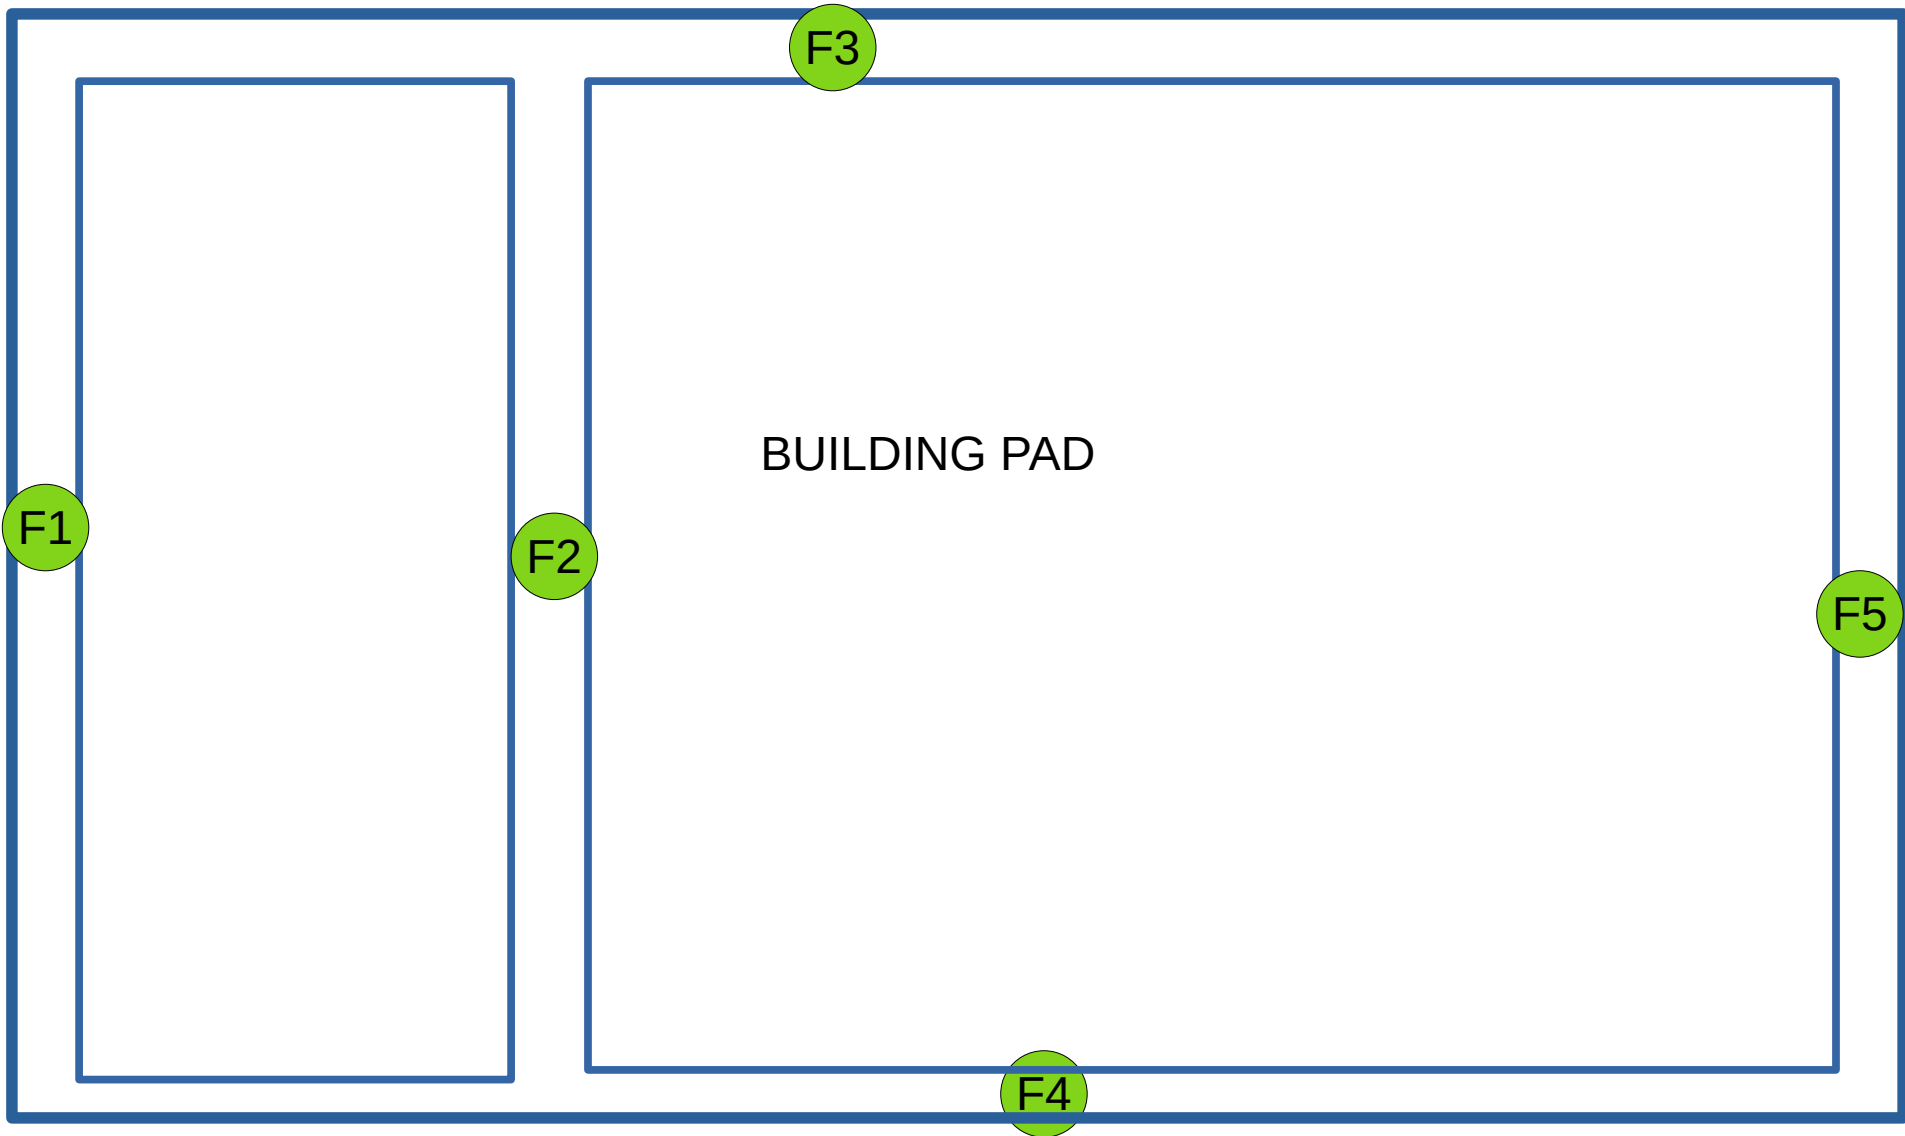
Gerald Bowling
6 NOV. 2024
Champs store
Proj.#7060
W/O#:80904

2: The excavation of building pad perimeter footings and 1 lug footing.

Utilizing a Dynamic Cone Penetrometer (ASTM STP-399) to check the bearing capacity of soil at the aforementioned locations, test results indicated that soils, at the areas and elevations tested, should be capable of supporting a foundation designed for a net allowable bearing capacity of of 2,000 psf.

,DCP footings

Test/sample Locations

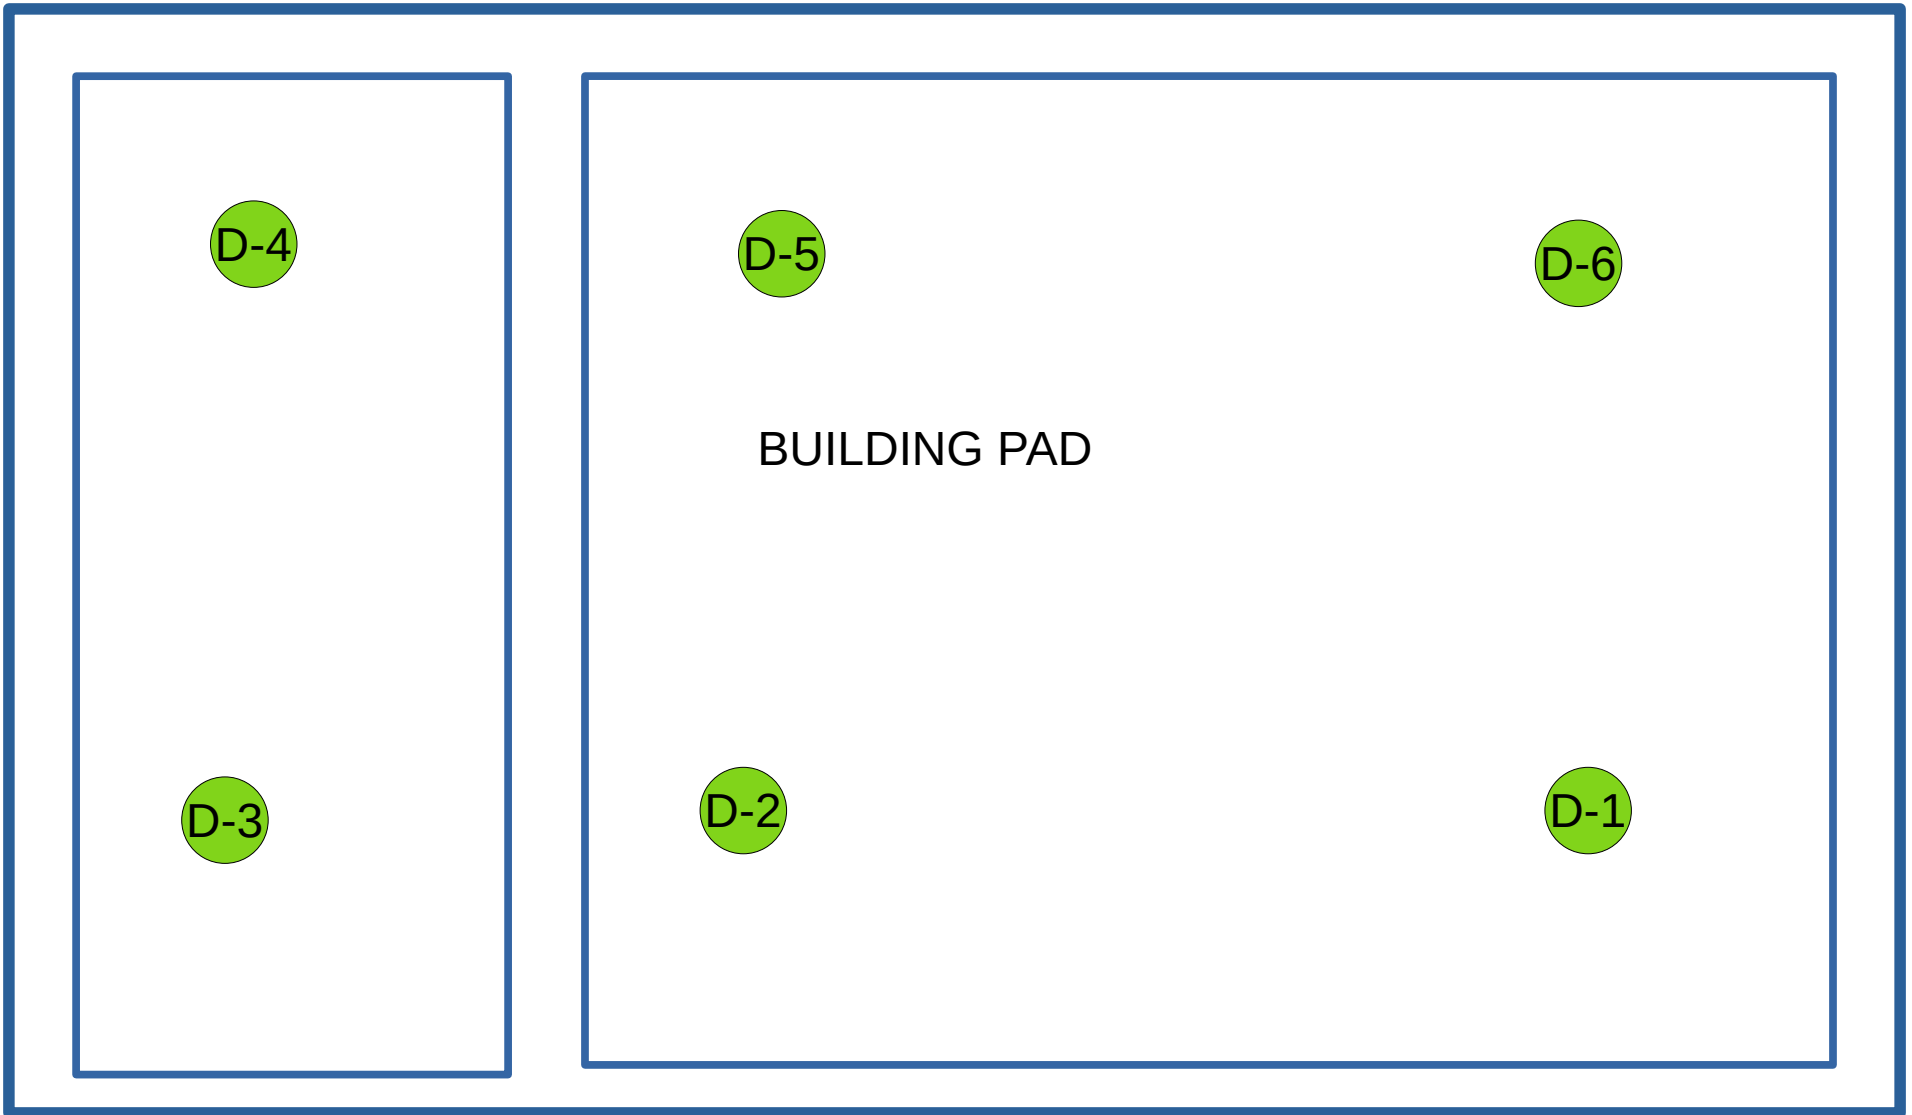
Gerald Bowling
 6 NOV. 2024
 Champs store
 Proj.#7060
 W/O#:80904

1: The placement and compaction of soils for building pad. Please see the attached sketch. Utilizing the nuclear test method to check the compaction of soils, test results indicated that the compacted material, at the areas and elevations tested, met or exceeded the project requirements of 98% of the maximum dry density as obtained in our laboratory using the unspecified proctor method.

Key:
 Compaction,DCP soils

Soil sample
 Test/sample Locations
