FIELD REPORT

Project Name: 308 Jarco Dr	Location: Fuquay Varina, NC
Project No.: 71571	Permit No.:
Client: Triangle Home Pros	Weather: 75°F Sunny
Contractor: E & M Concrete	Date: 6/4/25
Technician: George Nicksich	Portal to Portal Time: 2.0

Summary: Framing inspection of upper connections

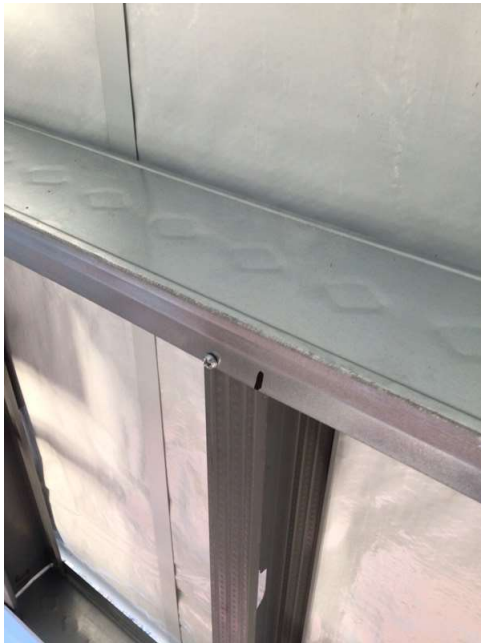
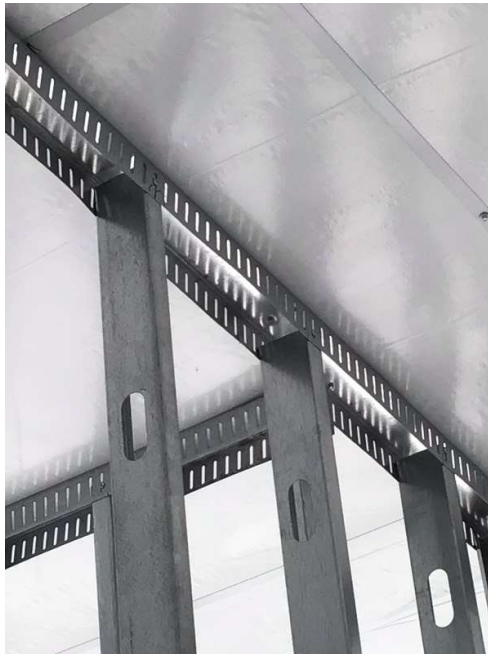
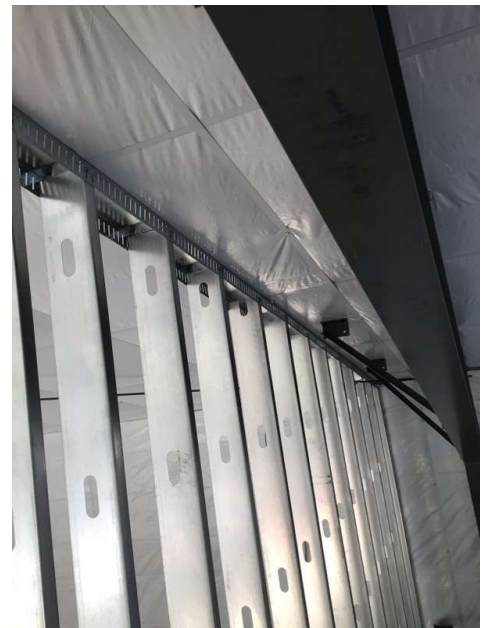
FIELD REPORT PHOTOS

Notes: Tech arrived on site as requested by contractor. Tech used scissor lift to observe steel stud framing was connected and secured to adjacent steel, ceiling framing, and track. Connection points were made with self tapping screws. Tech observed all areas above the 12' high ceiling to be completed. Tech will return to check lower connections at contractors request.
