Re: Structural Observation—24 West Landing, Sanford, NC 27332

At your request, on May 29<sup>th</sup>, 2020 we performed a visual structural observation of various interior walls for proposed removal at the Sanford residence noted above. Renovation drawings by Robert Mikesell dated 12/2/2005 were provided on site. The structure is a conventionally framed, two-story, detached, single family residence with raised 1<sup>st</sup> floor framing over a pier/girder foundation system with perimeter masonry foundation walls (*see picture 1*).

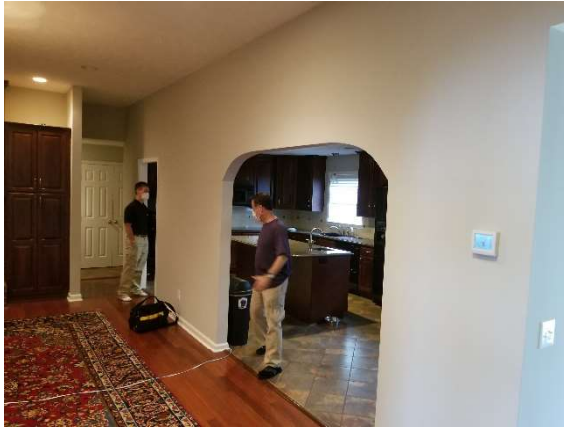
*Picture 2 – Back kitchen wall*

- The 1<sup>st</sup> floor load bearing wall at the back of the kitchen is to be removed to create a total opening of approximately 18'-4" starting at the edge of the existing door opening that is at the right of the kitchen. The wall provides support for roof and attic loads. A beam that is installed so the bottom of the beam is flush with the bottom of the kitchen ceiling joists is to be added to support structural loads from above (*see picture 2*).

- The beam should be a (2)1¾"x18" LVL (Boise Cascade VersaLam 3100, or better) beam with continuous span between end supports. The beam should be built-up using (3) rows of 16d sinkers at 12" o.c. spacing along the length of the member.

- Fasten the kitchen ceiling joists to the front side of the new beam using Simpson face hangers.
  - Support each end of the beam with (3)2x4 #2 Spruce-Pine-Fir (SPF) studs.

- Investigation into the crawlspace beneath the proposed bearing ends of the beam indicated that the left and right ends of the beam were located over CMU piers that are sufficient to support the new distribution of structural loads. No foundation modifications should be necessary to support the ends of the beam.

- Install tight fit, full depth (3)2x blocking beneath each of the bearing points in the 1<sup>st</sup> floor framing system for direct transfer of vertical loads to the foundation elements below. The ends of the beam should be aligned over the centerline of the existing masonry piers.

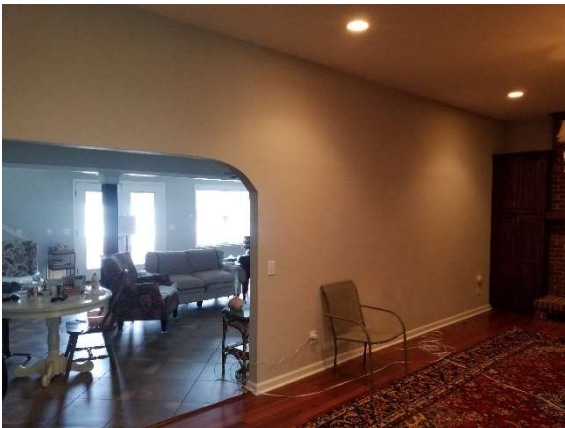
*Picture 3 – Back dining room wall*

- The 1<sup>st</sup> floor load bearing wall at the back of the dining room is to be removed to create a total opening of 29'-4". The wall provides support for 2<sup>nd</sup> story floor joists with front-to-back orientation, as well as roof, attic, and wall loads. A beam, installed flush to the underside of 2<sup>nd</sup> floor sheathing, is to be added to support structural loads from above (*see picture 3*).

- The beam should be a W10x68 steel beam (Fy=50ksi) with continuous span between end supports. Install with tight fit 2x filler within the web on the back side of the beam for face hanger attachment. Fasten the web filler to the beam with ¾" diameter through-bolts with nut and washer at 12" o.c. for the length of the beam.

- In order to facilitate the installation of the beam, the member may be shipped in sections and connected at the ends using a Complete Penetration Joint (CPJ) weld. All welds to be completed by a certified AWS welder.

- Fasten 2<sup>nd</sup> story floor joists to the back side of the beam to the web-filler using Simpson face hangers.
    - Support each end of the beam with (8)2x4 #2 SPF studs. The stud pack should be strapped together at 1/3 points using Simpson CS-16 straps.

- The end 3½ inches of the steel beam should have full bearing on the existing wall top plates. Fasten the bottom flange of the steel beam to the top of the wall plates using (2) ½" diameter x 4" long lag screws.

- Investigation in the crawlspace beneath the proposed bearing ends of the beam indicated that the left and right ends of the beam were located over CMU piers that are sufficient to support the new distribution of structural loads. No foundation modifications should be necessary to support the ends of the beam.

- Install tight fit, full depth (8)2x blocking beneath each of the bearing points in the 1<sup>st</sup> floor framing system for direct transfer of vertical loads to the foundation elements below.

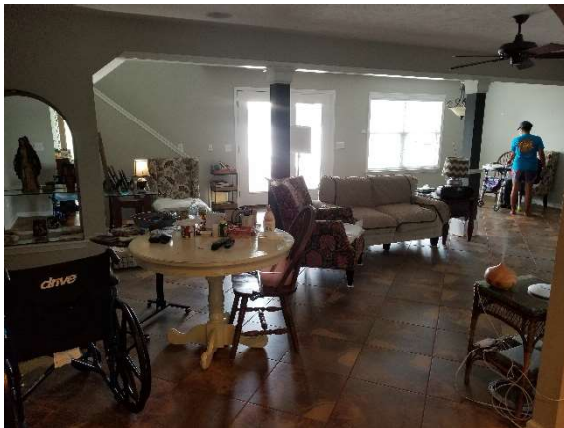
*Picture 4 – Posts and dropped beam*

- The posts in the sunroom and the beam they support are to be removed to create a total opening of approximately 24'-0" starting at the right wall of the sunroom. The wall provides support for 2<sup>nd</sup> story floor joists with front-to-back orientation, as well as roof, attic, and wall loads. A beam, installed flush to the underside of the 2<sup>nd</sup> floor sheathing, is to be added to support structural loads from above (*see picture 4*).

- The beam should be a W10x88 steel beam (Fy=50ksi) that is installed within the 2<sup>nd</sup> floor system and angled such that the left end bears on the back end of the header to the hallway that is at the left side of the stairs and the right end bears on the right wall of the sunroom over the back foundation wall of the master bedroom. Install with tight fit 2x filler within the web on both sides of the beam for face hanger attachment. Fasten the web filler at the beam with ¾" diameter through-bolts with nut and washer at 12" o.c. for the length of the beam.

- In order to facilitate the installation of the beam, the member may be shipped in sections and connected at the ends using a Complete

Penetration Joint (CPJ) weld. All welds to be completed by a certified AWS welder.

- Fasten 2<sup>nd</sup> story floor joists on both sides of the beam to the web-filler using Simpson face hangers.
- Support the right end of the beam with a 3½"x7" PSL 1.8E ParaLam post with and additional (2)2x4 #2 SPF studs built-up against each face of the post. The stud pack should be strapped together at 1/3 points using Simpson CS-16 straps.

- The end 3½ inches of the steel beam should have full bearing on the existing wall top plates. Fasten the bottom flange of the steel beam to the top of the wall plates using (2) ½" diameter x 4" long lag screws.

- Install tight fit, full depth (8)2x blocking beneath this bearing point for direct transfer of vertical loads to the foundation element below.
  - Widen the foundation wall at the location of this point load by adding a 4"x16" solid CMU pilaster, that is built-up off the existing wall footing projection. Mortar and anchor new pilaster to the cleaned inside face of the foundation wall using (2) grouted stainless steel brick ties at each pilaster course.

- Support the left end of the beam with a (2)1¾"x9¼" Boise Cascade VersaLam 3100 header that should be span over the hallway opening.
  - Support the back end of this header with (6)2x4 #2 SPF jack studs and a 2x4 king stud.

- Support the front end of the header with (3)2x4 #2 SPF jack studs and a 2x4 king stud.
- Investigation in the crawlspace beneath the proposed bearing ends of the beam and header indicated that the concrete footings that support the foundation at these areas are sufficient to support the new distribution of structural loads.

- Install tight fit, full depth 2x blocking beneath each of the bearing points in the 1<sup>st</sup> floor framing system for direct transfer of vertical loads to the foundation elements below.
