**SOIL/SITE EVALUATION
 for ON-SITE WASTEWATER SYSTEM**

Owner: *Parrell STANLEY* Applicant:
 Address: *459 Bungy Ln*
 Proposed Facility: *SFD*
 Location of Site:
 Water Supply: Public Individual Well
 Evaluation Method: Auger Boring Pit Cut
 Type of Wastewater: Sewage Industrial Process Mixed

Date Evaluated: *4-6-21*
 Design Flow (.1949): *360 GPD*
 Property Recorded:

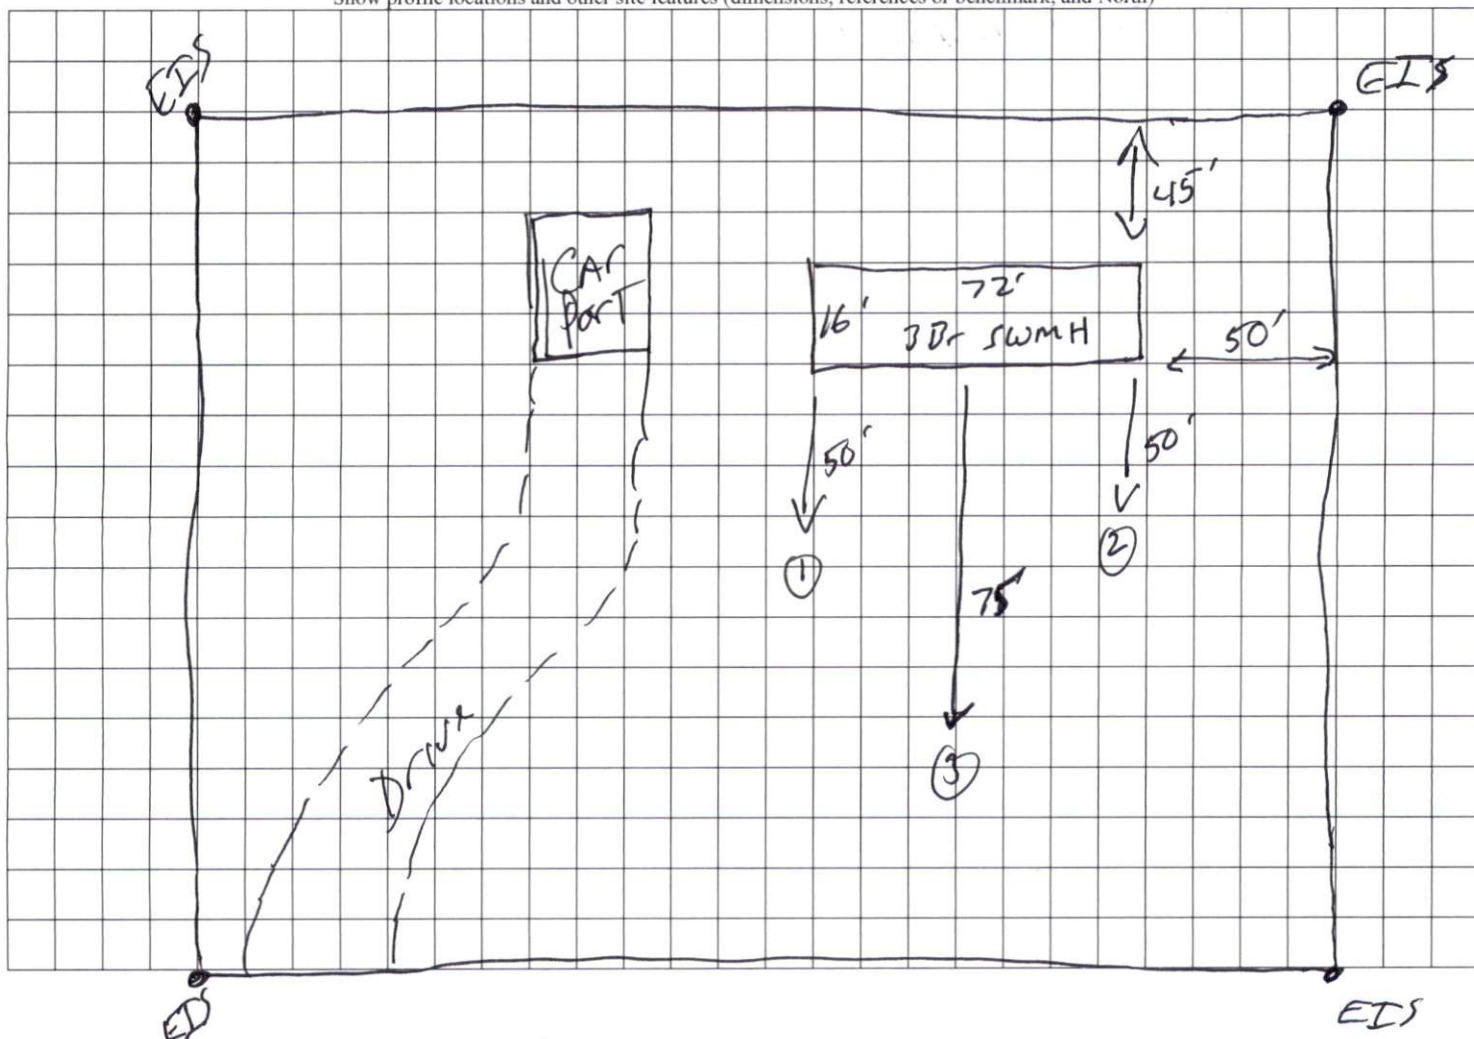
Show profile locations and other site features (dimensions, references or benchmark, and North)

4-6-21
 - Clear Lot
 - Accurately Stake house + Car Port + Drive

6-22-21
 Lot being cleared + large piles of
 woods being burned in center
 of lot
