Subject: **Structural Inspection**  
**260 Azalea Drive**  
**Spring Lake, North Carolina**  
**NSE Project #2300560**

On June 17, 2023, Neal Smith Engineering, Inc. (**NSE**) performed a structural inspection at the above subject location. The purpose of the inspection was to evaluate repairs made to a truss.

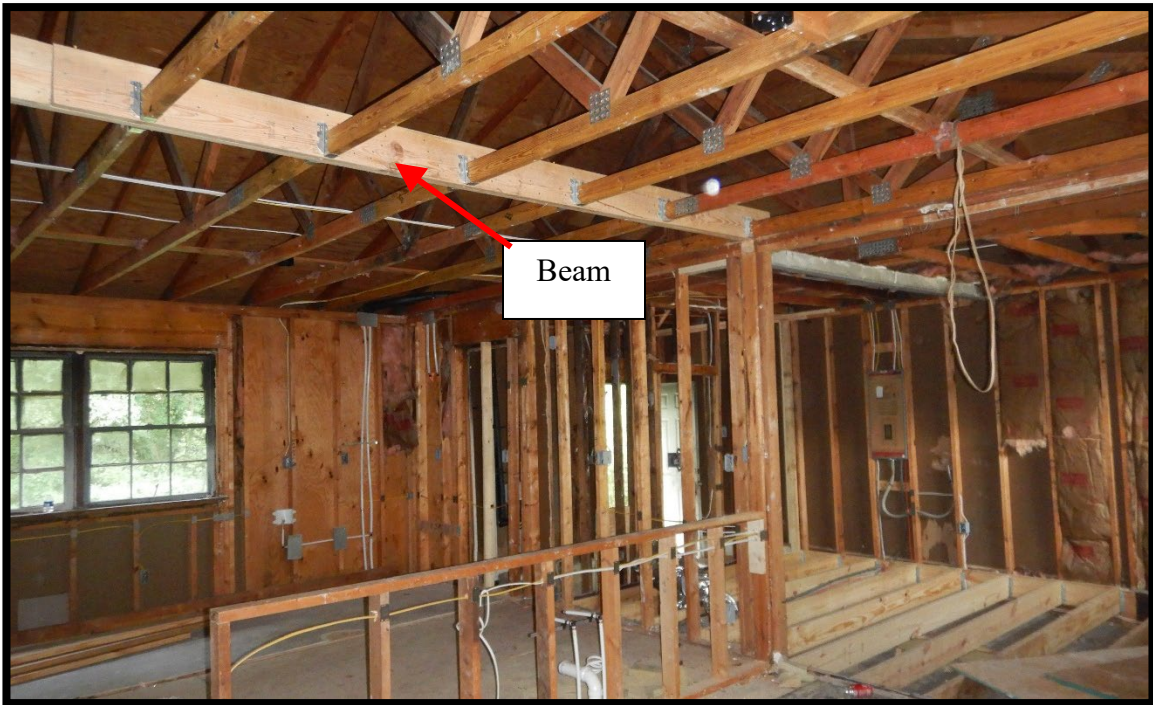
The property in question is a single-story wood framed house. A wall was removed, and a beam was added. The bottom chord of 8 trusses was attached to the beam.

**Photo #2** - This is a photo of the new beam that was added.

The bottom chord of the truss is a tension member and requires a strap to transfer the tension load. All 8 trusses require a strap.

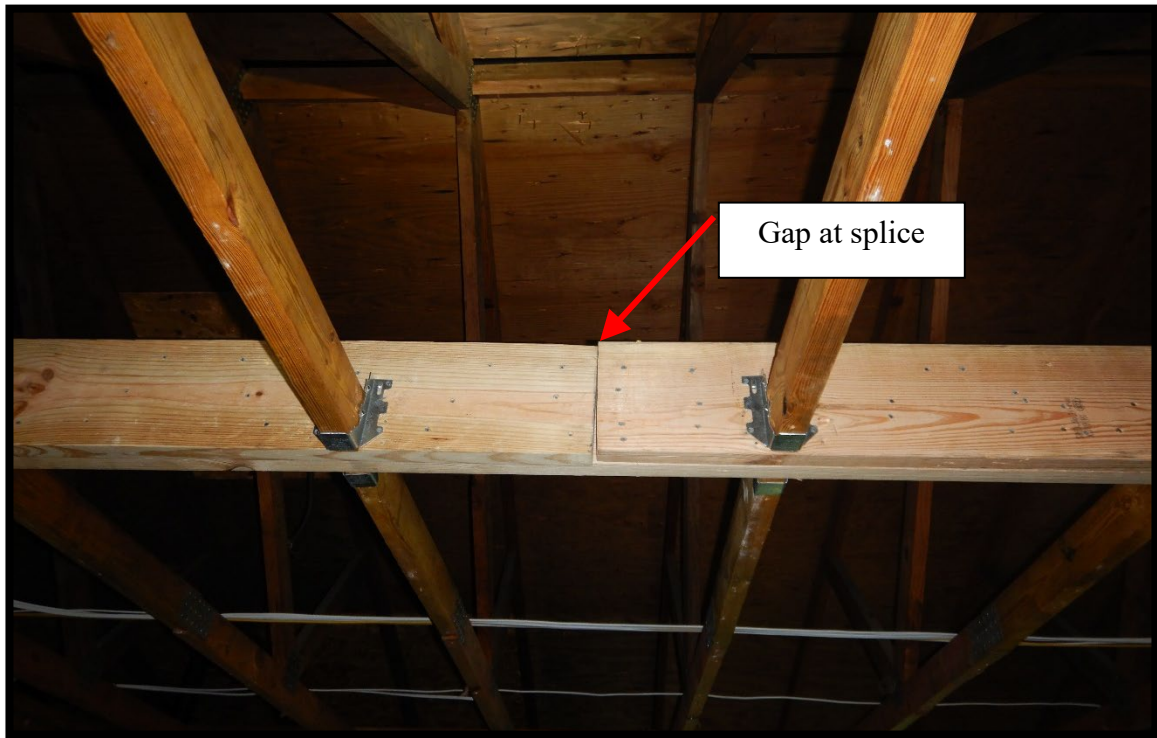
**Photo #3** – The beam had two splice points, one on each side.

Where the splices are located, the beam is effectively a one ply member. Attach a connection plate at both locations shown.

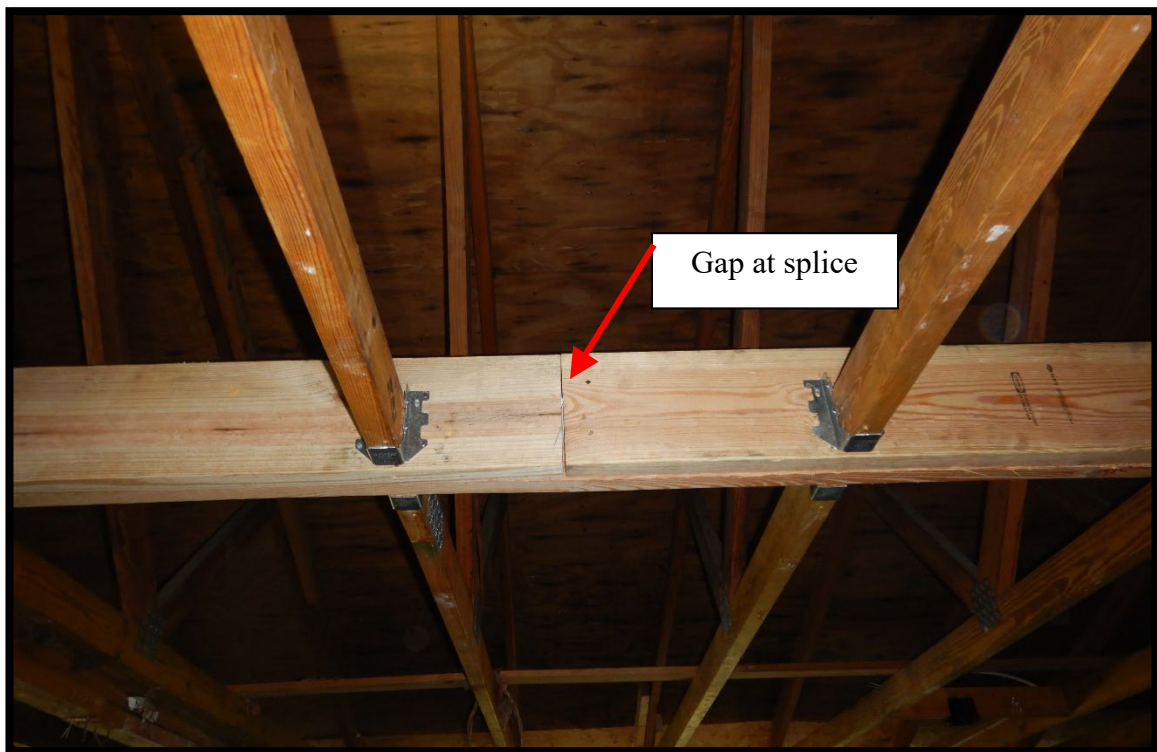
**Photo #4** – This is the other splice point.
