RE: **Clearview Court Retaining Wall**  
ECS Job # **33:6610**  
Permits:  
Location: **139 Clearview Ct**  
**Sanford, NC 27332**

# FIELD REPORT

Project **Clearview Court Retaining Wall**  
 Location **Sanford, NC**  
 Client **Creative Stone**  
 Contractor **None Listed**

## Report of Spread Footing - Foundation Observations

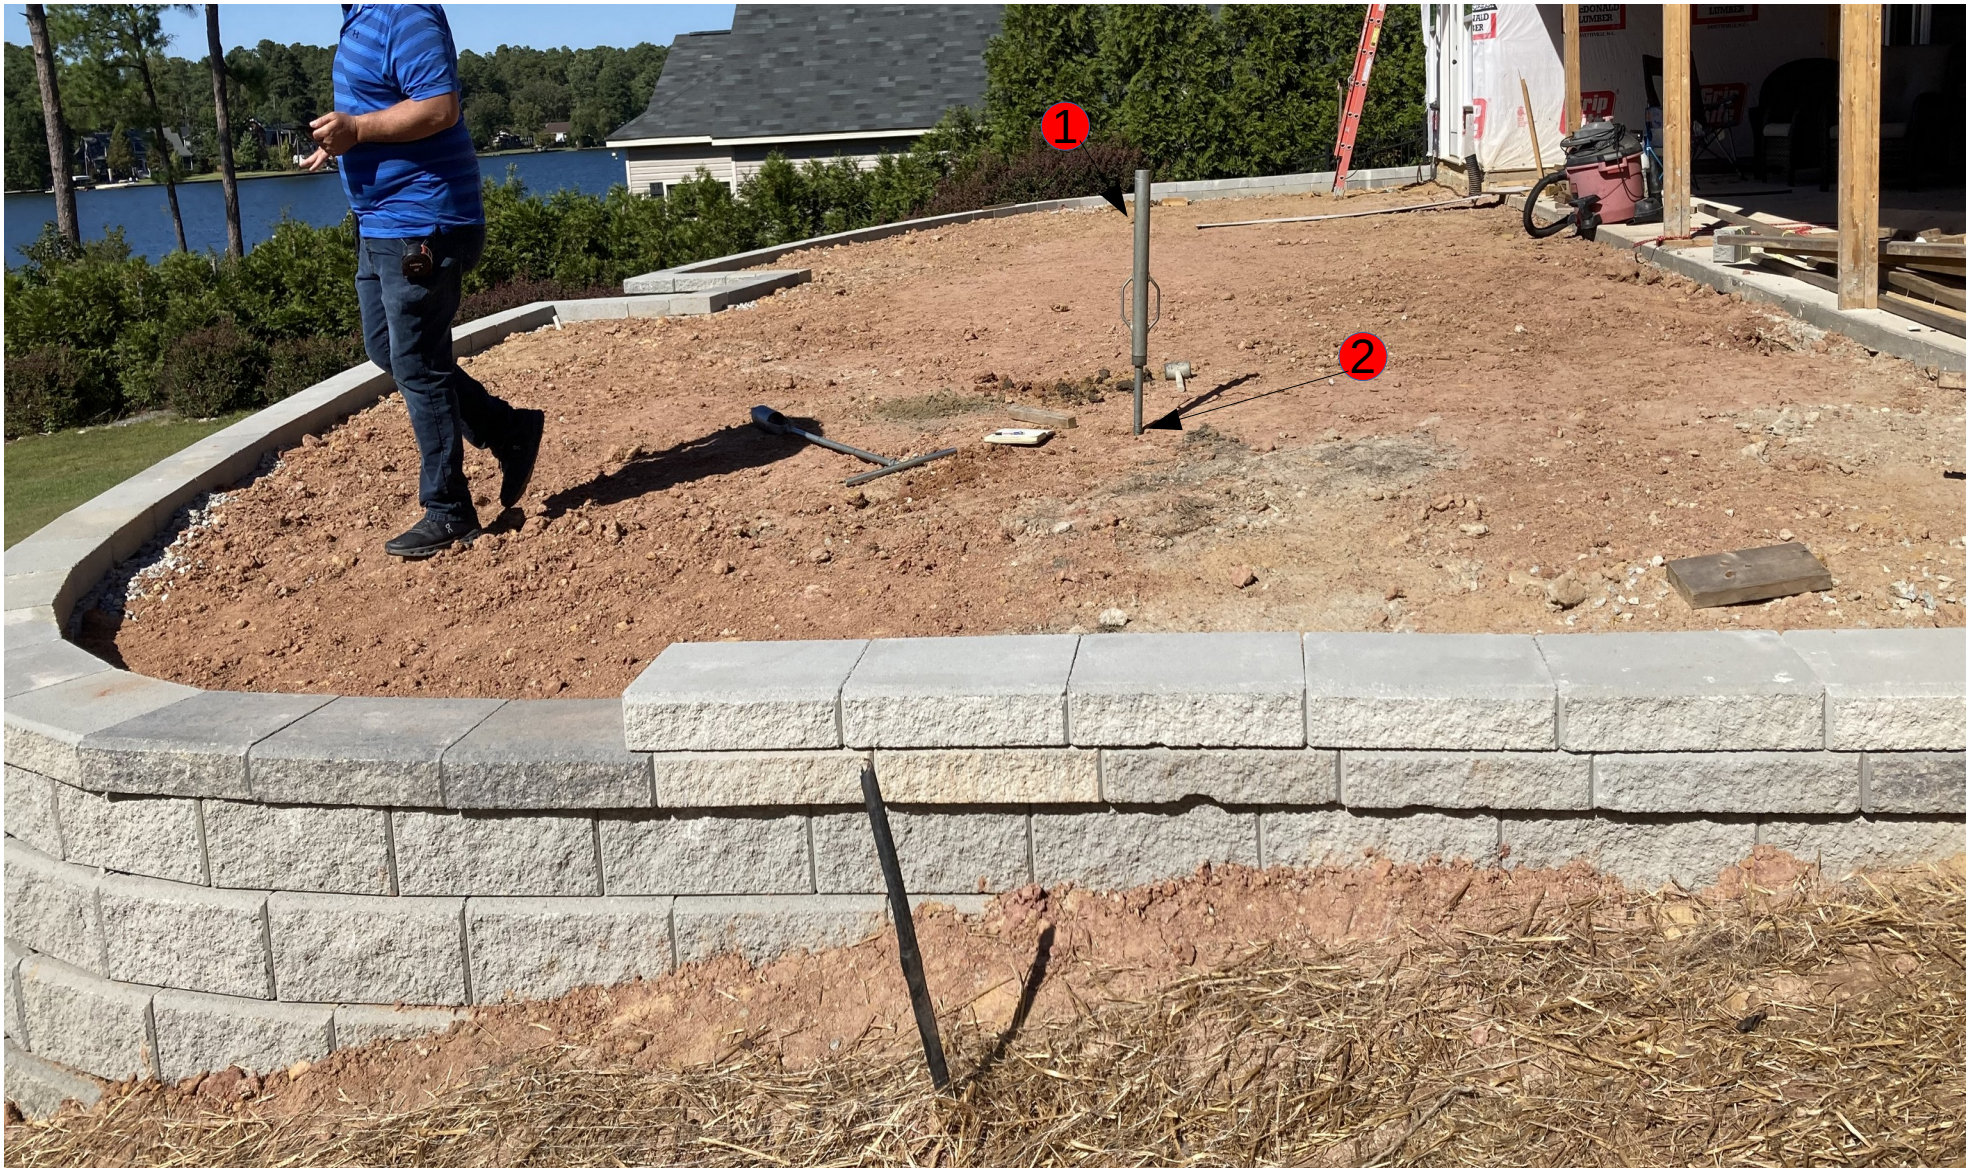
Chris Johnson  
10/9/2023  
Clearview Court  
Proj #: 6610  
W/O # 74583

ECS arrived on site, as requested, to check the bearing capacity of soils via hand auger/DCP method (ASTM STP-399) for retaining wall fill. Please see the attached sketch and data sheet for details.

A total of 2 hand auger/DCP evaluations were performed to a depth of approximately 3 feet below the current footing sub grade elevation. Test results indicated that the materials in place at location #1 did appear to be suitable to support the design bearing capacity 2,000 psf, but location #2 did not. ECS recommended the contractor use a jumping jack to compact the left side of the retaining wall so they could continue with the plan for concrete placement. ECS will not need to return once the left side of the retaining wall has been compacted.

**Key (NTS)**  
DCP Test Location
