FIELD REPORT

| Project Name: 450 River Bluff Dr | Location: Harnett County, NC |

Summary: Foundation inspection and rebar

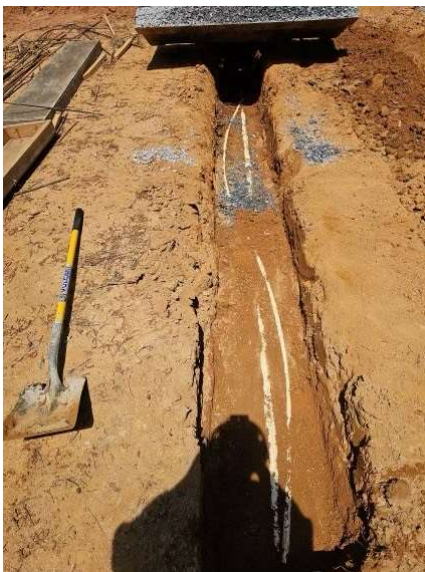
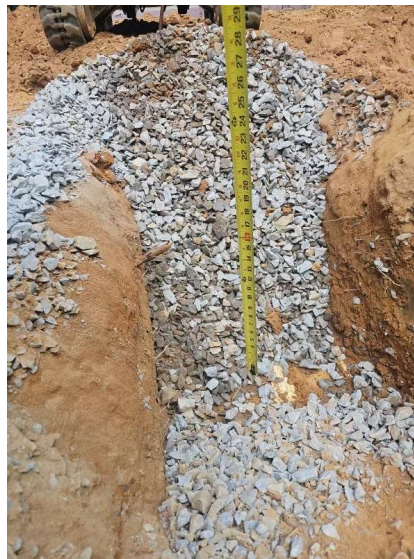
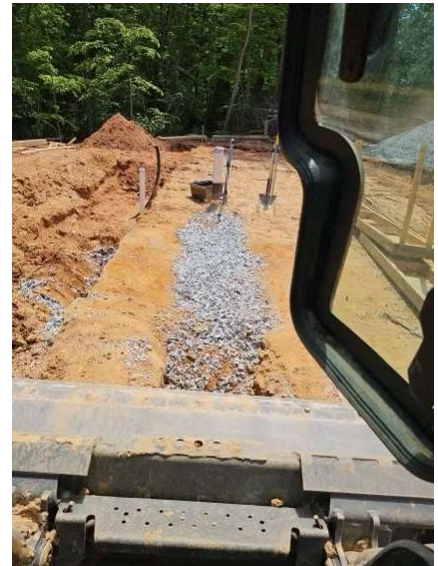
Notes: Timmons arrived on site as requested by contractor. Tech arrived to find site had been excavated for foundations and rebar in place. Tech observed all foundations were dug to firm bearing soils, and rebar was tied and in place as per plans provided on site. Tech did observe soils beneath probed firm with two hands on 1/2" steel probe rod. Tech marked two areas of organic roots that were suggested to be removed. Previous inspection found the area noted on 4-10-2025 which was located in workshop/garage section and suggested to contractor to excavate loose soils and replace with washed stone had been completed.

Tech observed Monolith slabs, with vapor barrier and insulation boards in place.

Repair for soft soils in drain line
repaired with washed stone
