Re: Structural Observation — 7232 Elliot Bridge Road, Spring Lake NC 28390

At your request, on February 6, 2025 we performed an on-site visual inspection and review of the structural plan proposed by *Tar Heel Basement Systems* for the first-floor framing reinforcement work at the Spring Lake residence noted above. The structure is a conventionally framed, detached, single family residence with raised first-floor framing over a pier/girder foundation system with perimeter masonry foundation walls (*see picture 1*).

Floor Framing Reinforcement

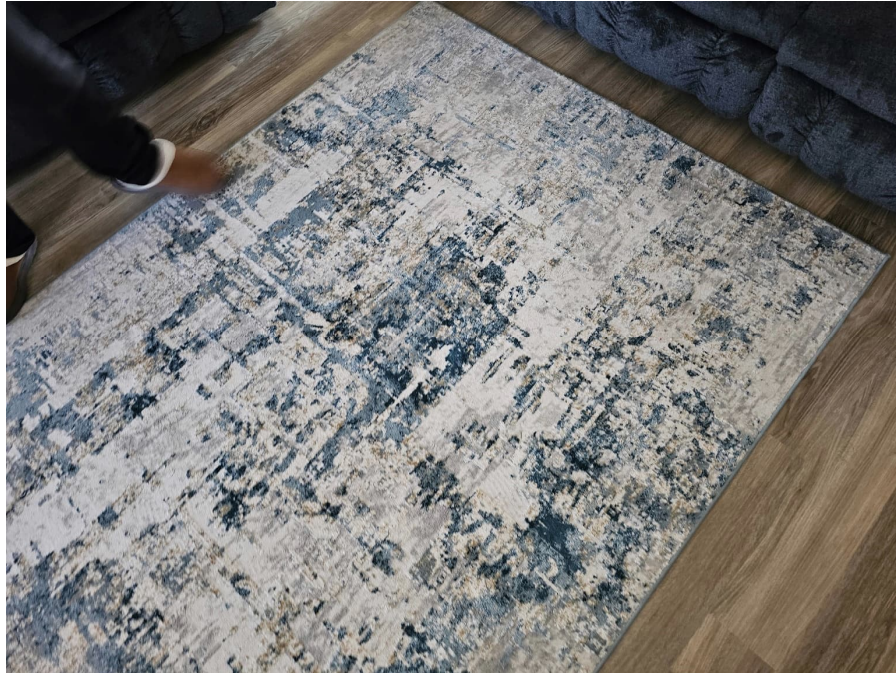
- Creaking floors were noted in the primary bedroom (*see picture 2*) and living room (*see picture 3*).
 - Measurement by laser level indicated that the back girder line was down as much as approximately $\frac{1}{2}$ " and $\frac{3}{4}$ " relative to the front girder line and back foundation wall, respectively.
 - Additional measurements indicated that the joists in the middle joist bay were sagging by as much as approximately $\frac{1}{2}$ " at mid-span.

Picture 3 – Area of creaking floors in the living room

- 1) To reinforce the living room and bedroom floor framing, install a supplemental S4x7.7 dropped girder within the middle $\frac{1}{3}$ of the joists. The new girders should span from the locations shown in the attached repair schematic over IntelliJack supports on well-compacted 18"x18"x18" gravel footings spaced no more than 6'-0" apart.
 - a) The ends of the girder may cantilever up to 2'-0" over the ends of the support.
 - b) If the creaking floors are caused by missed subfloor fasteners, further engineering may be required to reinforce the subfloor.

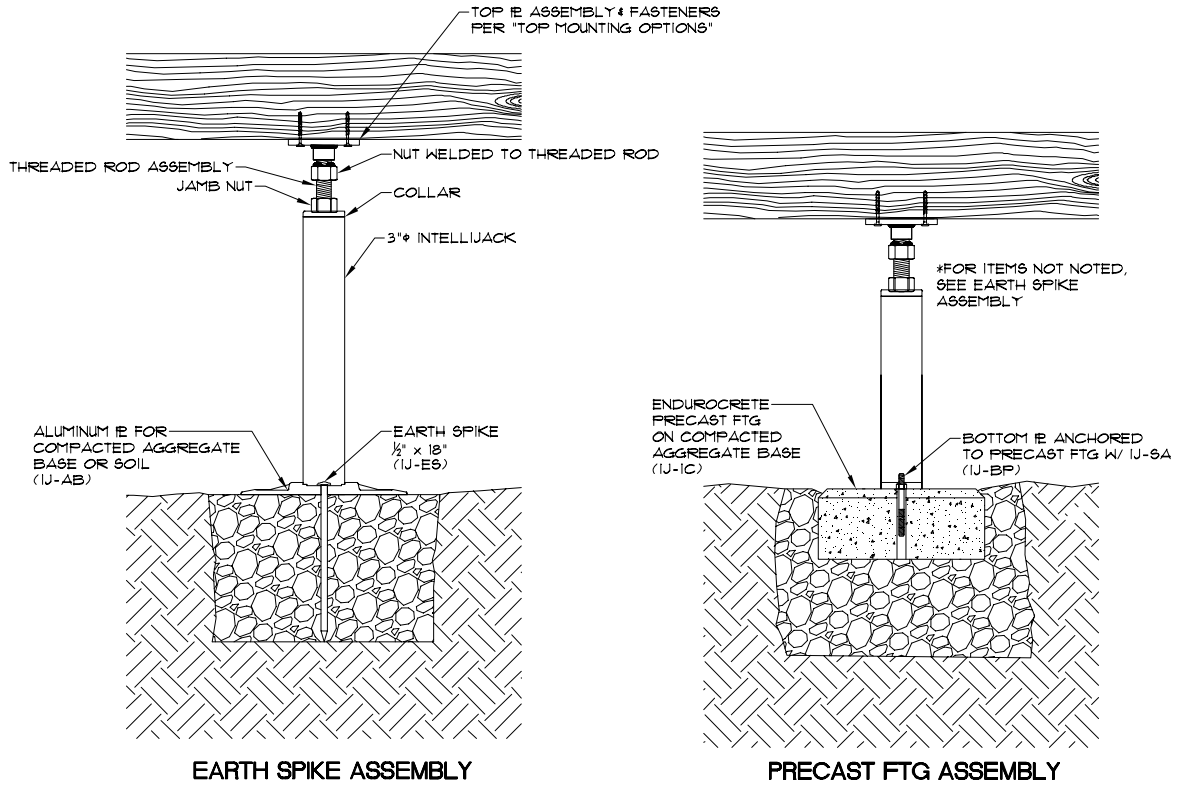
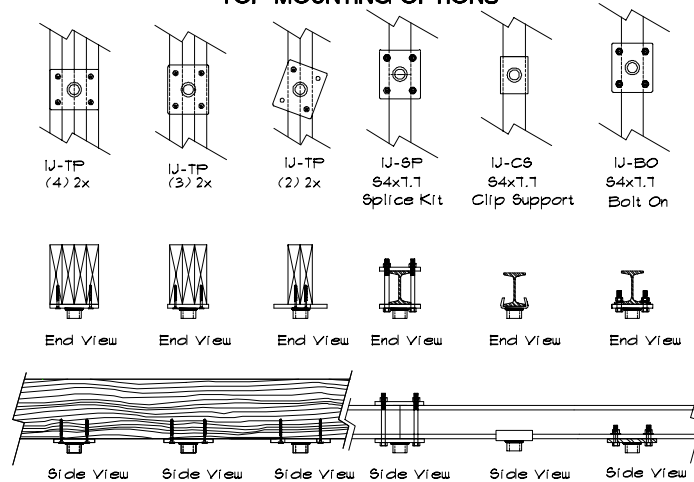
Detail 1 – Intellijack Installation Specifications

TOP MOUNTING OPTIONS
