Re: Structural Observation — 913 South 13th Street, Erwin, NC 28339

At your request, on February 14, 2025 we performed an on-site visual inspection and review of the structural plan proposed by *Tar Heel Basement Systems* for the first-floor framing repair work in the front-right living room at the Erwin residence noted above. The structure is a conventionally framed, detached, single family residence with raised first-floor framing over a pier/girder foundation system with perimeter masonry foundation walls (*see picture 1*).

Living Room Framing Repair Plan

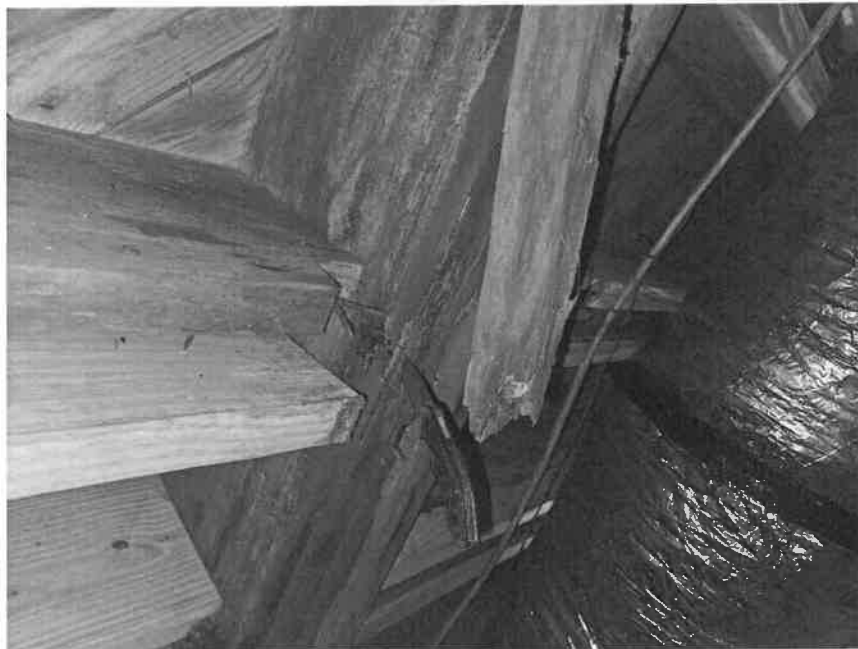
- Signs of moisture damage were noted throughout the first-floor framing system, particularly in the living room. Thorough probing indicated that the following framing members at the living room were deteriorated beyond salvageable limits:
 - The girder and ledger strip at 3rd span from the right along the front girder (*see picture 2*).
 - The leftmost (7) joists (*see picture 3 for example and attached repair schematic for reference*).
 - Most of these joists were noted to be improperly reinforced with non-continuous sister plies (*see picture 4 for example*).
 - Additional sections of the sill plate, rim band, and joists in the middle joist bay were deteriorated and/or cracked.

Picture 2 – Deteriorated girder and ledger strip

- 1) Remove the above-noted significantly deteriorated portion of the girder and replace using a new (3)2x10 #2 Southern Yellow Pine (SYP) material with continuous span between existing masonry girder support piers.

- a) Fasten joists to the sides of the new girder using Simpson face hangers.
- 2) Reinforce each of the deteriorated joists noted above with an additional full depth ply of 2x #2 SYP, fastened to the side of the deteriorated joists using (3)10d common nails at each end and at 12" on center staggered top and bottom along the lengths of the joists. Sistered material should span continuously between end supports.

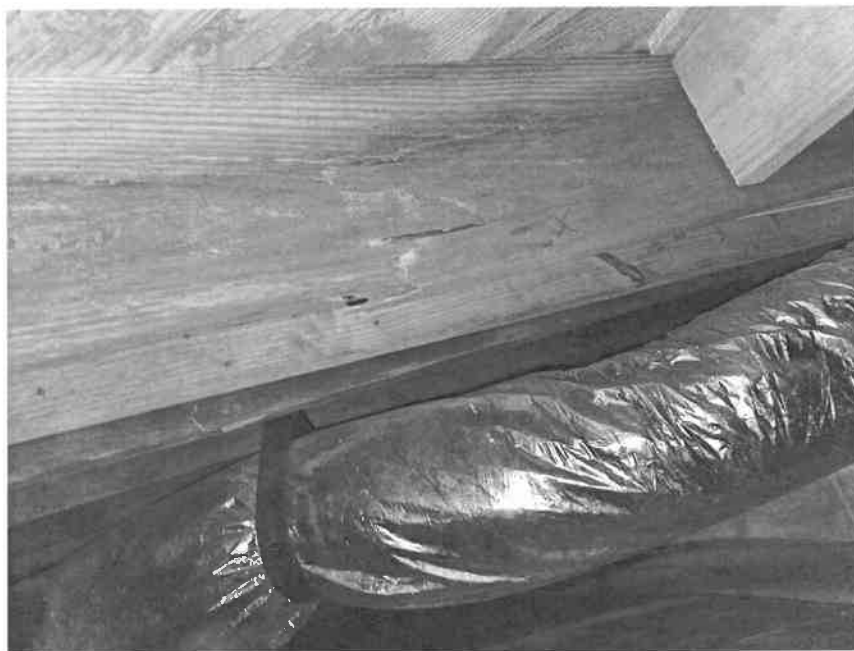
Picture 3 – Deteriorated joist

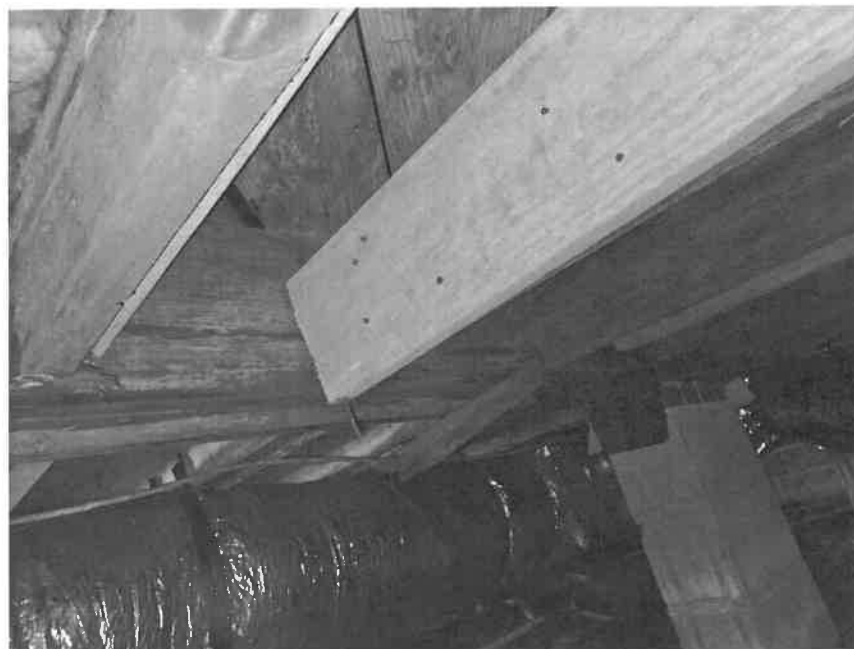
Picture 4 – Improperly reinforced joist
