Back Over Patio  
Side of House 1  
891 Highroad Dr.  
Spring Lake, NC 28390

**RWF Home Improvement**

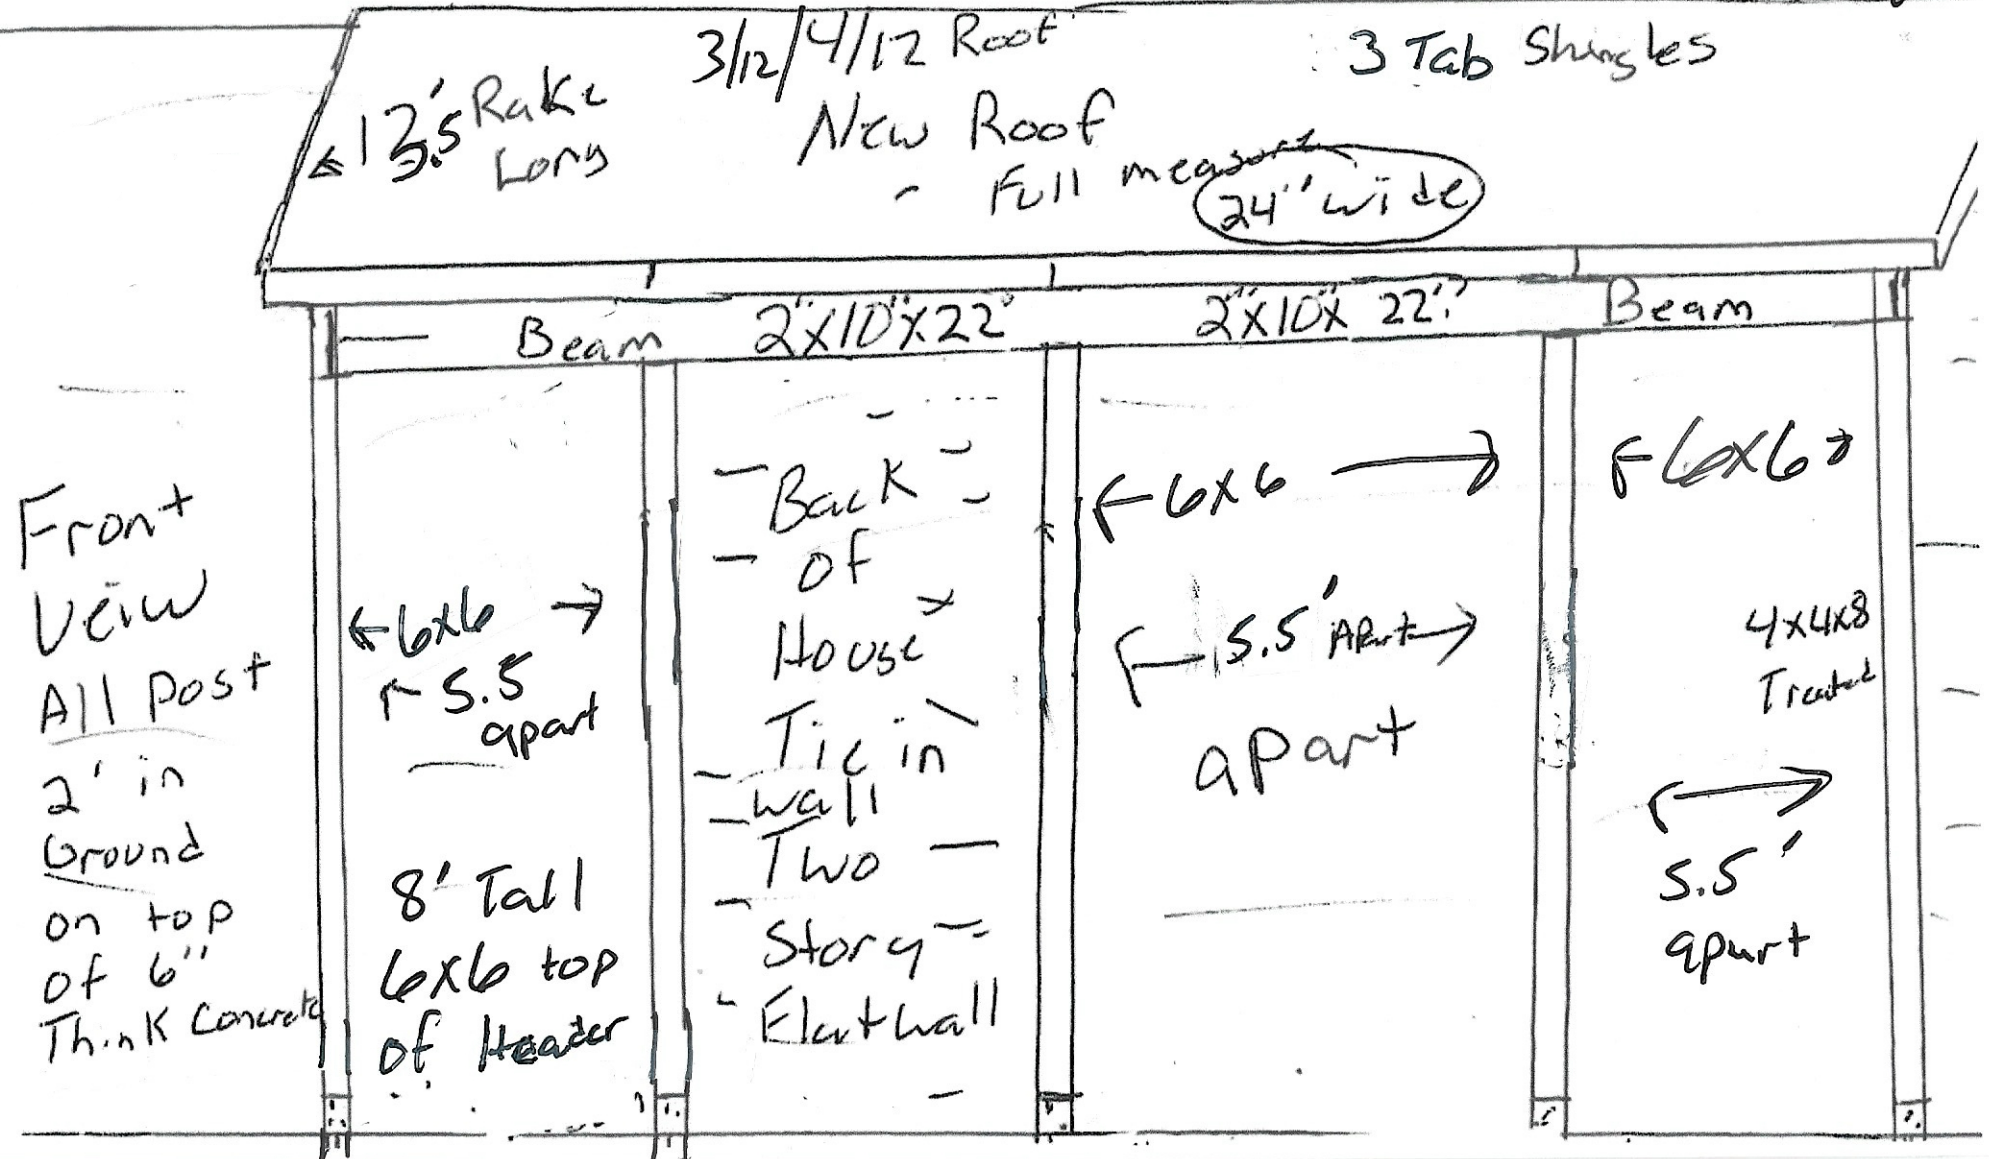
Drill Thor  
Patio Post  
Post in ground  
2' on 6" concrete  
thick

Diagram illustrating a roof truss system with various components and dimensions:

- Top Chord:** Labeled  $2 \times 6 \times 13$ .
- Span:** Indicated as  $16'$  on center.
- Web:** Labeled  $6'$  with arrows indicating the vertical spacing.
- Members:**
  - $2 \times 8$  Face
  - $2 \times 10$  Doubled Beam Notched in
  - $2 \times 6 \times 12$
  - $2 \times 4 \times 3$
  - $2 \times 4 \times 3$
  - $2 \times 6$  Header
- Ground Level:** Indicated by a horizontal line.
- Foundation/Support:**
  - $6' \times 6' \times 12'$
  - $2'$  foot in Ground
  - $12''$  hole Diameter
  - $6''$  concrete Form

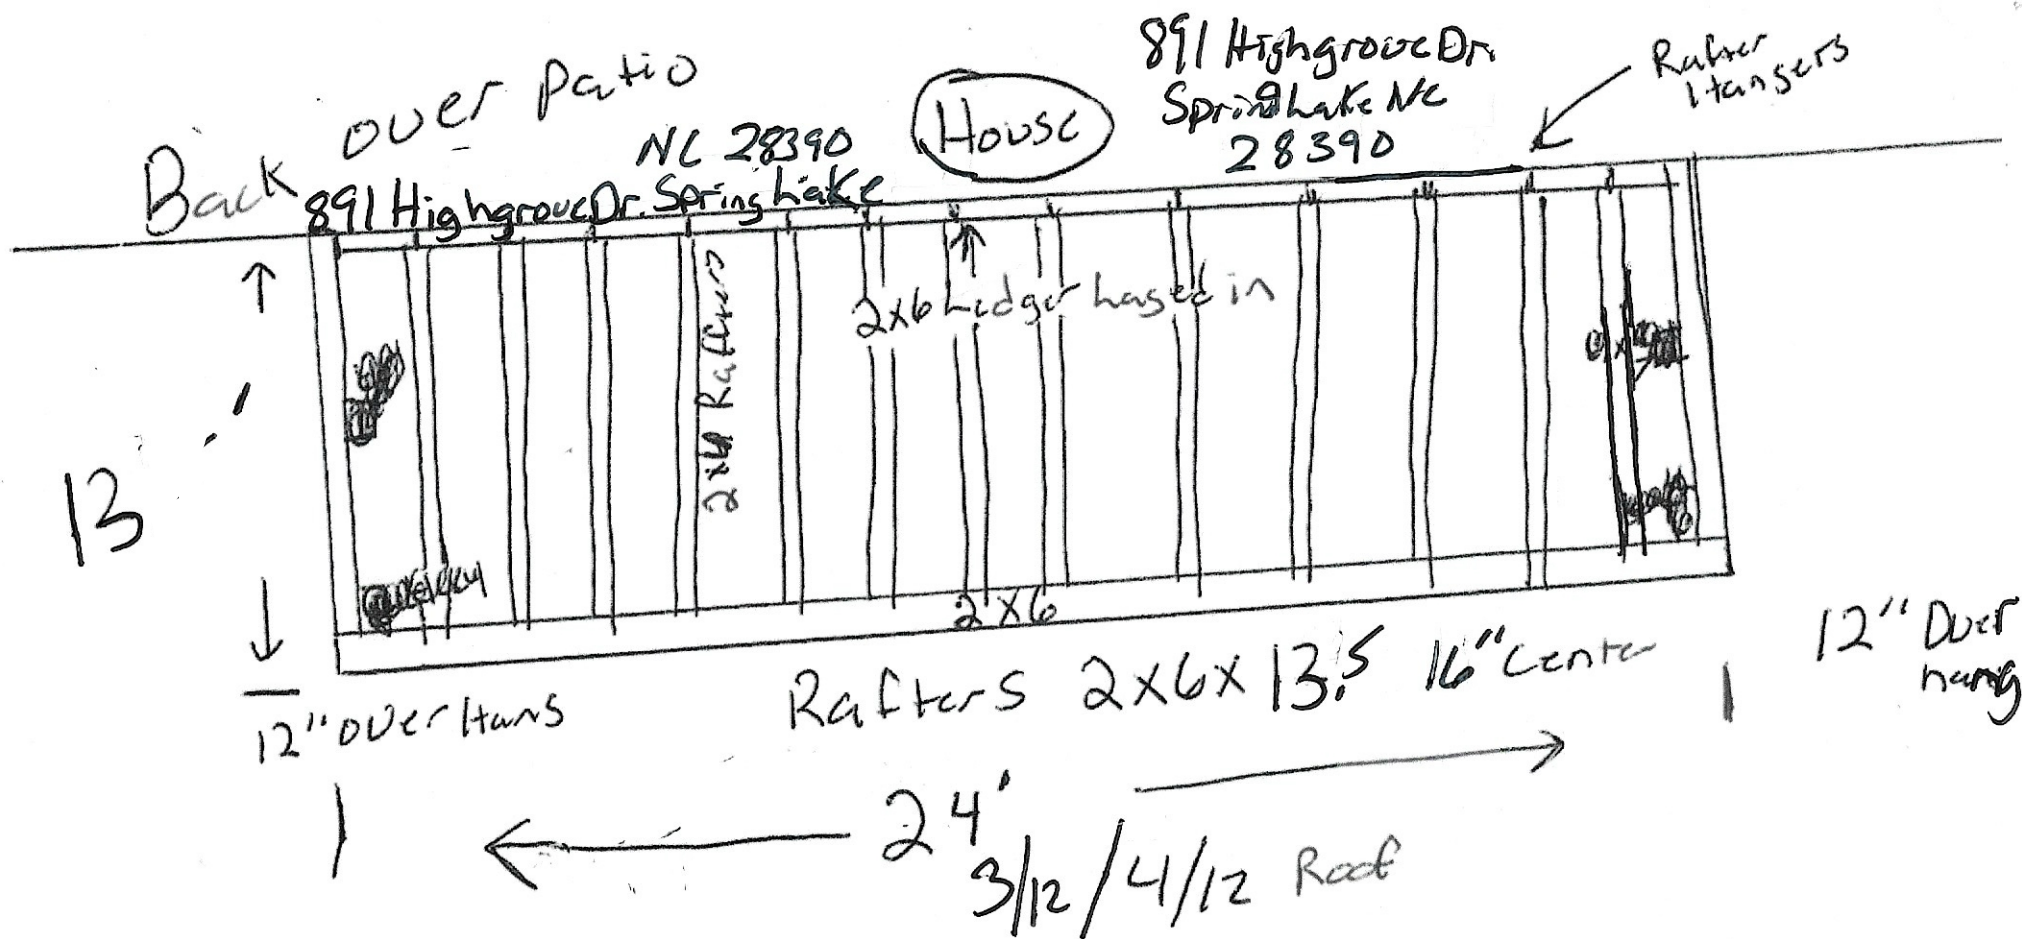
Top view of Roof lean two  
 1/2 OSB Sheeting with clips  
 3 tab Shingles
