# SITE/SOIL EVALUATION FOR ON-SITE WASTEWATER

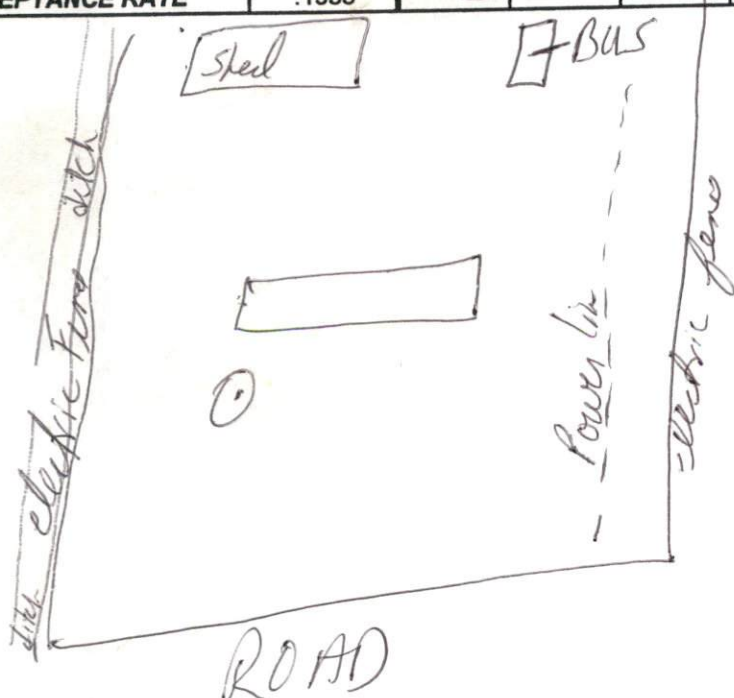
- ① mottles present in sand
- ② well located at rear of property beyond bus
- ③ Carolina Bay

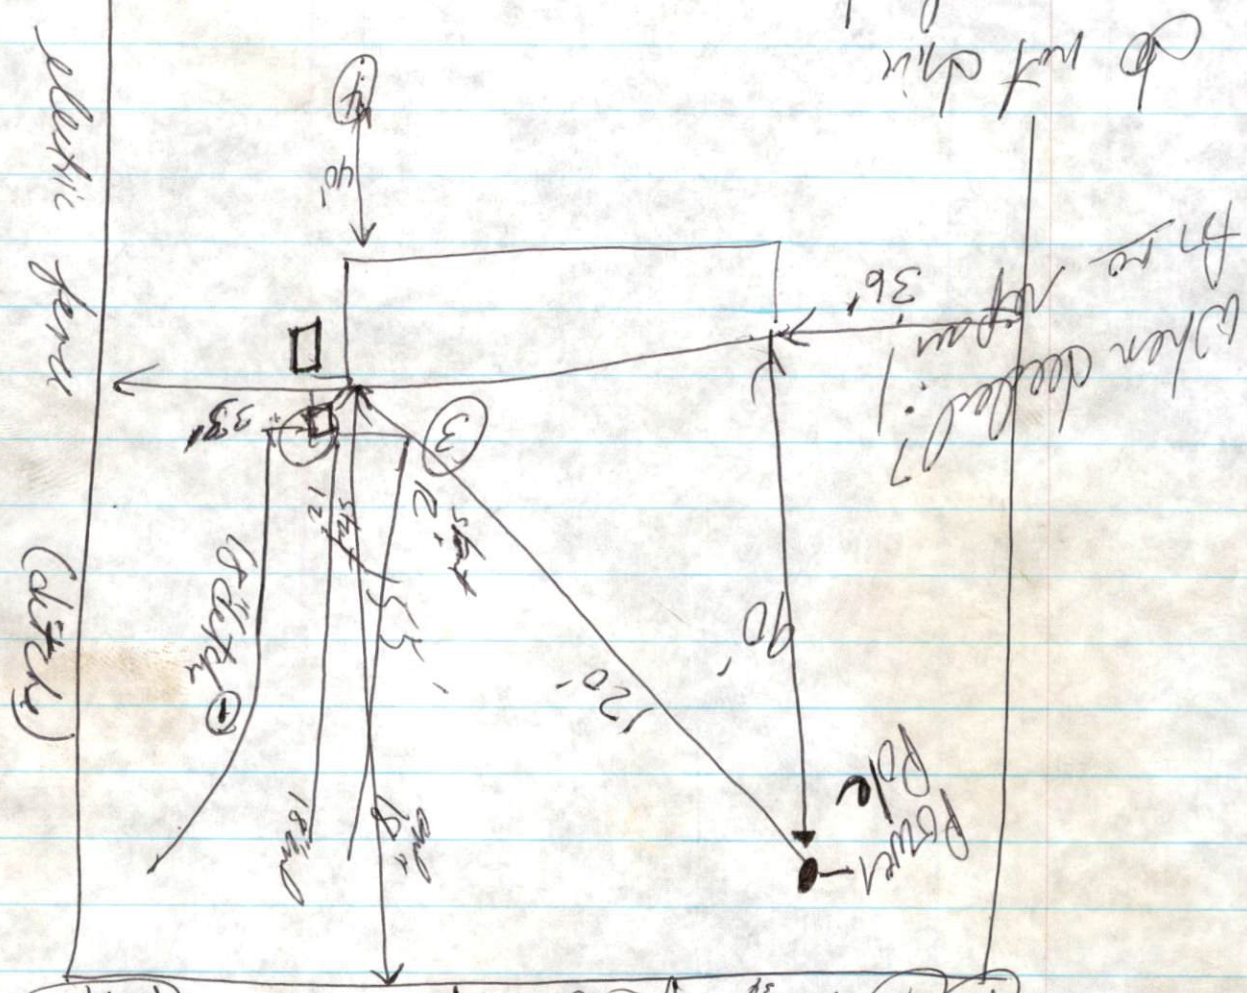
④ 2-16 loan  
 16-36 SICL  
 1/50K/50K  
 15.4" months  
 30"

③ 2-20 loan  
 20-36 SICL  
 1/50K/50K  
 30" months  
 14"

⑤ 0-20 loan  
 20-36 SICL  
 1/50K/50K  
 34" months  
 14"

⑥ 0-10 LS  
 10-36 SICL (SICL)  
 1/50K/50K  
 34" months  
 14"

When decided?  
 for the repair!
