FULL CIRCLE ENVIRONMENTAL, LLC.

RE: Septic System Point of Sale (POS) Inspection 1345 Dry Creek Rd., Harnett County NC

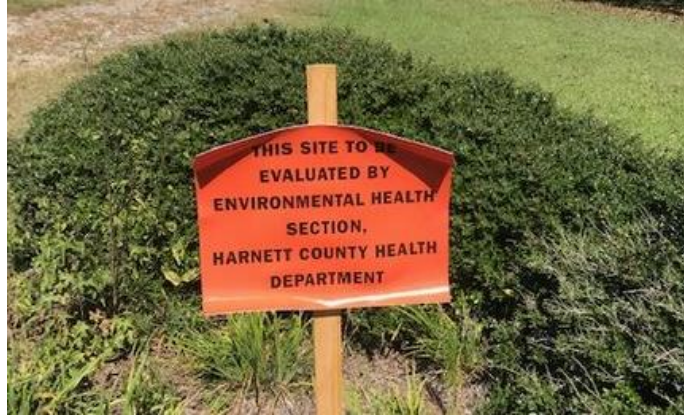
At the time of the inspection, no permits were identified by the local health department and the property was publicly noticed on site as being required to be evaluated by the Harnett County Health Department's Environmental Health Section.

Figure 1. Public notification on site

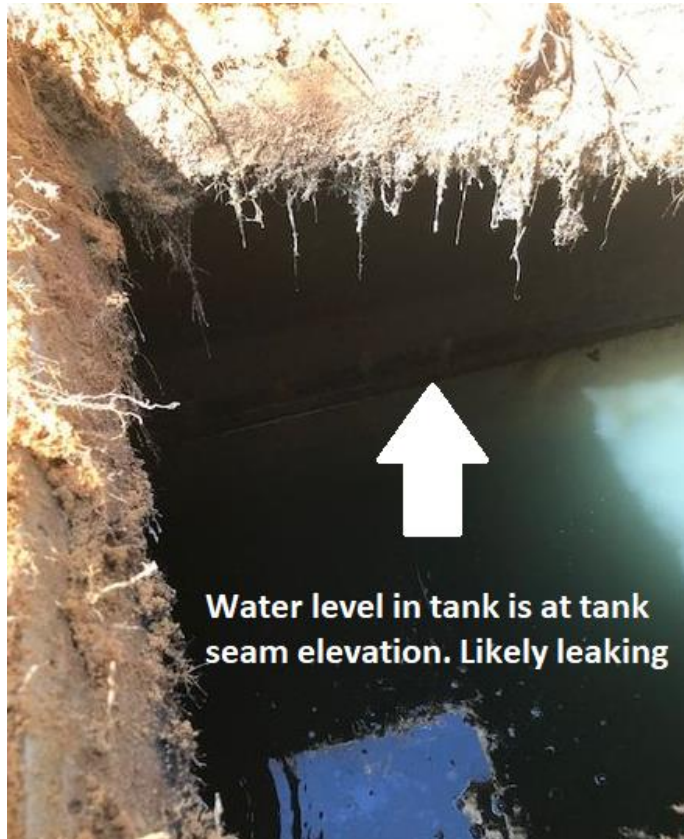
- 1- The septic tank was uncovered and was approximately 6" deep. The tank had an 18" by 18" inlet access and approximately a 6" by 6" outlet access. The tank is a single compartment with a deteriorated outlet tee and the tank appeared to be leaking (level was at the tank seam. Given the concerns of this tank (age, single compartment, not watertight) it is recommended this tank be abandoned and replaced with a NC State approved septic tank to match the design capacity and access opening risers be provided over both tank openings.

Figure 2. Inlet side of tank (leaking)

As noted above, this system appears to have no documentation and possibly be unpermitted. It is recommended the existing tank be replaced and a new drainfield be installed. Note that this must be coordinated with the Harnett County Health Department. Note also there are two potable wells located in close proximity of this residence and a water meter (County Water) appears to also be on this site. If the wells are not being used, a permit should be obtained and these wells should be abandoned. If there are in use, then water quality analysis should be performed to verify this water is safe.

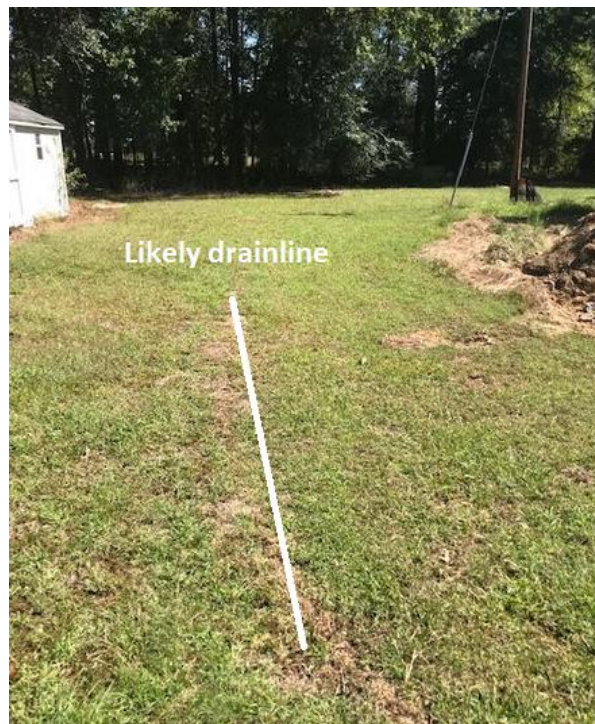
- 3- The distribution box and drainlines could not be specifically located however the ground surface showed signs of possible trench location.

Figure 4. Possible drainline location

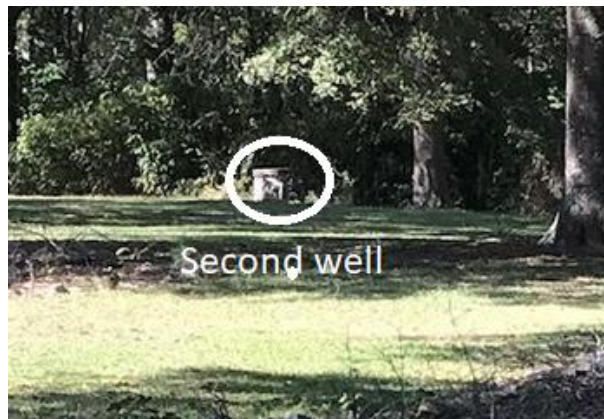
Figure 6. Second well location
