# **Application for Repair**

# **SEPTIC SYSTEM EVALUATION**

Inspection address: 184 Deer Run Court, Angier, NC 27501

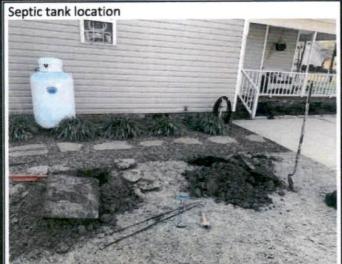
Higher sustained effluent level (primary chamber shown

- 1) The septic tank is located approximately 12 feet off the left of the house foundation. The primary chamber was excavated, opened, and inspected. The solid accumulation inside of the primary chamber was noted as being at an acceptable level (A higher sustained effluent level was noted inside of the septic tank).

- > A higher sustained effluent level was observed inside the septic tank at the time of the inspection. A normal effluent level, inside the septic tank, places the water level at the invert (bottom of the drainpipe) of the outgoing drain line. The higher effluent level is an indication that there is a blockage in the outgoing drain line leading to the drain field. An evaluation of the drain field's ability to disperse effluent to the surrounding sub surface soils needs to be completed after any cleaning/removal of solids found block the effluent flow is removed\*\*.

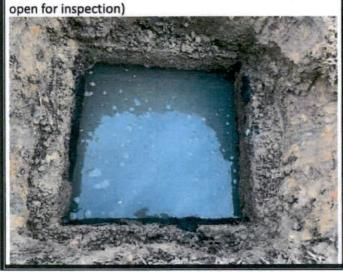
Primary chamber location shown

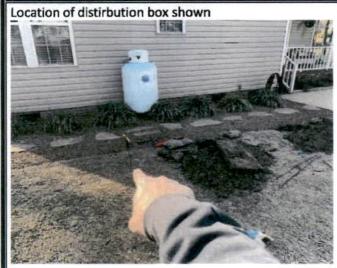
Higher sustained effluent level (secondary chamber shown open for inspection)

3) A higher sustained effluent level was observed inside the septic tank at the time of the inspection. A normal effluent level, inside the septic tank, places the water level at the invert (bottom of the drainpipe) of the outgoing drain line. The higher effluent level is an indication that there is a restriction in the outgoing drain line leading to the drain field.

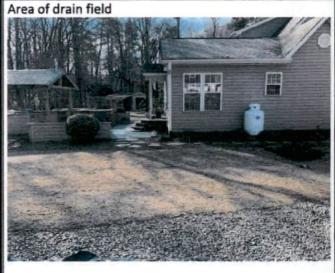
Area of drain field (Addition noted as being over top of drain field)

Note: The back addition is encroaching on the septic system (drain field). Foundations, footing, sidewalks, driveways etc, must have a 5-foot clearance from the septic tank. In some municipalities, a 3-foot clearance is allowed. (See link below) Although it varies county to county checking with the local health department will help clarify what the specifics are pertaining to decks/house foundations encroachment.

Based on the information determined at the time of the inspection, the drain field is known to be located at the rear quadrant of the lot. Note: A section of the drain field is located under the back addition. The location of the septic tank's distribution box along with the permit suggest that the addition is above a section of the drain field.

- > The back foundation addition is encroaching on the septic system. The addition of the house was noted as being built overtop a portion of the drain field. A septic tank cannot be used as a means of support for any structure whatsoever. A variance for the encroachment of the addition on the septic system should be provided and repairs made so that the no part of the septic system is providing support for the raised structure above it.

- The back addition can affect the operating efficiency of the system by compacting the soils underneath, it in the area of the drain lines and by reducing the open free space of ground surface above the drain field which reduces naturally occurring transpiration.
