Application for Repair

Onsite Wastewater System Inspection

236 Washington Lane

System Overview:

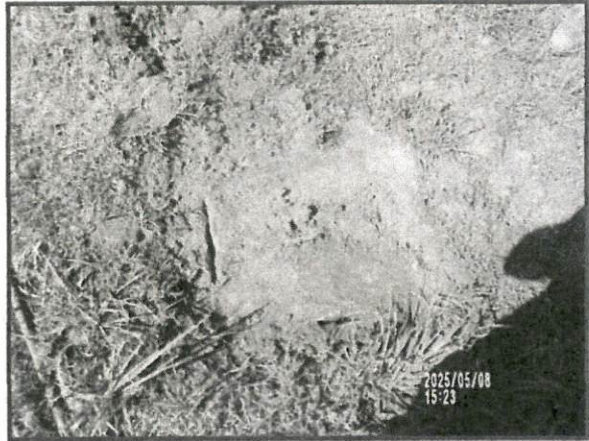
P6. Septic Tank Outlet Lid

The outlet compartment access to the septic tank was located nineteen feet behind the back left corner of the house, and it was six inches below grade. The outlet lid was in poor condition. In fact, the outlet lid cracked during removal. This lid was replaced with a spare lid. The water level inside the outlet was found to be precisely at the lower invert of the outlet pipe, which is the correct operating water level. Next, I inspected the interior of the outlet compartment above the water level, and there was substantial corrosion around the lid opening, on the end wall of the tank. In fact, some of the concrete that holds the lid was very loose. The outlet lid is no longer sealed or structurally sound. There is a baffle wall inside the septic tank that separates the inlet and outlet compartments. The baffle wall was found to be in satisfactory condition above the water level, containing no cracks, or damage, but there was some corrosion. There was a concrete outlet baffle on the outlet of the tank, but it was nearly non-existent due to corrosion. Lastly, I ran water into the outlet pipe to ensure that effluent enters the drain field, and it did. At no point during the inspection, did any of the water back up into the septic tank.

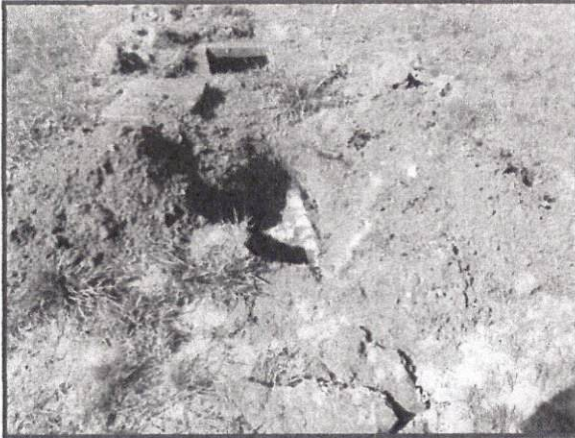
P9. Drain-Waste-Vent Tee

There is a drain-waste-vent tee installed in place of the distribution box, and the tee was measured to be approximately six feet from the outlet of the septic tank. A drain-waste-vent tee is not an approved distribution device. Examples of approved distribution devices include distribution boxes and flow dividers. At this time, I ran water into the outlet pipe, to ensure that effluent did not back up into the septic tank, and it did not. Since a tee is installed, I am unable to inspect for equal distribution. Next, I began to probe and locate the drain field lines. There are two, three feet wide gravel drain field lines that are 100 feet long. The drain field lines run from the distribution box directly towards the rear of the property, through the wooded area, behind the house. Due to the over grown vegetation, I was unable to locate the entire 100 feet of each line. There was at least six inches of soil cover over top of each drain field line where they were located, and each drain line was at least nine feet apart, when measured from center to center. I have marked the drain lines with marking paint and marking flags—see pictures that conclude this report along with the attached septic permit.

2. The concrete outlet baffle of the septic tank is so deteriorated, it is nearly non-existent.
3. There is a PVC drain-waste-vent tee installed in place of the original distribution box. This tee is not an approved distribution device, and it cannot equally distribute effluent to the two drain field lines.

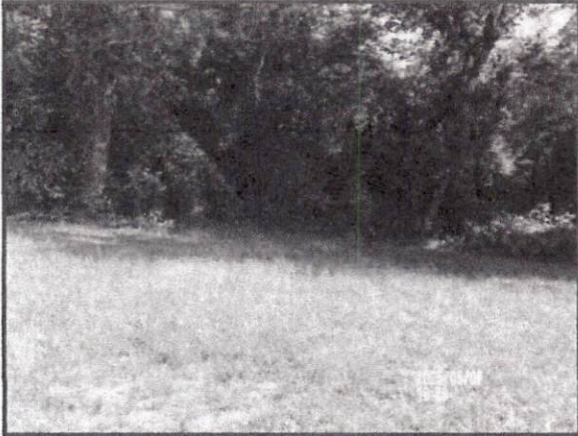
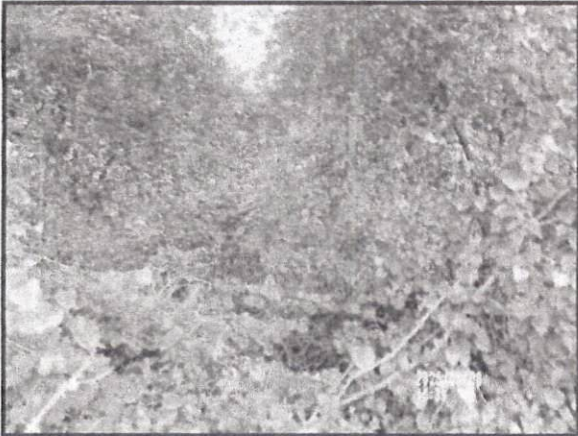
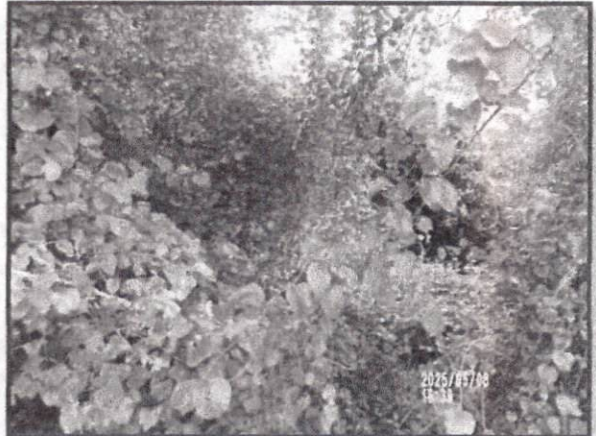
P32. Location of Drain Field Lines

At this time I did a final walkthrough of the system to look for any grading issues, non-permitted connections, excessive saturation in the drain field, or evidence of surfacing effluent, and none were observed. However, I did make note of the large trees and vegetation in the drain field. While there is no setback requirement for vegetation or trees from septic system components, it is well known that roots tend to grow towards sources of water, nitrogen, and phosphorus, and wastewater contains all three. I did not observe any symptoms of a malfunction resulting from a root intrusion at the time of the inspection. Next, I observed the boundaries of the property with respect to the septic system components. Since the property

4. There was so much excessive vegetation growing in the drain field that I was unable to mark each drain field line. While I did not observe any symptoms of a malfunction resulting from root intrusion, it is well known that roots tend to grow towards water, nitrogen, and phosphorus—wastewater contains all three.

8. Keep the drain field area properly maintained. Do not leave vegetation such as trees and shrubs to go unmanaged as the roots from these can cause damage to the system. Keep a good ground cover, such as grass, over this area to prevent erosion, and to achieve more evapotranspiration. Do not allow settled areas or holes to remain. Any low spots will allow storm water to puddle, which will eventually drain down into the drain field media. The drain field media is for storage of wastewater, not storm water. Any accumulation of storm water in the media will reduce the system's capacity to treat the wastewater.
