RE: Daily Field Report for 01/16/2019
Lot 3 Hidden Lakes (CMT) Spring Lake, NC
Building & Earth Project No : RD190032

Field Observations Report

1 : Foundation Inspection-Stem Wall

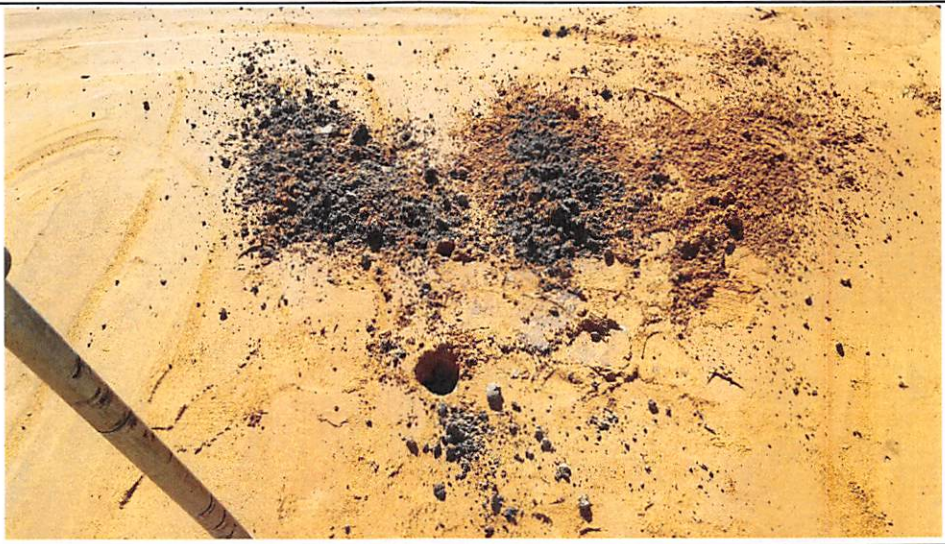
Picture ID	Dcp
10617

DCP Testing: Our representative performed Dynamic Cone Penetration (DCP) testing in general accordance with ASTM STP-399 at four representative locations to a depth of 36 inches. Our representative did not observe water within the DCP boreholes as noted below.
