RE: Daily Field Report for 05/31/2019
Lot 241 Highgrove at Anderson Creek HGR (CMT) Spring Lake, NC
Building & Earth Project No : RD190252

Field Observations Report

Project Name:	Lot 241 Highgrove at Anderson Creek HGR (CMT) Spring Lake, NC	Project Number:	RD190252
Client Name:	H & H Homes	Placement#:	FO-3
Contractor:	H & H Homes	Technician:	Juan Garcia
Monitoring:	DCP

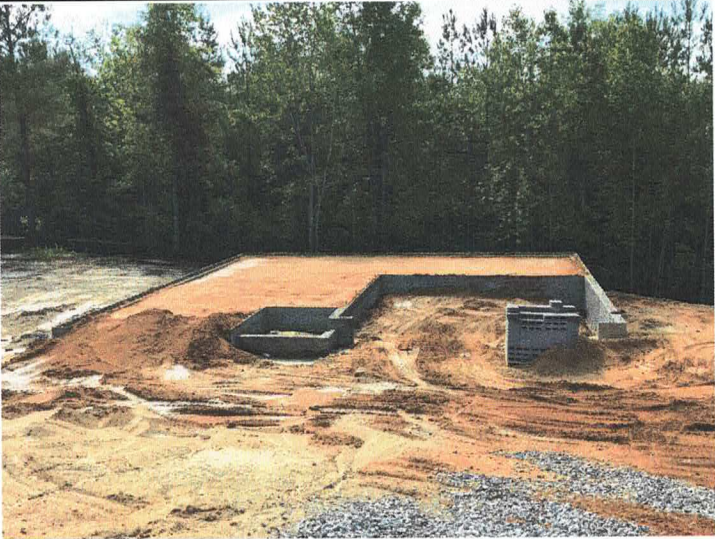
Picture ID	Job site
14200

The lot is relatively flat. Building locations are referenced from the street looking at the front of the residence. Maximum relief across the lot is approximately 1 foot. Surface water runoff appears to drain towards the back of the lot in a ditch.

The site has been stripped of surface cover and topsoil. It appears that 2-3 inches of topsoil has been removed from the building pad area.

Structural fill has been placed at the site to level the building pad. Based on our observations, we understand the pad has been filled according to the following:
