57 old
Montague
Way

ATTACH 2x SCAB OF THE SAME SIZE AND GRADE AS THE BROKEN MEMBER TO EACH FACE OF THE TRUSS (CENTER ON BREAK OR SPLICE) WITH 10d NAILS (TWO ROWS FOR 2x4, THREE ROWS FOR 2x6) SPACED 4" O.C. AS SHOWN (.131" dia. x 3") STAGGER NAIL SPACING FROM FRONT FACE AND BACK FACE FOR A NET 0-2-0 O.C. SPACING IN THE MAIN MEMBER. USE A MIN. 0-3-0 MEMBER END DISTANCE.

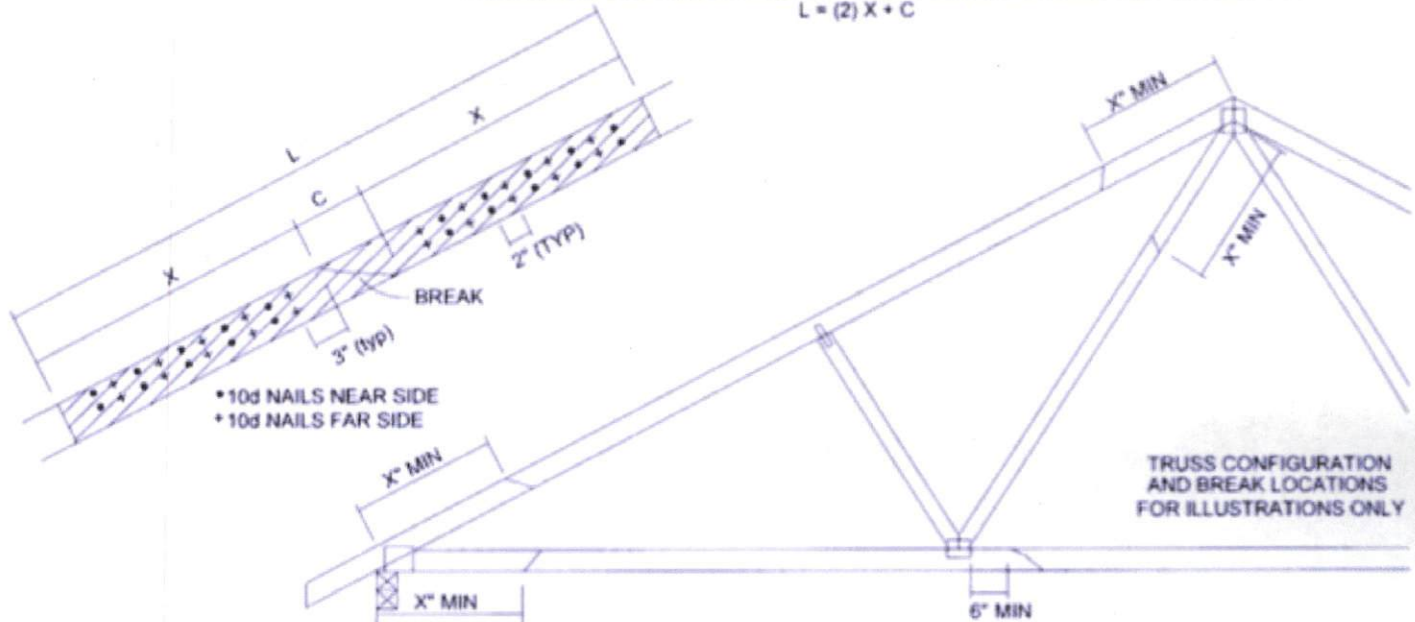
THE LENGTH OF THE BREAK (C) SHALL NOT EXCEED 12". (C=PLATE LENGTH FOR SPLICE REPAIRS) THE MINIMUM OVERALL SCAB LENGTH REQUIRED (L) IS CALCULATED AS FOLLOWS:
 $L = (2) X + C$

THE LOCATION OF THE BREAK MUST BE GREATER THAN OR EQUAL TO THE REQUIRED X DIMENSION FROM ANY PERIMETER BREAK OR HEEL JOINT AND A MINIMUM OF 6" FROM ANY INTERIOR JOINT (SEE SKETCH ABOVE)

TOTAL NUMBER OF NAILS EACH SIDE OF BREAK *		X INCHES	MAXIMUM FORCE (lbs) 15% LOAD DURATION							
			SP		DF		SPF		HF	
2x4	2x6		2x4	2x6	2x4	2x6	2x4	2x6	2x4	2x6
20	30	24"	1706	2559	1561	2342	1320	1980	1352	2028
26	39	30"	2194	3291	2007	3011	1697	2546	1738	2608
32	48	36"	2681	4022	2454	3681	2074	3111	2125	3187
38	57	42"	3169	4754	2900	4350	2451	3677	2511	3767
44	66	48"	3657	5485	3346	5019	2829	4243	2898	4347

* DIVIDE EQUALLY FRONT AND BACK

DO NOT USE REPAIR FOR JOINT SPLICES
