Project Name: Quail Glen - Lots 33, 34, 57 and 58 Date: 3 / 13 / 2020 GTA Rep: Brandon Parker  
 Project No.: 200385N\*\*\* Client: Ryan Homes Weather: Sunny Temperature: 62 °F

Quail Glen - Harnett Central Road, Angier, North Carolina

GTA representative arrived on-site, as requested, to test the bearing capacity of near surface soils for turn-down footings, and to perform 3rd party mono-slab observations prior to concrete placement for Lots 33, 34, 57, and 58 in the Quail Glen subdivision in Angier, North Carolina. Please see the above physical site addresses and building permit numbers for the Lots observed on this date.

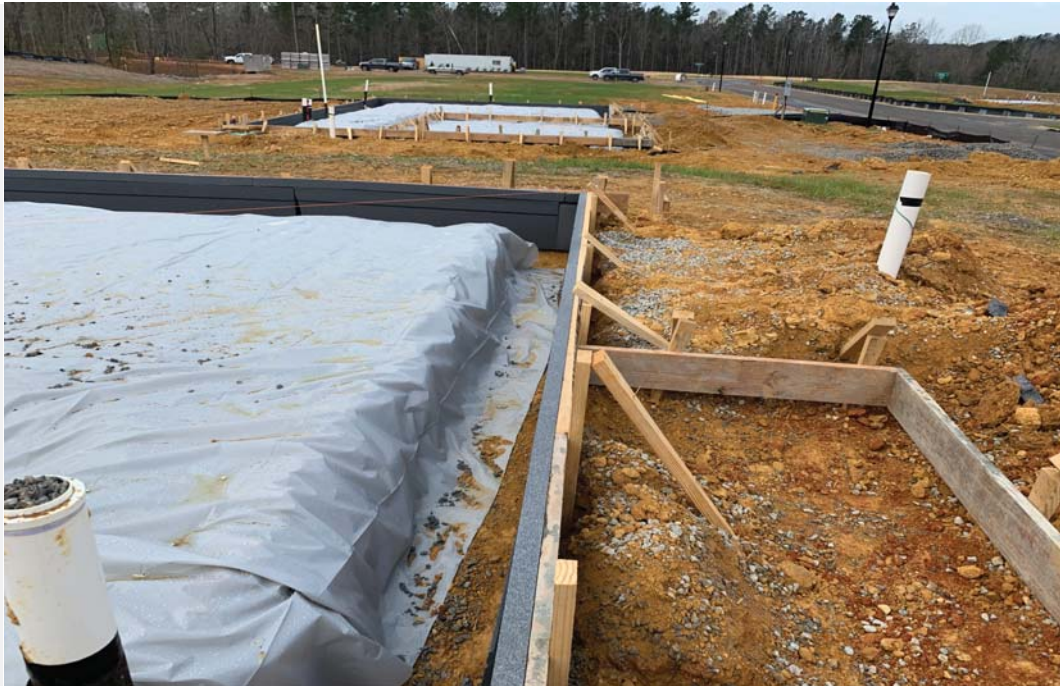
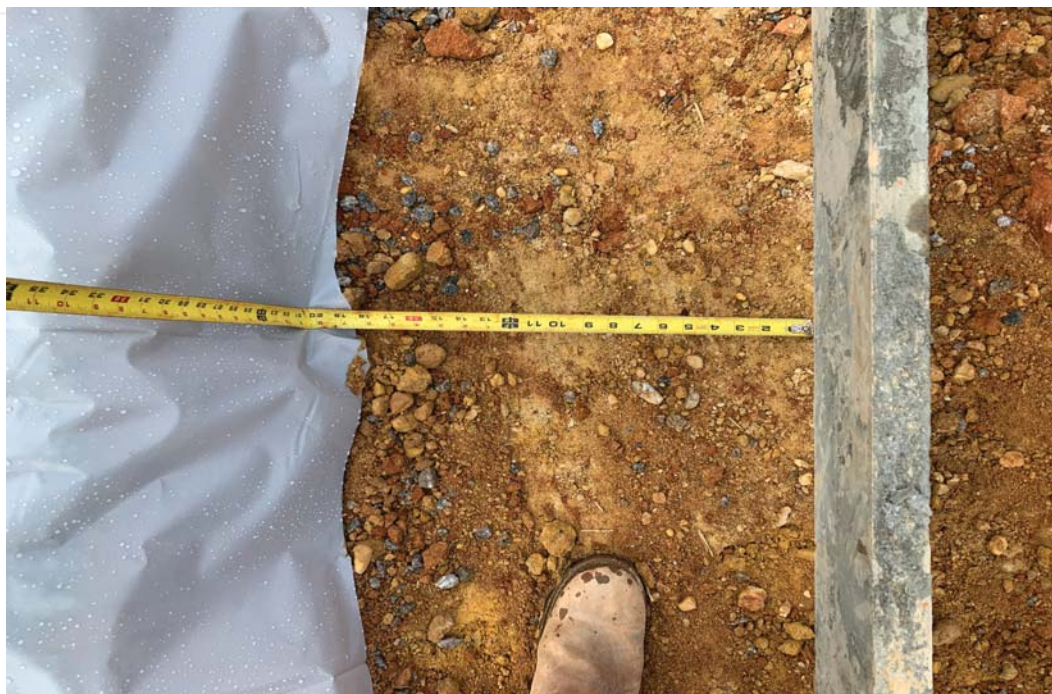
Utilizing the approved construction drawings, foundation excavations (turn-down footings and grade-beams) observed on this date, appeared to have been excavated to the specified depth and size. The foundation excavations were observed to be free of loose soil, debris, and water.

Also, GTA observed a 6-Mil vapor barrier had been placed in slab areas. Additionally, GTA observed insulation board along the perimeter of the exterior walls. The vapor barrier and insulation board placement observed, appeared to be in general accordance with the approved project drawings.

Based on GTA visual observations and testing performed on this date, the soil bearing conditions and mono-slab preparations for Lots 33 and 34, appeared to be in general conformance with the 2018 North Carolina Residential Code and approved construction drawings.

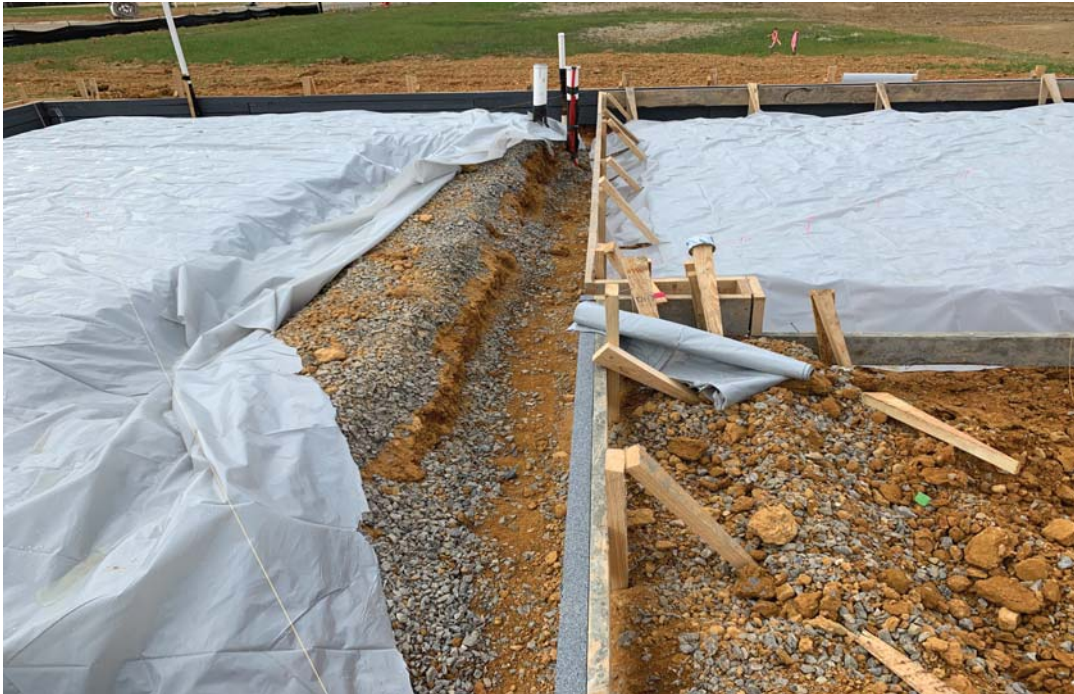
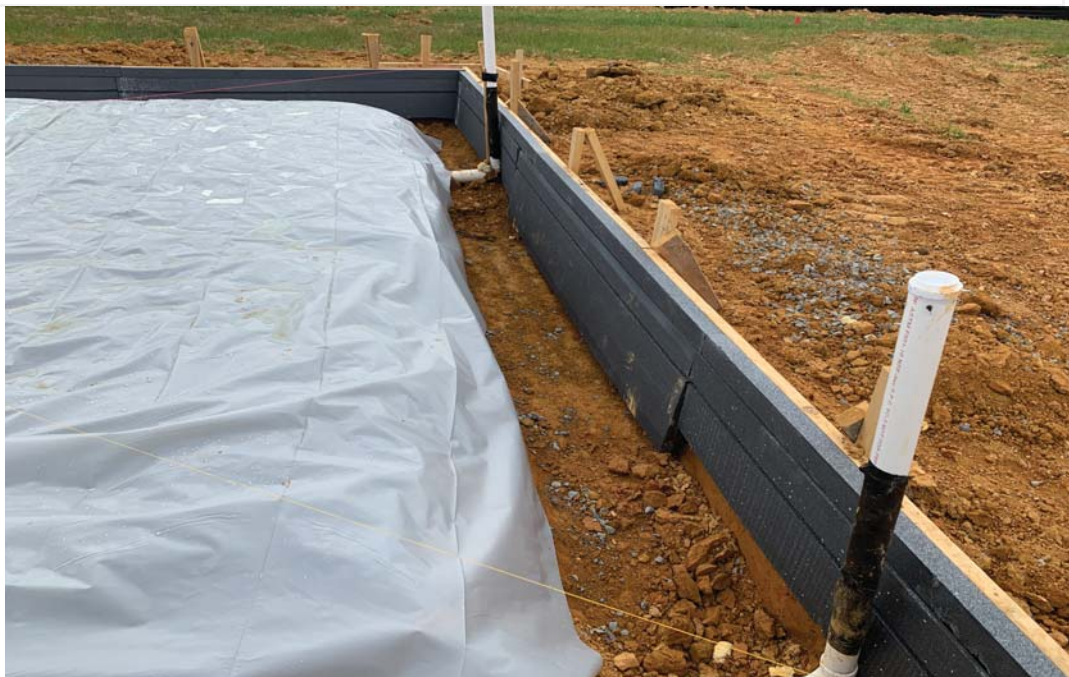
Please note, while performing soil bearing capacity testing on this date, GTA encountered a water line in the open footing excavation at Lot 57 (see sketch). GTA informed the on-site Ryan Home representative Tim Collins, of the water line in the footing excavation. Tim Collins notified GTA that the water line will be removed and re-located, and GTA will be contacted to re-test bearing capacity once remediation is complete.

Soft soils identified at Lot 58. Water line running parallel in footing excavation at Lot 57.  
 Ryan Homes representative Tim Collins plans to contact GTA to re-test bearing capacity of soils, after the removal of soft soils at Lot 58, and re-locating water line at Lot 57.

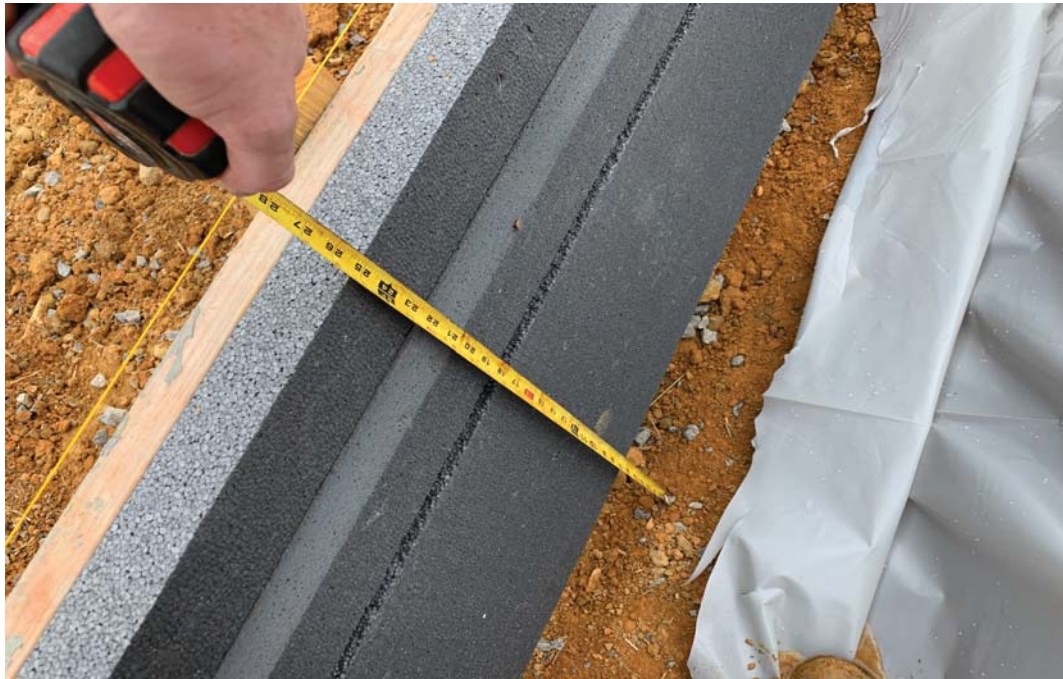
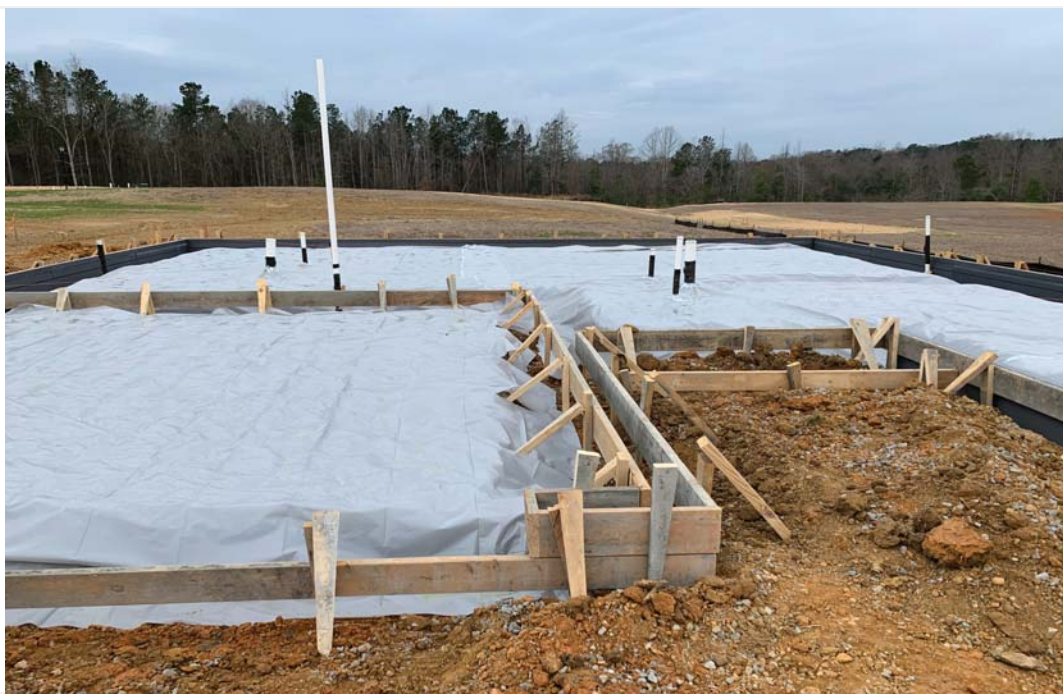
Utilizing a steel probe rod, hand auger, and Dynamic Cone Penetrometer (ASTM STP399) to test the bearing capacity of near surface soils for turn-down footings, test results indicated that soils; at the locations and elevations tested, appear capable of supporting a foundation designed utilizing a net allowable bearing pressure of 2,000 psf, with the exception of soft soil areas identified at the right wall footing at Lot 58, and middle/interior wall footing at Lot 57 (see sketches).

GTA recommended removing the identified soft soils to expose a competent bearing subgrade, and backfill of the resulting excavation with #57 stone, or additional concrete during concrete placement for footing construction.
