Project Name: Quail Glen - Lots 59 and 60 Date: 8 / 24 / 2020 GTA Rep: Junior Wheeler  
 Project No.: 200385N0\*\* Client: Ryan Homes Weather: Sunny Temperature: 82 °F

GTA representative arrived on-site, as requested, to test the bearing capacity of near surface soils for turn-down footings, and to perform 3rd party mono-slab observations prior to concrete placement for Lots 59 and 60 in the Quail Glen subdivision in Angier, North Carolina. Please see the above physical site addresses and building permit numbers for the Lots observed on this date.

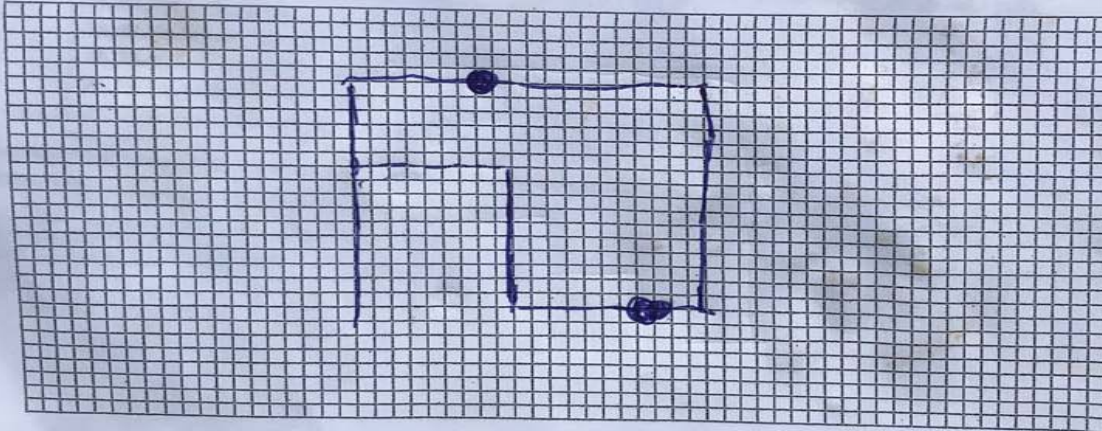
Date: 8 / 24 / 2020  
Sketch No. 2

Project: \_\_\_\_\_ Project No.: \_\_\_\_\_ Date: 8 / 24 / 20  
Soils Report Used: \_\_\_\_\_ Structural Plan Used: \_\_\_\_\_  
Lot No.: 60 Site Plan Used: \_\_\_\_\_ Revisions: \_\_\_\_\_  
Technician: Junior House Type: \_\_\_\_\_ Soil Bearing: 2000 psf  
6 Mil Vapor Barrier Observed:  Yes  No Insulation Board Observed:  Yes  No  
Permit No.: 2006-0035 Address: 61 Bellini DR

Comments: Areas at the location and elevation appear to be capable of supporting the footing as designed.

GTA recommends testing bearing capacity of foundation bearing materials and pouring concrete for footings on the same day, if possible. Foundation observations and soil bearing capacity testing are only valid between rain events. If foundation bearing materials are exposed to inclement weather or disturbed due to construction activity, GTA should be contacted to re-evaluate the foundation bearing materials prior to the placement of concrete.
