**RE:** Daily Field Report for 03/05/2021  
Lot 37 Olde Farm Village OFV (CMT) Spring Lake, NC  
Building & Earth Project No : RD210147

Project Name: <b>Lot 37 Olde Farm Village OFV (CMT) Spring Lake, NC</b>	Project Number: <b>RD210147</b>
Client Name: <b>H &amp; H Homes</b>	Placement#: <b>FO-1</b>
Contractor: <b>H &amp; H Homes</b>	Technician: <b>Bruce Rohr</b>
Monitoring: <b>DCP</b>

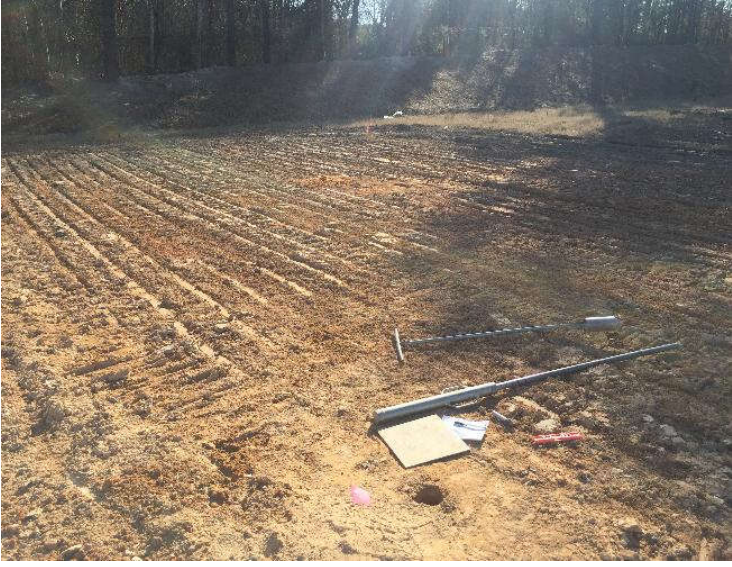
Picture ID	DCP Location 2
27009

Test 2: Front Left Corner

```
-- Depth---"N"-----Soil Color---USCS-----Notes:
-- ESG -- 14.5 ----- Red ----- CL -----
-- -1' --- 8.5 ----- Red ----- CL -----
-- -2' --- 15+ --- Red/Yellow --- CL/SP ----
```

--- -3' ---- 15+ --- Red/Yellow ---- CL/SP ----
