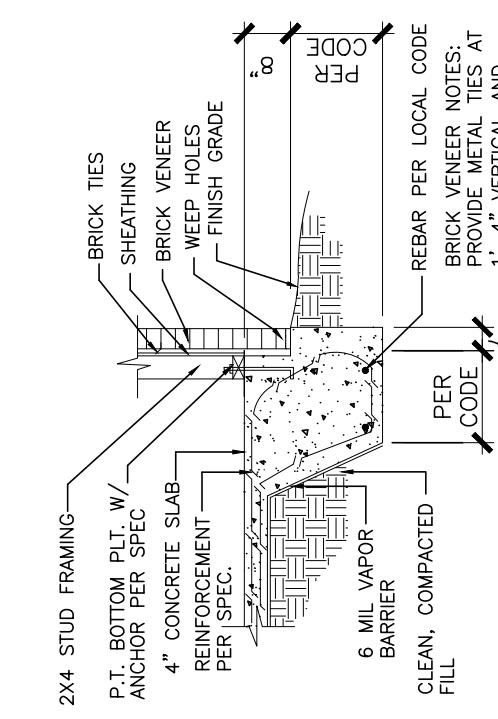
3 SECTION W/ BRICK LEDGE
 N.T.S.

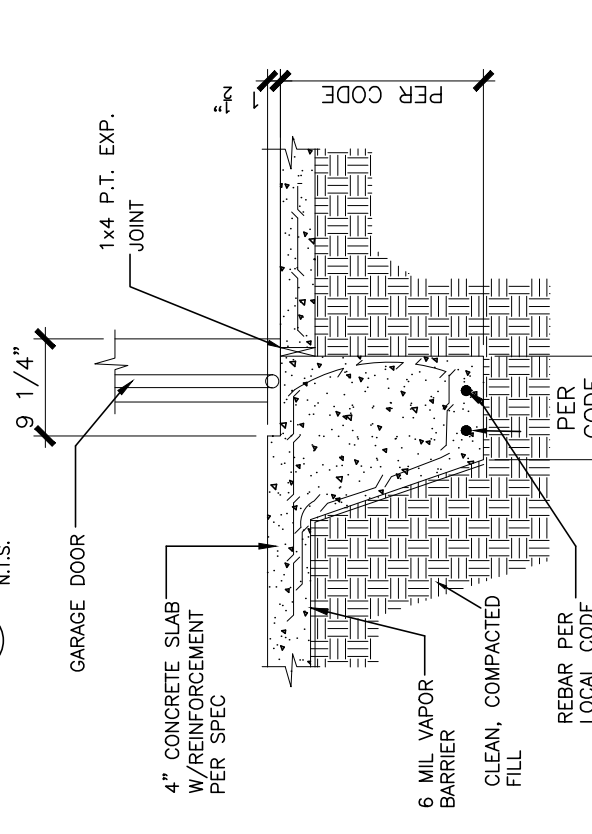
6 TYPICAL GARAGE DOOR DETAIL
 N.T.S.

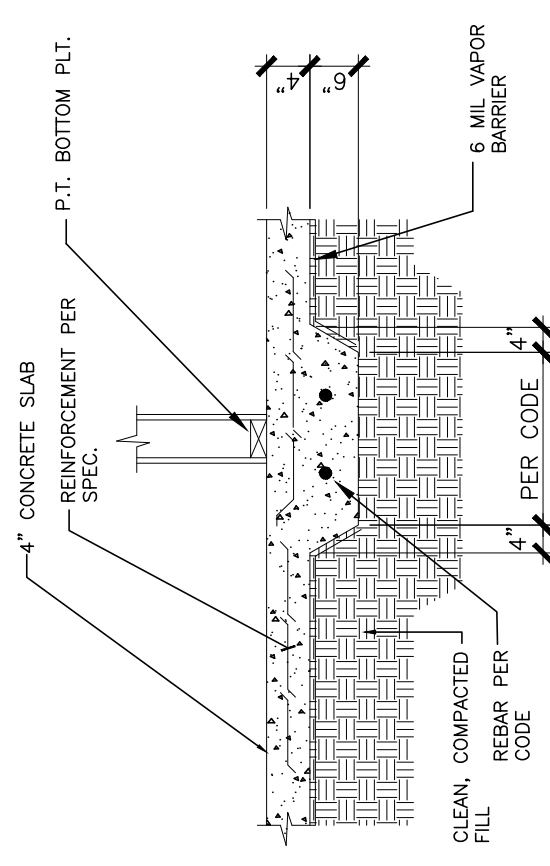
9 SECTION @ GRADE BEAM
 N.T.S.

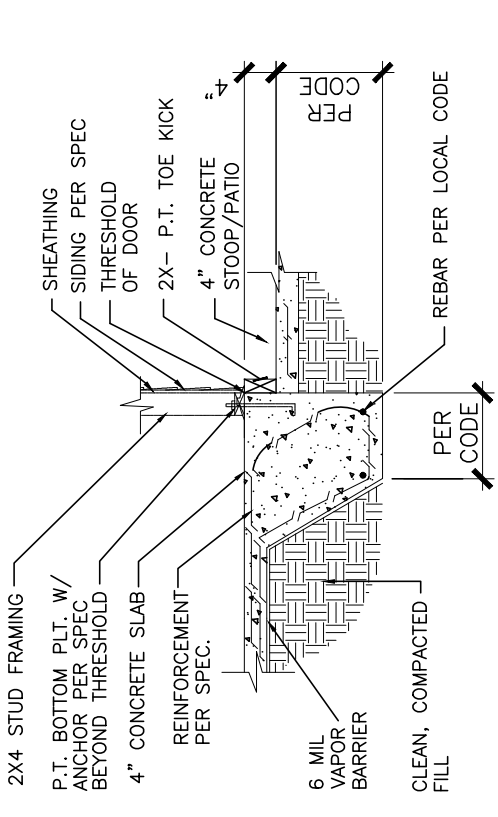
2 SECTION @ PORCH/PATIO
 N.T.S.

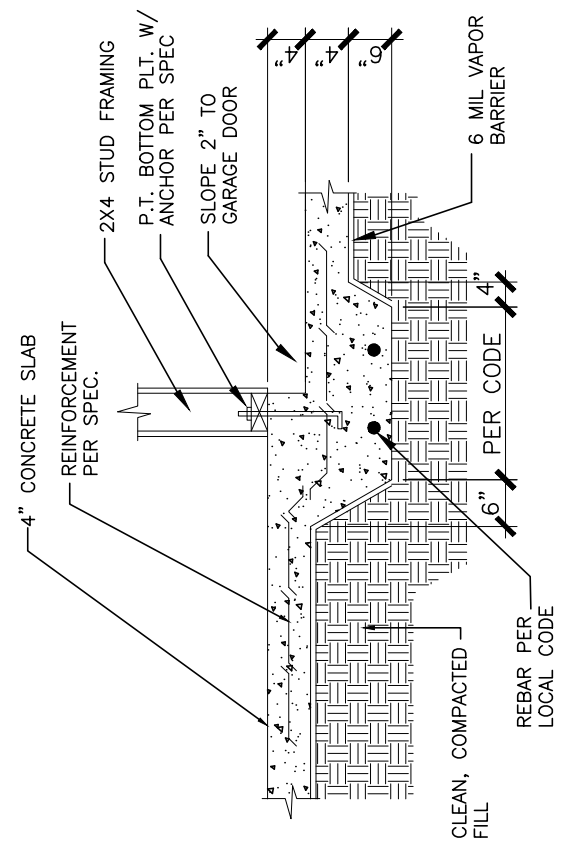
5 SECTION @ GARAGE
 N.T.S.

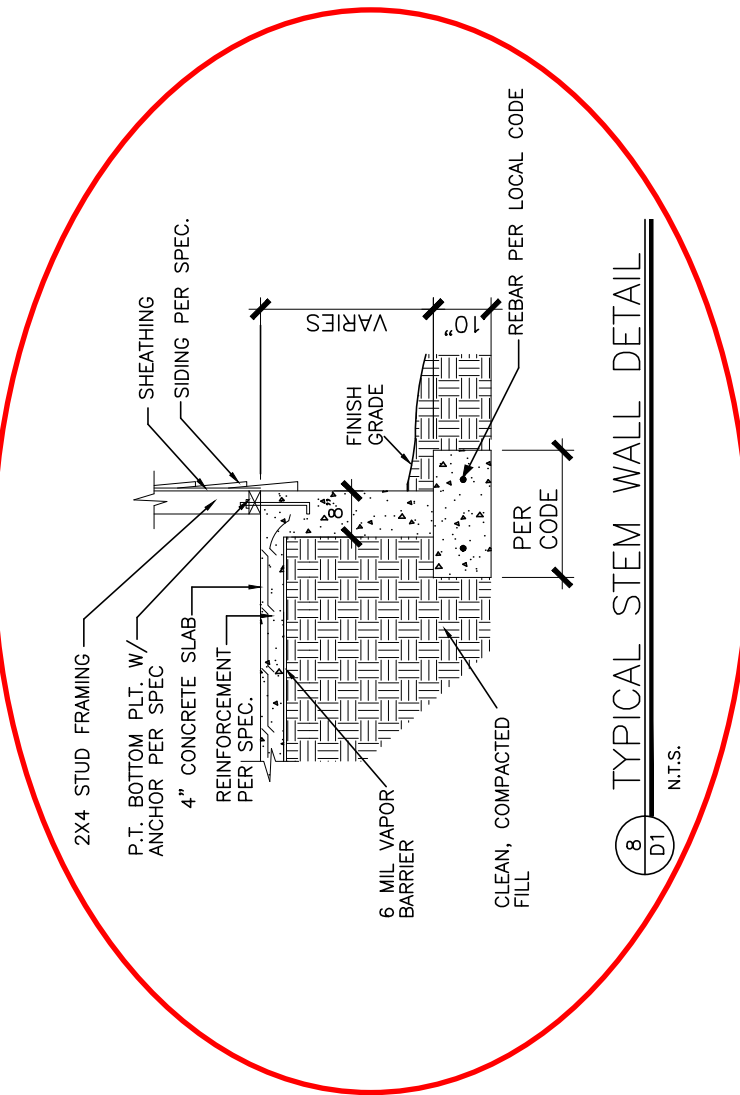
8 TYPICAL STEM WALL DETAIL
 N.T.S.

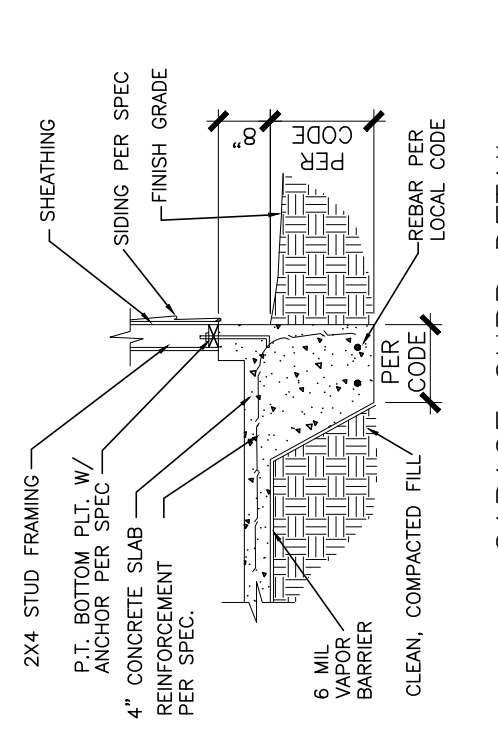
1 GARAGE CURB DETAIL
 N.T.S.

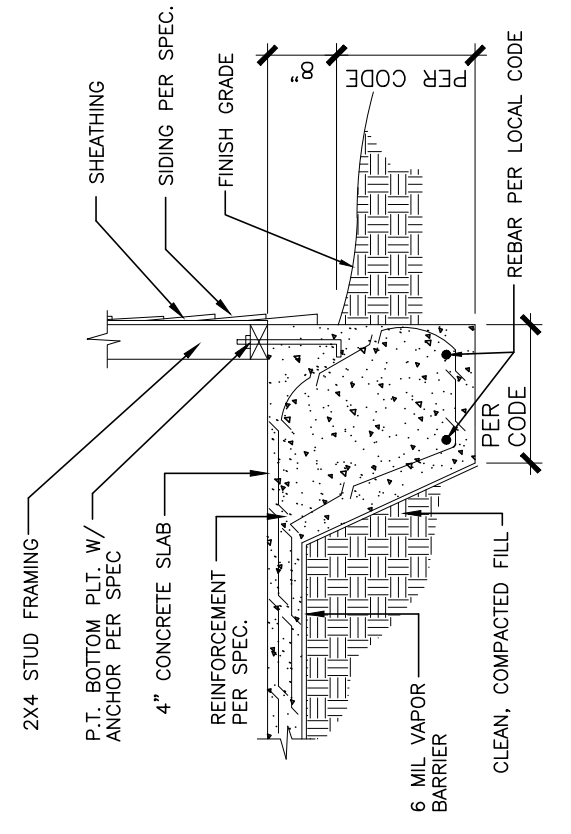
4 TYPICAL SLAB DETAIL
 N.T.S.

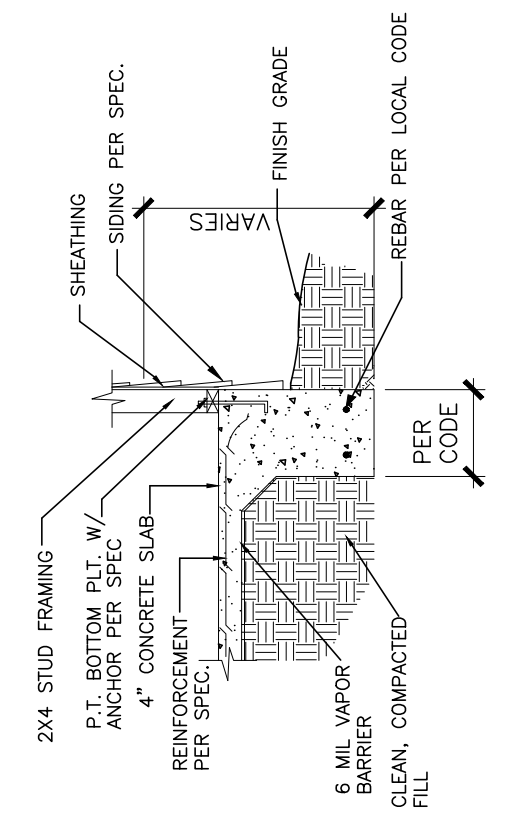
7 TYPICAL TURNDOWN SLAB DETAIL
 N.T.S.
