Reference: Engineering Services
140 Thorntons Creek Dr.
Erwin, NC 28339
TE&D Project No.: 2301-020777

- 1) Assessment of the attachment of the 2 x 10 joists to the girder truss above the garage.

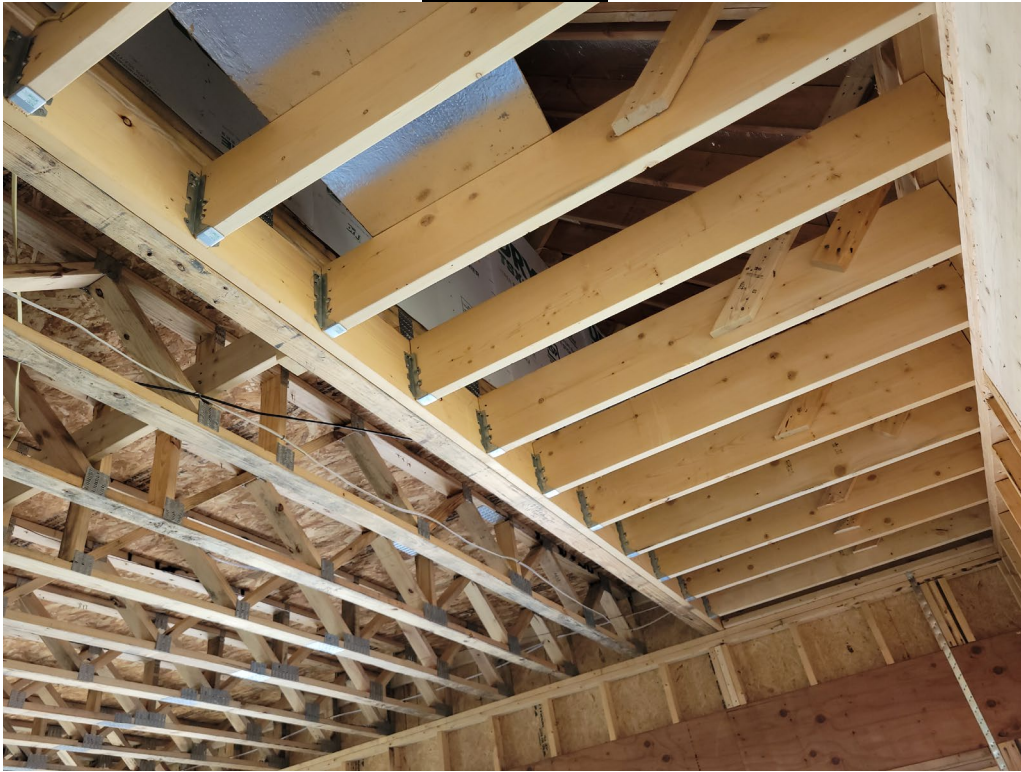
Item 1 examples

- 1) The 2 x 10 joists were secured to a 2 x 10 band at the girder truss with joist hangers. The band was secured to the girder truss with a limited number of nails. Based on our observations and analysis, the band is to be fastened to the double bottom chord with (2) rows of 10d nails at 4" o.c. and to the webs with (1) row of 10d nails at 4" o.c.
