RE: Daily Field Report for 09/24/2021
331 Pendagraft Road (CMT) Bunnlevel, NC
Building & Earth Project No : RD210742

Field Observations Report

1 : Foundation Inspection-Stem Wall

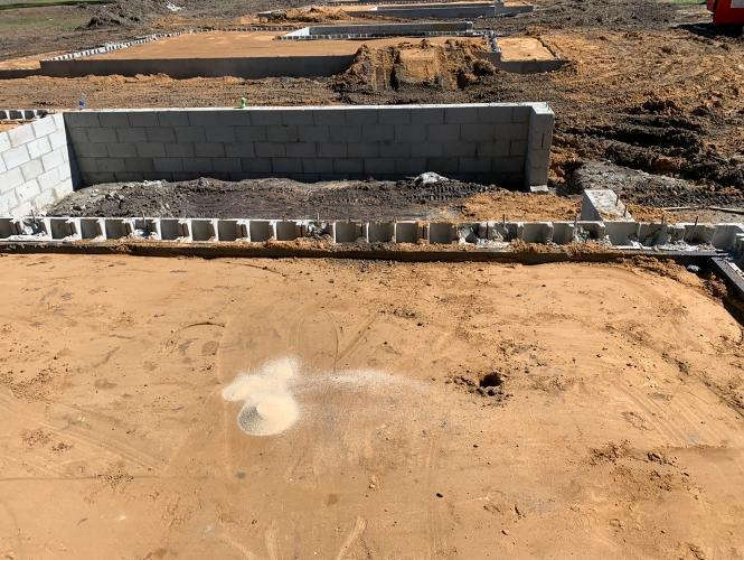
Picture ID	Caption
33013	<p>Front Right Corner</p>

-- Depth---"N"-----Soil Color---USCS-----
--- FSG --- 6.5 --- Brown ---- SPSM -----
--- -1' --- 6.5 --- Brown --- SP/SM -----
--- -2' --- 9 ----- Brown ---- SP/SM ----
--- -3' --- 7 ----- Brown ---- SM ----

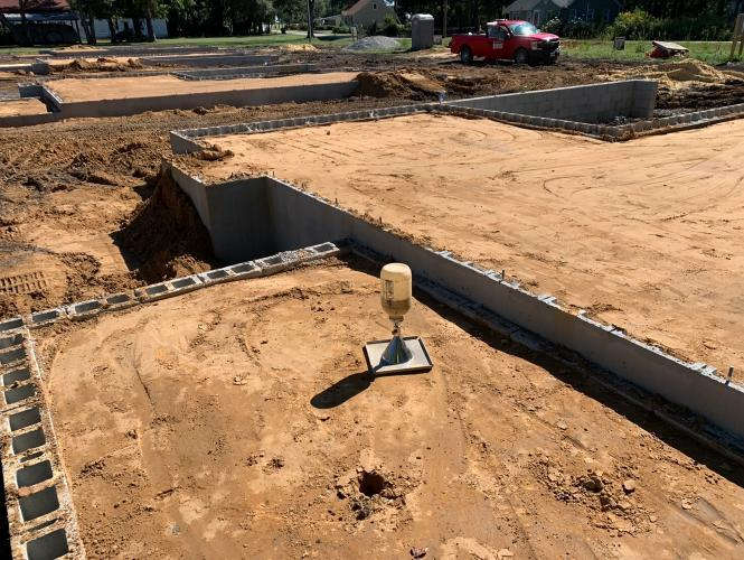
33015	<p>Back Porch</p>

-- Depth---"N"-----Soil Color---USCS-----
--- FSG --- 6.5 --- Brown --- SPSM -----
--- -1' --- 7 ----- Brown --- SPSM -----
--- -2' --- 10 --- Yellow ---- SPSM ----
--- -3' --- 6 ----- Brown ---- SM ----
