**RE:** Daily Field Report for 11/08/2021  
Lot 47 Williams Farm (CMT) Erwin, NC  
Building & Earth Project No : RD210858

## Field Observations Report

### 1 : Foundation Inspection

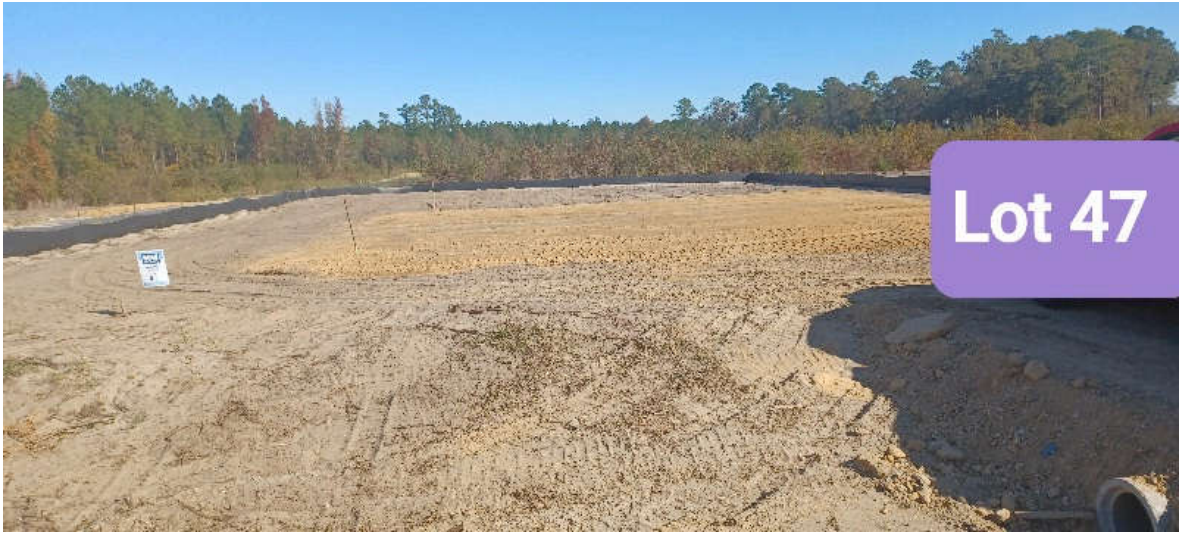
Picture ID	Lot 47
34514

The site slopes downward from back to front. Building locations are referenced from the street looking at the front of the residence. Maximum relief across the lot is approximately 2-3 feet. Surface water runoff appears to drain in the drainage ditch along the roadway.

The site has been stripped of surface cover and topsoil. It appears that 4 inches of topsoil has been removed from the building pad area.

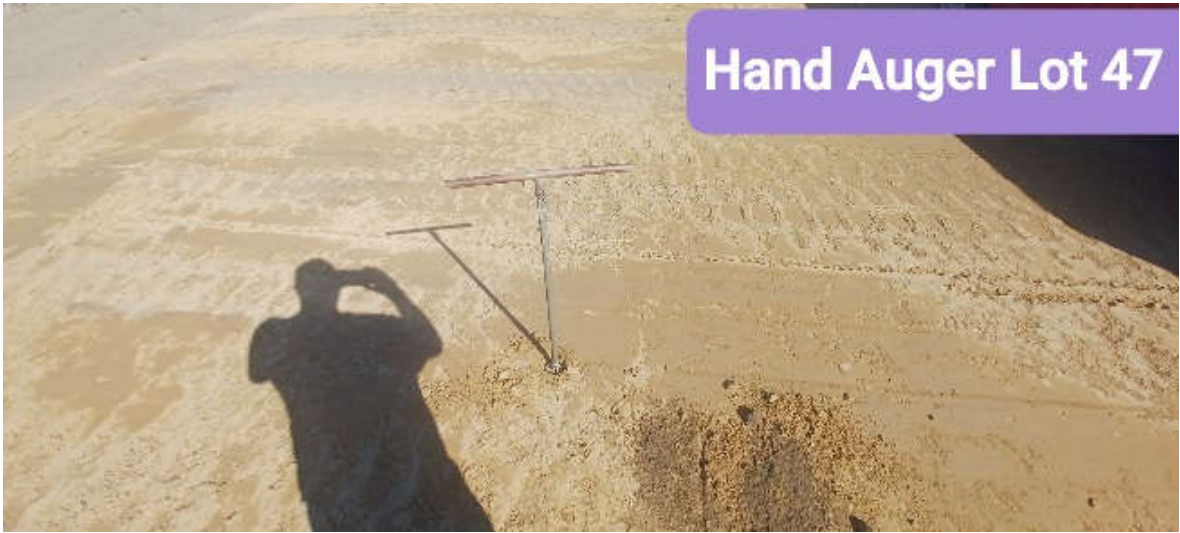
Picture ID	Hand Auger
34515

Our evaluation included hand rod probing, advancing hand auger borings with DCPs and performing a density test on the surface. Based upon our hand rod probing the newly placed soils are firm and resistant to significant penetration. Hand auger borings were then advanced at 2 selected location across the building envelope to determine the consistency of the below grade soils. At 12-inch increments in the hand auger boring, to a depth of 3 feet, Dynamic Cone Penetrometer (DCP) Testing was performed in accordance with ASTM STP-399. With proper evaluation, DCP Testing can be correlated to both bearing capacity and percent compaction. Based upon the results of this testing, the below grade soils that will support the foundations and floor slab are acceptable.
