RE: Daily Field Report for 04/22/2022
Lot 69 Oakmont OKM (CMT) Lillington, NC
Building & Earth Project No : RD220268

Field Observations Report

Project Name: **Lot 69 Oakmont OKM (CMT) Lillington, NC** Project Number: **RD220268**
Client Name: **H & H Homes** Placement#: **FO-1**
Contractor: **H & H Homes** Technician: **Frank Hamlin**
Monitoring: **Shallow Footing Testing**

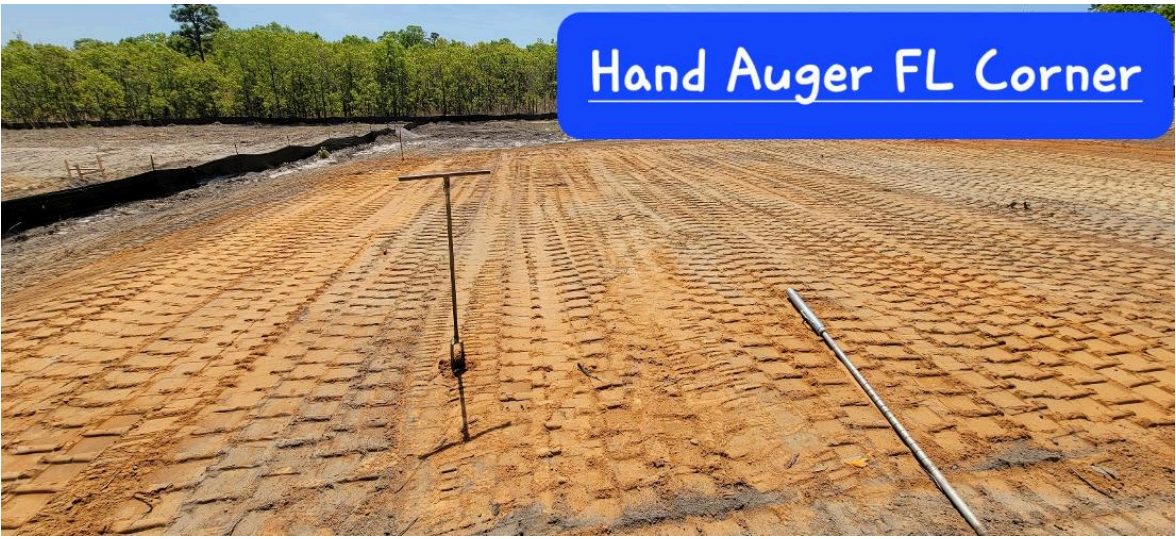
Picture ID	Hand Auger FL Corner
40950

Test 1: [Front Left Corner]

-- Depth---"N"-----Soil Color---USCS-----
--- FSG ---- 13 ---- Light Tan -- SM -----
--- -1' ----- 12 ---- Light Tan ---- SM -----
--- -2' ----- 8 ----- Light Tan ---- SM ----
--- -3' ----- 8 ----- Light Tan ---- SM ----

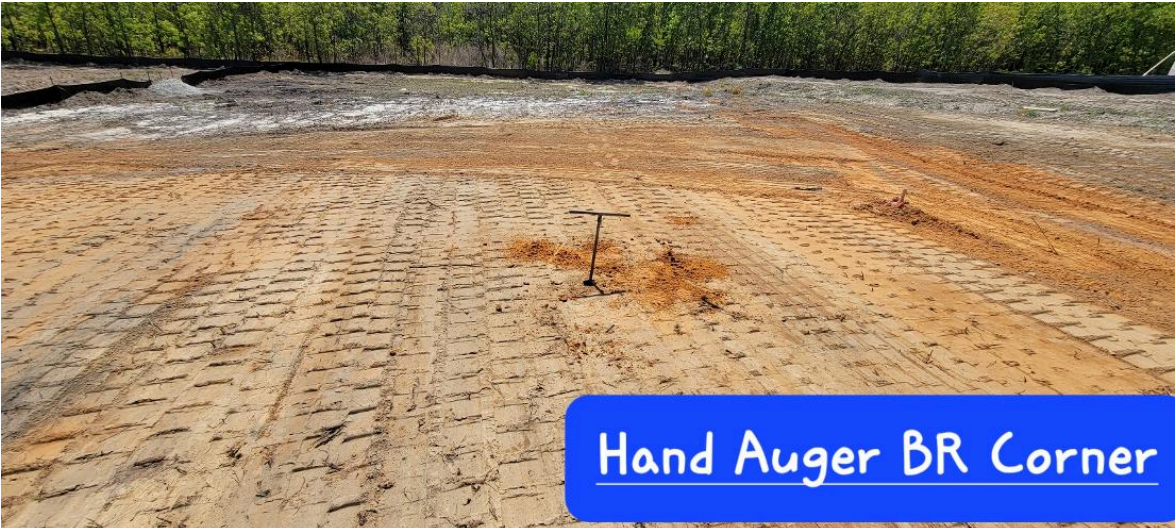
Picture ID	Hand Auger BR Corner
40952

Test 3: [Back Right Corner]

-- Depth----"N"-----Soil Color---USCS-----
--- FSG --- 15+ --- Light Tan -- SM -----
--- -1' ----- 15+ ----- Light Tan ---- SM -----
--- -2' ----- 9 ----- Light Tan ----- SM ----
--- -3' ----- 7 ----- Light Tan ----- SM ----
