DESIGN PROFESSIONAL INSPECTION FORM

Residential Single-Family Project: Y <input checked="" type="checkbox"/> N <input type="checkbox"/>	Commercial Project: Y <input type="checkbox"/> N <input checked="" type="checkbox"/>
Code Enforcement Project No:	Permit No: 2112-0007
Project Name: 5015 Hillmon Grove Road	Owner: Dewitt, Melissa
Project Address: 5015 Hillmon Grove Road, Cameron, NC 28326	Suite No:
Date Inspected: 1/19/2022	Contractor Name: Schumacher Homes / McGee Brothers
Component Inspected: residential home footings prior to concrete placement

Project Name: 5015 Hillmon Grove Road Date: 1 / 19 / 2022 GTA Rep: Matthew Wright
 Project No.: 201253x037 Client: McGee Brothers Weather: Sunny Temperature: 51 °F

Anderson Modern/Custom - Foundation Plan

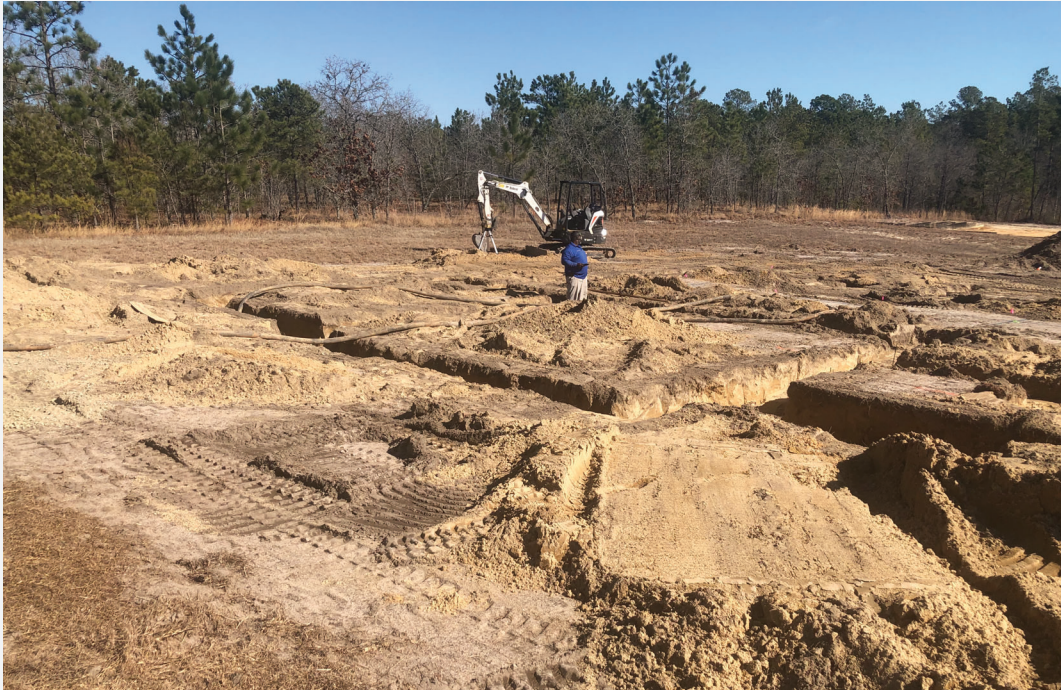
Date: 1 / 19 / 2022
Photo Page No. 1

Also on this date, utilizing the approved construction drawings, GTA performed 3rd party footing observations prior to concrete placement for the above referenced residential home. Based on GTA visual observations, the footings (size, dimensions, general locations) at the above referenced lot, appear to have been prepared in general accordance with the approved project drawings. The footing excavations observed were free of loose soil, debris, and water.

Based on the results of GTA visual observations and testing performed on this date, the soil bearing conditions and foundation preparations observed appear to be in general accordance with the 2018 North Carolina Residential Code and the approved project drawings. Please see the attached site photos for site conditions observed on this date.

Site conditions observed

GTA recommends footings be excavated, tested, and concrete placed on the same day, if possible. Foundation observations and soil bearing capacity testing are only valid between rain events. If foundation bearing materials are exposed to freezing temperatures, inclement weather, or disturbed due to construction activity, GTA should be contacted to re-evaluate the foundation bearing materials prior to the placement of concrete.

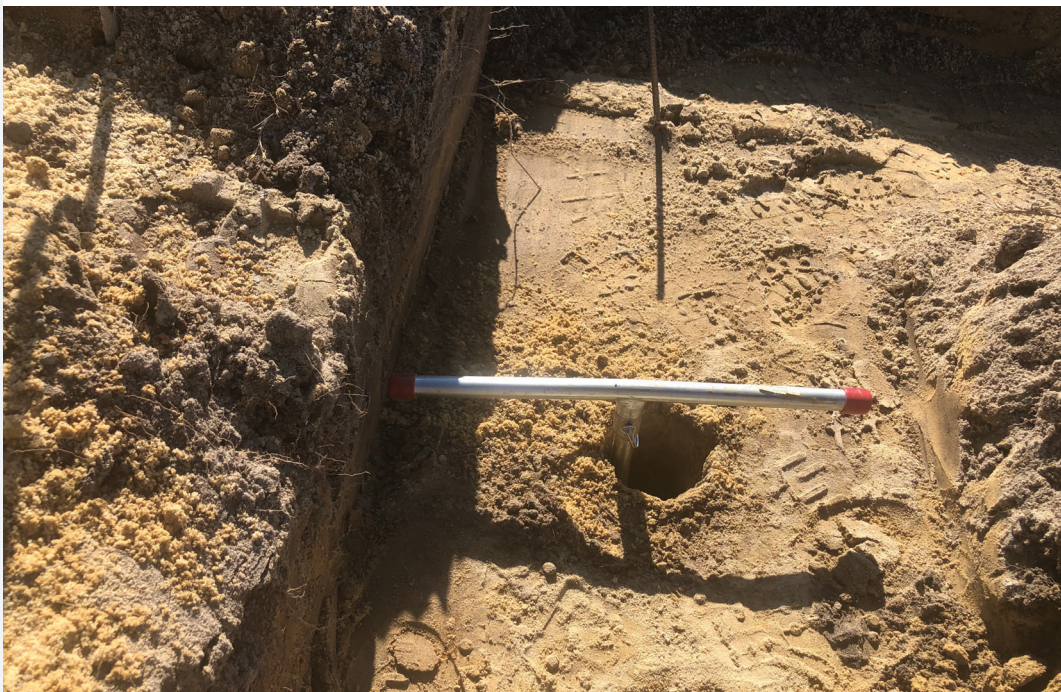
Site conditions observed
