**Project:** Quail Glen Lot 176

**Location:** Angier, NC

**Subject:** Framing Items

**Job Number:** 2-2091-22

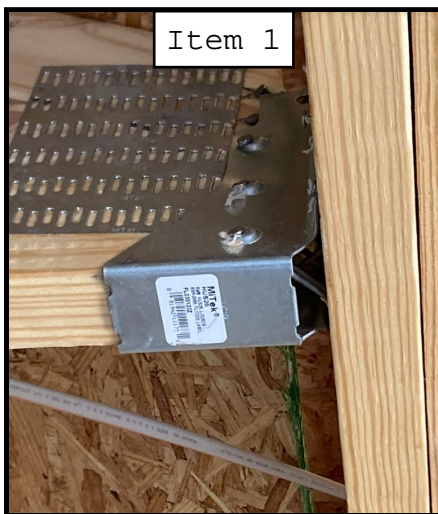
1) Side loaded roof trusses (SE 13184) to 3 ply girder roof truss (SE16445) features gaps in hangers which exceed 1/8" (but not more than 1"). Moving forward, we recommend installing the fasteners as shown in the detail found on page 2. Typical where conditions apply.

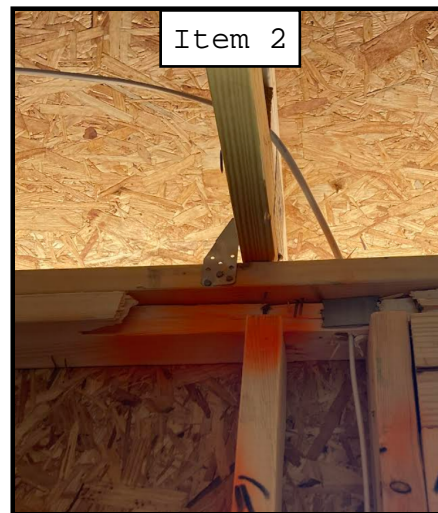
2) Section of top plate under roof truss (shown picture 2) is broken. Moving forward we recommend flushing the broken (jagged) sections of top plate away as to enable the installation of a corresponding shim/ packing of the same size to be placed in its position. Then, install a CS22 strap over the top plate and shim/ packing extending ~ 6" down the top plate in each direction.
