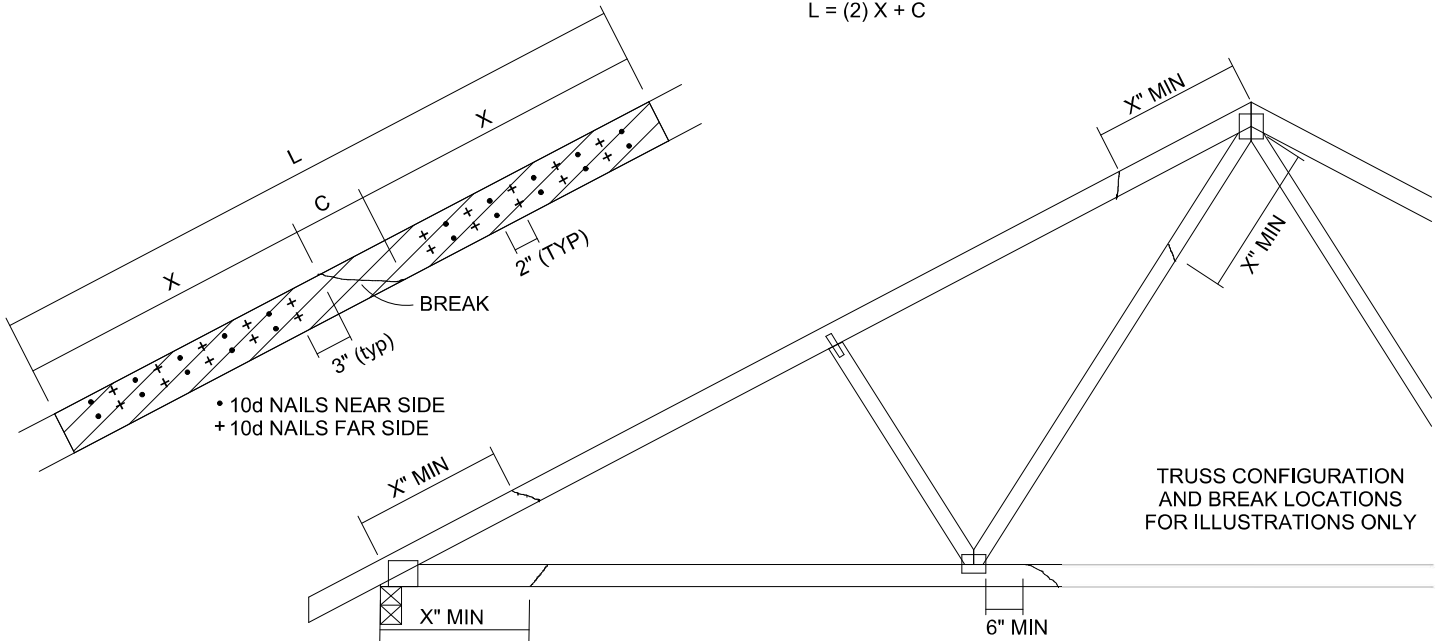
ATTACH 2x SCAB OF THE SAME SIZE AND GRADE AS THE BROKEN MEMBER TO EACH FACE OF THE TRUSS (CENTER ON BREAK OR SPLICE) WITH 10d (0.131" X 3") NAILS (TWO ROWS FOR 2x4, THREE ROWS FOR 2x6) SPACED 4" O.C. AS SHOWN. STAGGER NAIL SPACING FROM FRONT FACE AND BACK FACE FOR A NET 0-2-0 O.C. SPACING IN THE MAIN MEMBER. USE A MIN. 0-3-0 MEMBER END DISTANCE.

THE LENGTH OF THE BREAK (C) SHALL NOT EXCEED 12". (C=PLATE LENGTH FOR SPLICE REPAIRS)
 THE MINIMUM OVERALL SCAB LENGTH REQUIRED (L) IS CALCULATED AS FOLLOWS:
 $L = (2) X + C$

THE LOCATION OF THE BREAK MUST BE GREATER THAN OR EQUAL TO THE REQUIRED X DIMENSION FROM ANY PERIMETER BREAK OR HEEL JOINT AND A MINIMUM OF 6" FROM ANY INTERIOR JOINT (SEE SKETCH ABOVE)

TOTAL NUMBER OF NAILS EACH SIDE OF BREAK *		X INCHES	MAXIMUM FORCE (lbs) 15% LOAD DURATION							
			SP		DF		SPF		HF	
2x4	2x6		2x4	2x6	2x4	2x6	2x4	2x6	2x4	2x6
20	30	24"	1706	2559	1561	2342	1320	1980	1352	2028
26	39	30"	2194	3291	2007	3011	1697	2546	1738	2608
32	48	36"	2681	4022	2454	3681	2074	3111	2125	3187
38	57	42"	3169	4754	2900	4350	2451	3677	2511	3767
44	66	48"	3657	5485	3346	5019	2829	4243	2898	4347

* DIVIDE EQUALLY FRONT AND BACK
