RE: Daily Field Report for 05/23/2022
Lot 63 Anderson Creek Crossing ACX (CMT) Spring Lake, NC
Building & Earth Project No : RD220344

Field Observations Report

1 : Foundation Inspection-Monolithic

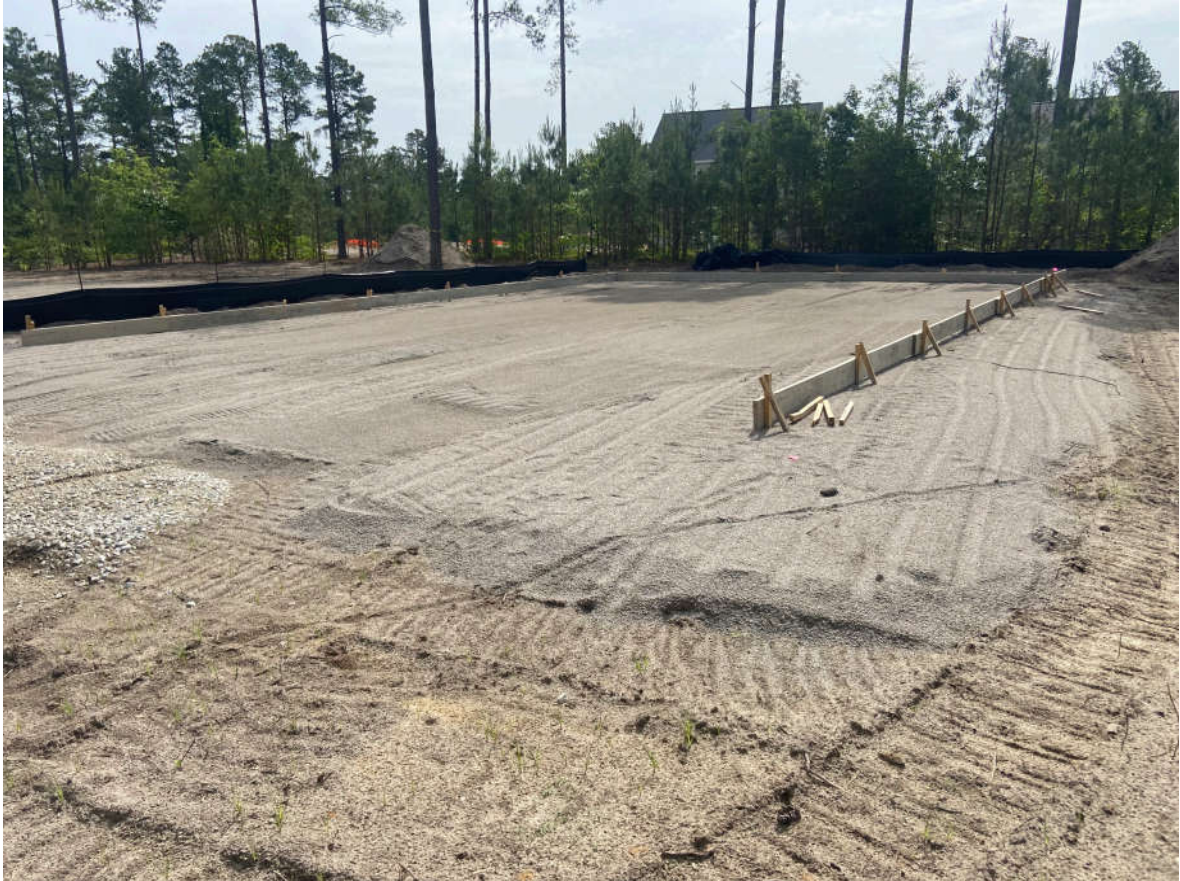
Picture ID	Building pad
42224

The lot generally slopes. The site slopes downward from front to back. Building locations are referenced from the street looking at the front of the residence. Maximum relief across the lot is approximately 1 foot. Surface water runoff appears to drain to the back of the lot.

The site has been stripped of surface cover and topsoil. It appears that 6 inches of topsoil has been removed from the building pad area.

Hand Rod Probing: Our representative performed hand rod probing of the surface of the building pad. Hand rod probing of the bearing material generally showed an average penetration of approximately 2 inches.

Based on our observations and test results, the newly placed fill/existing soils appear to be suitable to provide support for the floor slab and footings, provided the floor slab has a loading of less than 150 pounds per square foot, and the footings have a design bearing capacity of 2,000, or less.
