ATTACH 2x SCAB OF THE SAME SIZE AND GRADE AS THE BROKEN MEMBER TO EACH FACE OF THE TRUSS (CENTER ON BREAK OR SPLICE) WITH 10d (0.131" X 3") NAILS (TWO ROWS FOR 2x4, THREE ROWS FOR 2x6) SPACED 4" O.C. AS SHOWN. STAGGER NAIL SPACING FROM FRONT FACE AND BACK FACE FOR A NET 0-2-0 O.C. SPACING IN THE MAIN MEMBER. USE A MIN. 0-3-0 MEMBER END DISTANCE.

ENGINEERING BY
TRENCO
 A MiTek Affiliate
 818 Soundside Road
 Edenton, NC 27932

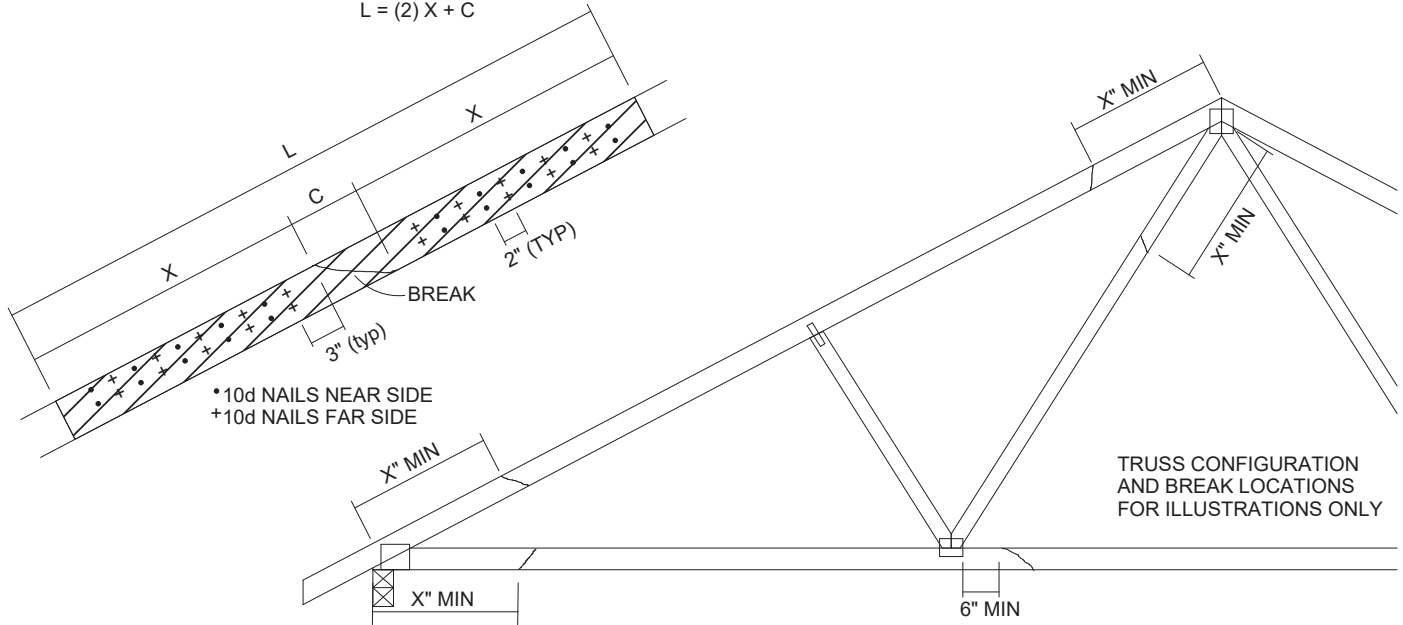
THE LENGTH OF THE BREAK (C) SHALL NOT EXCEED 12". (C=PLATE LENGTH FOR SPLICE REPAIRS)
 THE MINIMUM OVERALL SCAB LENGTH REQUIRED (L) IS CALCULATED AS FOLLOWS:
 $L = (2) X + C$

THE LOCATION OF THE BREAK MUST BE GREATER THAN OR EQUAL TO THE REQUIRED X DIMENSION FROM ANY PERIMETER BREAK OR HEEL JOINT AND A MINIMUM OF 6" FROM ANY INTERIOR JOINT (SEE SKETCH ABOVE)

TOTAL NUMBER OF NAILS EACH SIDE OF BREAK *		X INCHES	MAXIMUM FORCE (lbs) 15% LOAD DURATION							
			SP		DF		SPF		HF	
2x4	2x6		2x4	2x6	2x4	2x6	2x4	2x6	2x4	2x6
20	30	24"	1706	2559	1561	2342	1320	1980	1352	2028
26	39	30"	2194	3291	2007	3011	1697	2546	1738	2608
32	48	36"	2681	4022	2454	3681	2074	3111	2125	3187
38	57	42"	3169	4754	2900	4350	2451	3677	2511	3767
44	66	48"	3657	5485	3346	5019	2829	4243	2898	4347

* DIVIDE EQUALLY FRONT AND BACK

DO NOT USE REPAIR FOR JOINT SPLICES
