lot 130 T2V
broken web

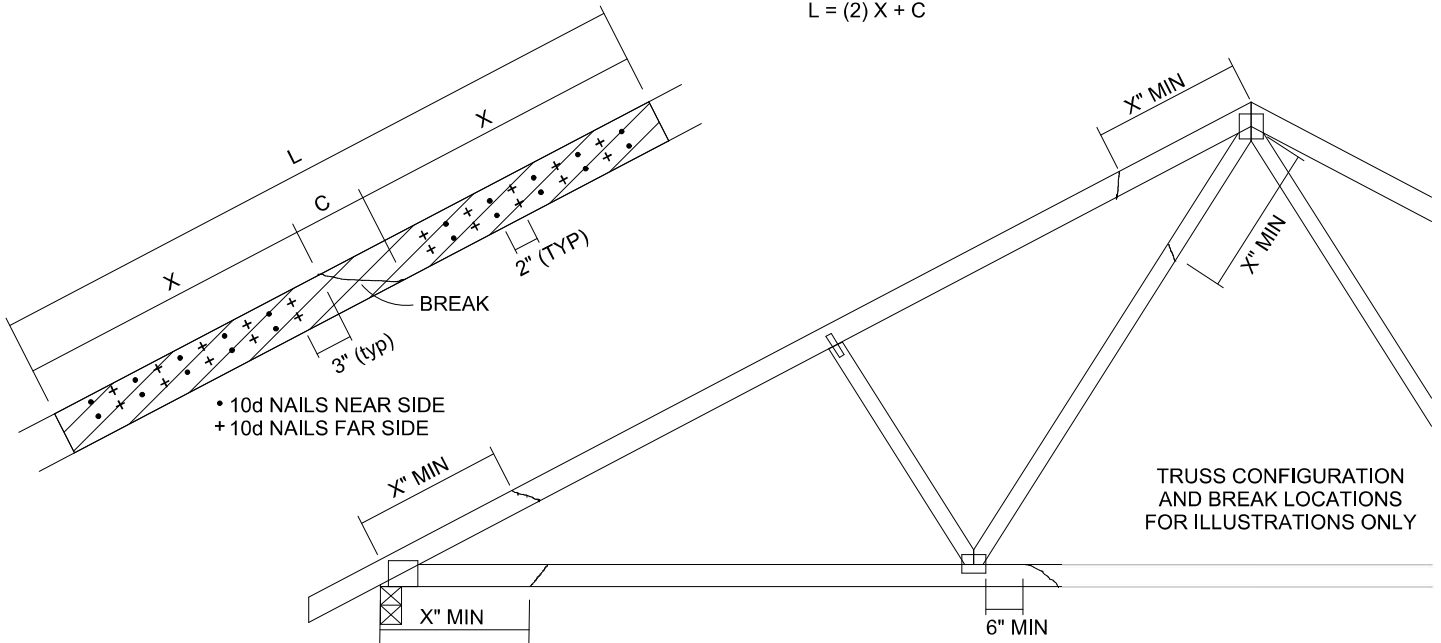
THE LENGTH OF THE BREAK (C) SHALL NOT EXCEED 12". (C=PLATE LENGTH FOR SPLICE REPAIRS)
THE MINIMUM OVERALL SCAB LENGTH REQUIRED (L) IS CALCULATED AS FOLLOWS:
 $L = (2) X + C$

THE LOCATION OF THE BREAK MUST BE GREATER THAN OR EQUAL TO THE REQUIRED X DIMENSION FROM ANY PERIMETER BREAK OR HEEL JOINT AND A MINIMUM OF 6" FROM ANY INTERIOR JOINT (SEE SKETCH ABOVE)

TOTAL NUMBER OF NAILS EACH SIDE OF BREAK *		X INCHES	MAXIMUM FORCE (lbs) 15% LOAD DURATION							
			SP		DF		SPF		HF	
2x4	2x6		2x4	2x6	2x4	2x6	2x4	2x6	2x4	2x6
20	30	24"	1706	2559	1561	2342	1320	1980	1352	2028
26	39	30"	2194	3291	2007	3011	1697	2546	1738	2608
32	48	36"	2681	4022	2454	3681	2074	3111	2125	3187
38	57	42"	3169	4754	2900	4350	2451	3677	2511	3767
44	66	48"	3657	5485	3346	5019	2829	4243	2898	4347

* DIVIDE EQUALLY FRONT AND BACK

ATTACH 2x SCAB OF THE SAME SIZE AND GRADE AS THE BROKEN MEMBER TO EACH FACE OF THE TRUSS (CENTER ON BREAK OR SPLICE) WITH 10d (0.131" X 3") NAILS (TWO ROWS FOR 2x4, THREE ROWS FOR 2x6) SPACED 4" O.C. AS SHOWN. STAGGER NAIL SPACING FROM FRONT FACE AND BACK FACE FOR A NET 0-2-0 O.C. SPACING IN THE MAIN MEMBER. USE A MIN. 0-3-0 MEMBER END DISTANCE.

DO NOT USE REPAIR FOR JOINT SPLICES
