Lot 122 Birchwood
BG1 cracked web

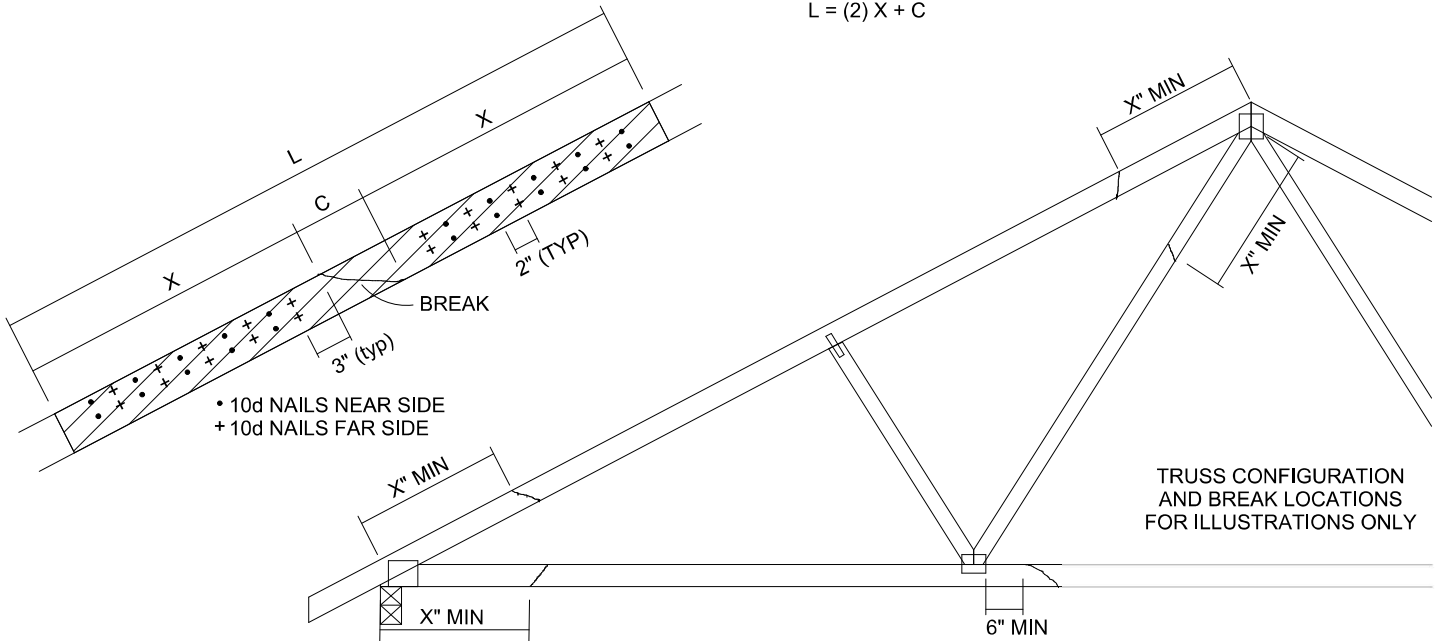
THE LENGTH OF THE BREAK (C) SHALL NOT EXCEED 12". (C=PLATE LENGTH FOR SPLICE REPAIRS)
 THE MINIMUM OVERALL SCAB LENGTH REQUIRED (L) IS CALCULATED AS FOLLOWS:
 $L = (2) X + C$

THE LOCATION OF THE BREAK MUST BE GREATER THAN OR EQUAL TO THE REQUIRED X DIMENSION FROM ANY PERIMETER BREAK OR HEEL JOINT AND A MINIMUM OF 6" FROM ANY INTERIOR JOINT (SEE SKETCH ABOVE)

TOTAL NUMBER OF NAILS EACH SIDE OF BREAK *		X INCHES	MAXIMUM FORCE (lbs) 15% LOAD DURATION							
			SP		DF		SPF		HF	
2x4	2x6		2x4	2x6	2x4	2x6	2x4	2x6	2x4	2x6
20	30	24"	1706	2559	1561	2342	1320	1980	1352	2028
26	39	30"	2194	3291	2007	3011	1697	2546	1738	2608
32	48	36"	2681	4022	2454	3681	2074	3111	2125	3187
38	57	42"	3169	4754	2900	4350	2451	3677	2511	3767
44	66	48"	3657	5485	3346	5019	2829	4243	2898	4347

* DIVIDE EQUALLY FRONT AND BACK

ATTACH 2x SCAB OF THE SAME SIZE AND GRADE AS THE BROKEN MEMBER TO EACH FACE OF THE TRUSS (CENTER ON BREAK OR SPLICE) WITH 10d (0.131" X 3") NAILS (TWO ROWS FOR 2x4, THREE ROWS FOR 2x6) SPACED 4" O.C. AS SHOWN. STAGGER NAIL SPACING FROM FRONT FACE AND BACK FACE FOR A NET 0-2-0 O.C. SPACING IN THE MAIN MEMBER. USE A MIN. 0-3-0 MEMBER END DISTANCE.
