Residence
8213 Old US 421, Broadway, NC 27505

Foundation Damage

Inspections

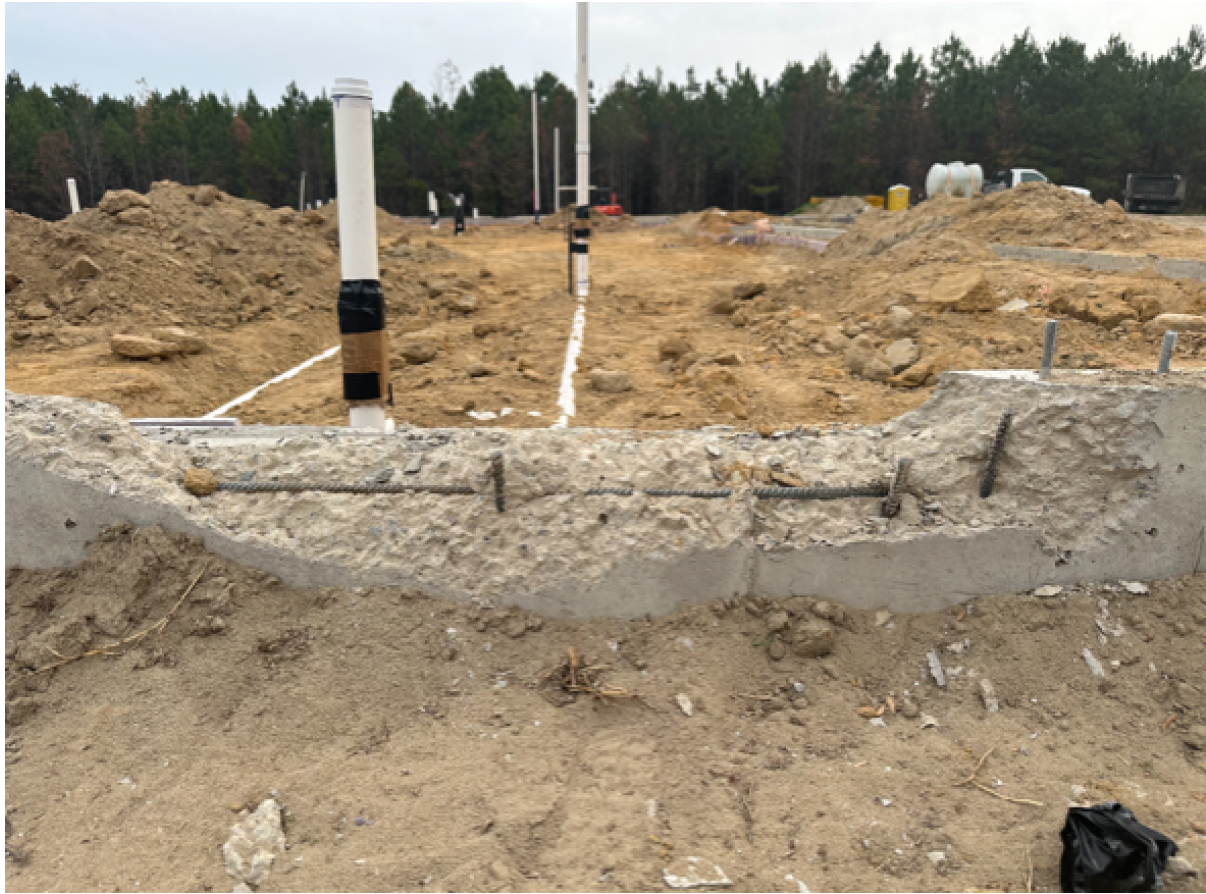
I have reviewed the damage done to the foundation. Since this is a vertical load condition and the steel reinforcement has not been damaged or changed, I recommend reforming the foundation and placing a new concrete cap over the damaged area. The face will need to be troweled to finish the joint between the existing and the new placed concrete for cosmetic look. The broken insulation will need to be repaired or replaced as needed to create a continuous layer of insulation.

After completed the foundation shall meet the structural requirements per the documents.
