Birchwood Grove
 Lot 175
 486 Saint Clair Drive
 Fuquay Varina, NC
 27526

DO NOT USE REPAIR FOR JOINT SPLICES

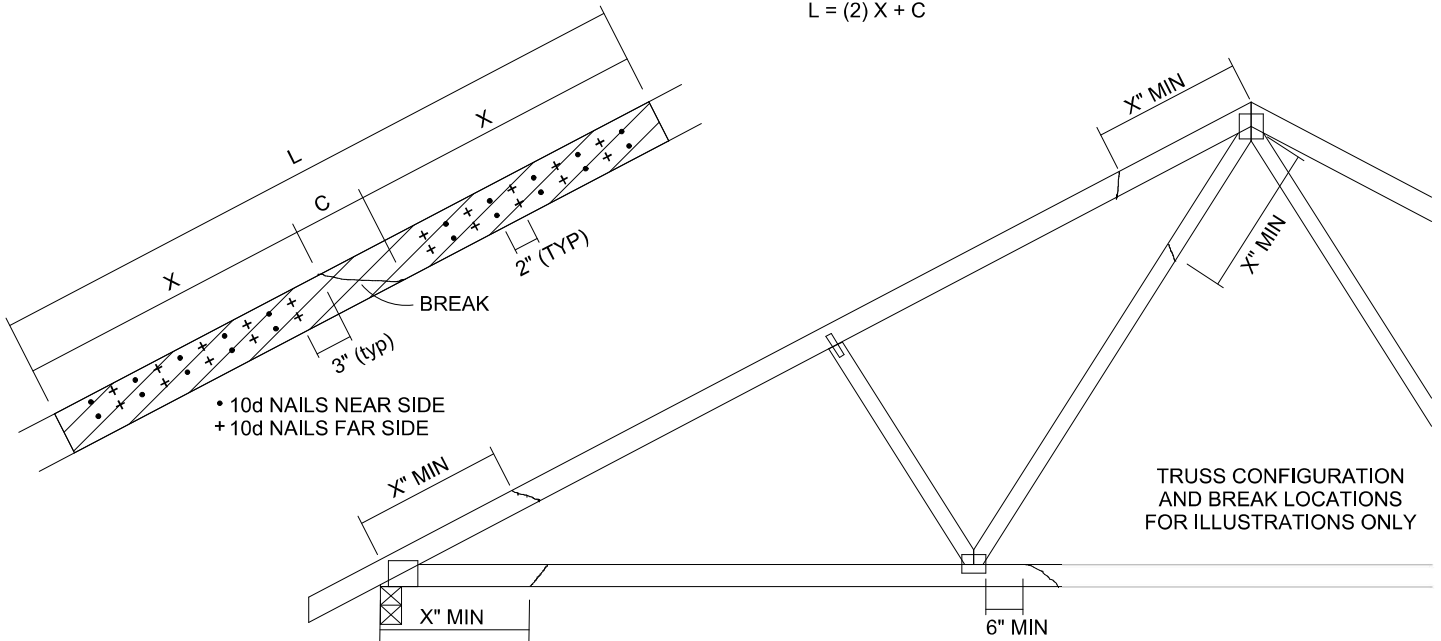
ATTACH 2x SCAB OF THE SAME SIZE AND GRADE AS THE BROKEN MEMBER TO EACH FACE OF THE TRUSS (CENTER ON BREAK OR SPLICE) WITH 10d (0.131" X 3") NAILS (TWO ROWS FOR 2x4, THREE ROWS FOR 2x6) SPACED 4" O.C. AS SHOWN. STAGGER NAIL SPACING FROM FRONT FACE AND BACK FACE FOR A NET 0-2-0 O.C. SPACING IN THE MAIN MEMBER. USE A MIN. 0-3-0 MEMBER END DISTANCE.

THE LENGTH OF THE BREAK (C) SHALL NOT EXCEED 12". (C=PLATE LENGTH FOR SPLICE REPAIRS)
 THE MINIMUM OVERALL SCAB LENGTH REQUIRED (L) IS CALCULATED AS FOLLOWS:
 $L = (2) X + C$

THE LOCATION OF THE BREAK MUST BE GREATER THAN OR EQUAL TO THE REQUIRED X DIMENSION FROM ANY PERIMETER BREAK OR HEEL JOINT AND A MINIMUM OF 6" FROM ANY INTERIOR JOINT (SEE SKETCH ABOVE)

TOTAL NUMBER OF NAILS EACH SIDE OF BREAK *		X INCHES	MAXIMUM FORCE (lbs) 15% LOAD DURATION							
			SP		DF		SPF		HF	
2x4	2x6		2x4	2x6	2x4	2x6	2x4	2x6	2x4	2x6
20	30	24"	1706	2559	1561	2342	1320	1980	1352	2028
26	39	30"	2194	3291	2007	3011	1697	2546	1738	2608
32	48	36"	2681	4022	2454	3681	2074	3111	2125	3187
38	57	42"	3169	4754	2900	4350	2451	3677	2511	3767
44	66	48"	3657	5485	3346	5019	2829	4243	2898	4347

* DIVIDE EQUALLY FRONT AND BACK
