RE: Daily Field Report for 01/12/2024
7612 Overhills Road (CMT) Spring Lake, NC
Building & Earth Project No : RD230748

Field Observations Report

Report of Field Density Testing

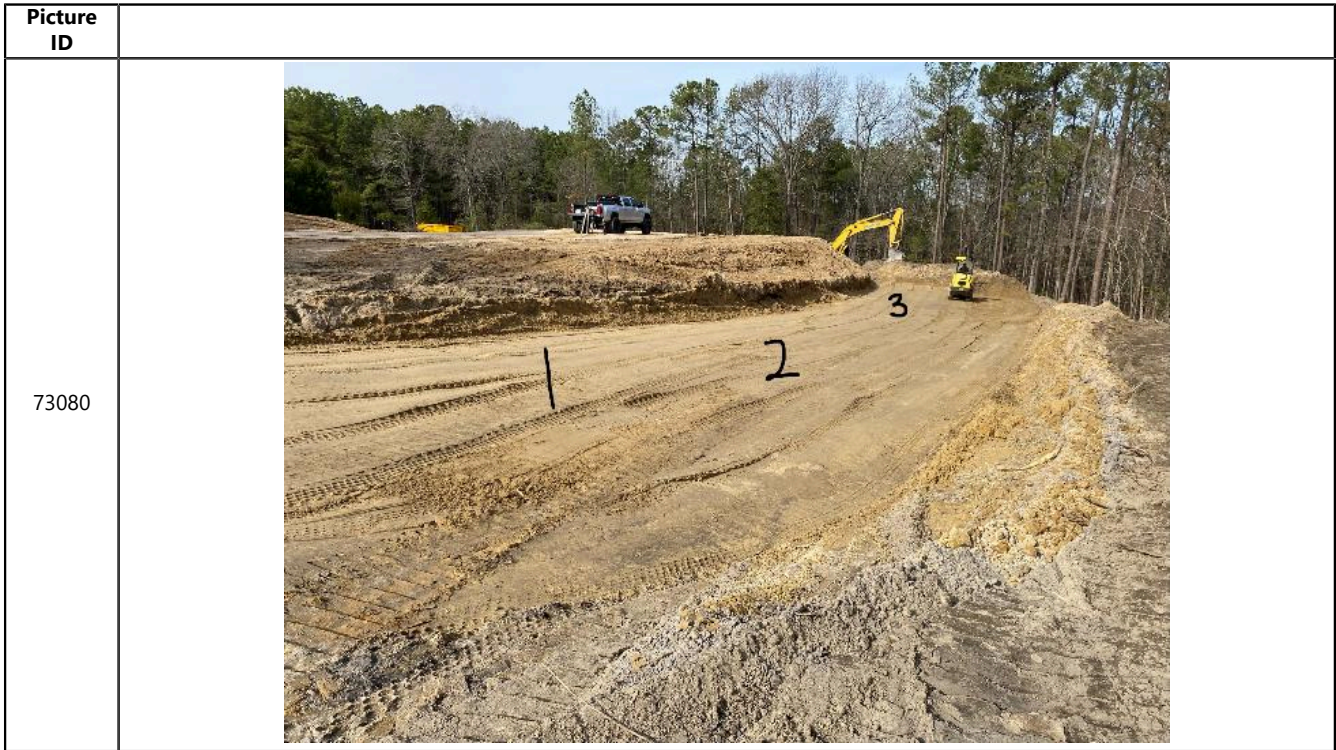
| Picture ID | |
|---|---|
| 73082 | |

| Test # | IDs | | Test Type | Location | Probe Depth (in) | Elev. (ft) | Dry Density(pcf) | % Moisture | % Compaction | Result |
|---|---|---|---|--|---|---|---|---|---|---|
| 3 | fSG-Bldg | Fld 230748 | ASTMD6938 | Structural Fill- Building : Station 1 (see pic) | 8 | FSG -5.5' | 118.8 | 16.2 | 100+ | PASS |
| 4 | fSG-Bldg | Fld 230748 | ASTMD6938 | Structural Fill- Building : Station 2 (see pic) | 8 | FSG -8.5' | 114.8 | 16.8 | 98% | PASS |
| 5 | fSG-Bldg | Fld 230748 | ASTMD6938 | Structural Fill- Building : Station 3 (see pic) | 8 | FSG -11.5' | 113.6 | 17.5 | 97% | PASS |
