ATTACH 2x SCAB OF THE SAME SIZE AND GRADE AS THE BROKEN MEMBER TO EACH FACE OF THE TRUSS (CENTER ON BREAK OR SPLICE) WITH 10d (0.131" X 3") NAILS (TWO ROWS FOR 2x4, THREE ROWS FOR 2x6) SPACED 4" O.C. AS SHOWN. STAGGER NAIL SPACING FROM FRONT FACE AND BACK FACE FOR A NET 0-2-0 O.C. SPACING IN THE MAIN MEMBER. USE A MIN. 0-3-0 MEMBER END DISTANCE.

DO NOT USE REPAIR FOR JOINT SPLICES

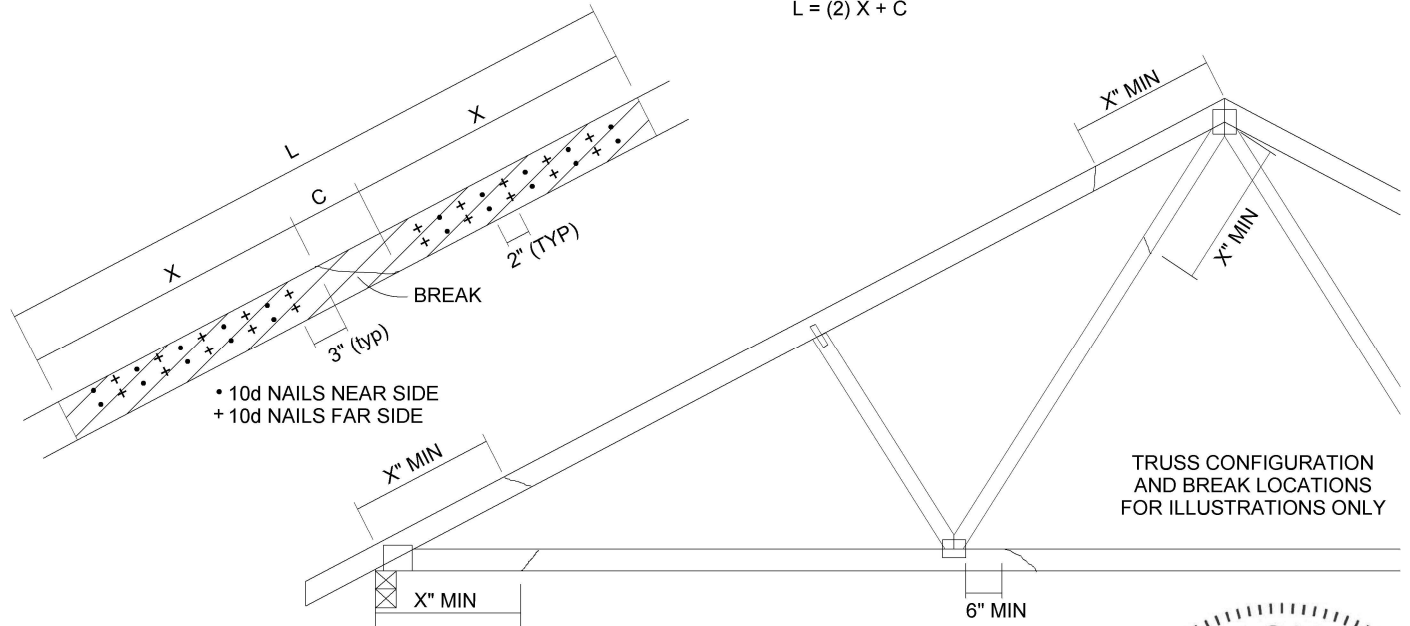
THE LENGTH OF THE BREAK (C) SHALL NOT EXCEED 12". (C=PLATE LENGTH FOR SPLICE REPAIRS)
 THE MINIMUM OVERALL SCAB LENGTH REQUIRED (L) IS CALCULATED AS FOLLOWS:
 $L = (2) X + C$

THE LOCATION OF THE BREAK MUST BE GREATER THAN OR EQUAL TO THE REQUIRED X DIMENSION FROM ANY PERIMETER BREAK OR HEEL JOINT AND A MINIMUM OF 6" FROM ANY INTERIOR JOINT (SEE SKETCH ABOVE)

TOTAL NUMBER OF NAILS EACH SIDE OF BREAK *		X INCHES	MAXIMUM FORCE (lbs) 15% LOAD DURATION							
			SP		DF		SPF		HF	
2x4	2x6		2x4	2x6	2x4	2x6	2x4	2x6	2x4	2x6
20	30	24"	1706	2559	1561	2342	1320	1980	1352	2028
26	39	30"	2194	3291	2007	3011	1697	2546	1738	2608
32	48	36"	2681	4022	2454	3681	2074	3111	2125	3187
38	57	42"	3169	4754	2900	4350	2451	3677	2511	3767
44	66	48"	3657	5485	3346	5019	2829	4243	2898	4347

* DIVIDE EQUALLY FRONT AND BACK
